AUBURN VILLAGE SCHOOL  
AUBURN, NEW HAMPSHIRE

## FACILITY ASSESSMENT FINAL REPORT

MAY 13, 2013

Facility Assessment Audit

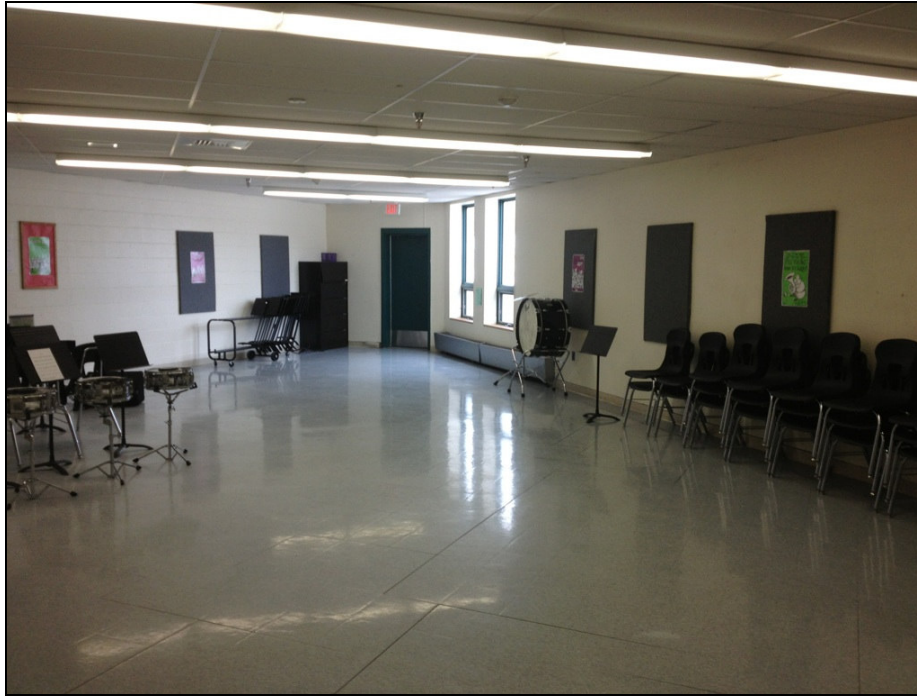
1. Flooring Example: Note the large cracks/separation in floor tile joints.  
(Photo from: First floor music room - 80's wing.)

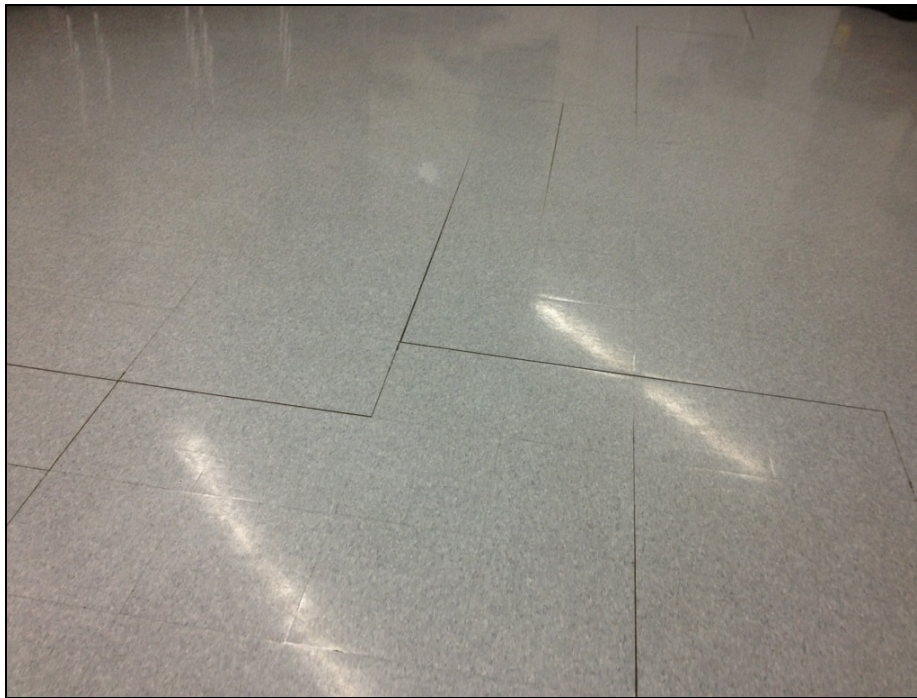
2. Flooring Examples: Another example of floor tile joint separation.  
(Photo from: First floor perimeter classroom.)

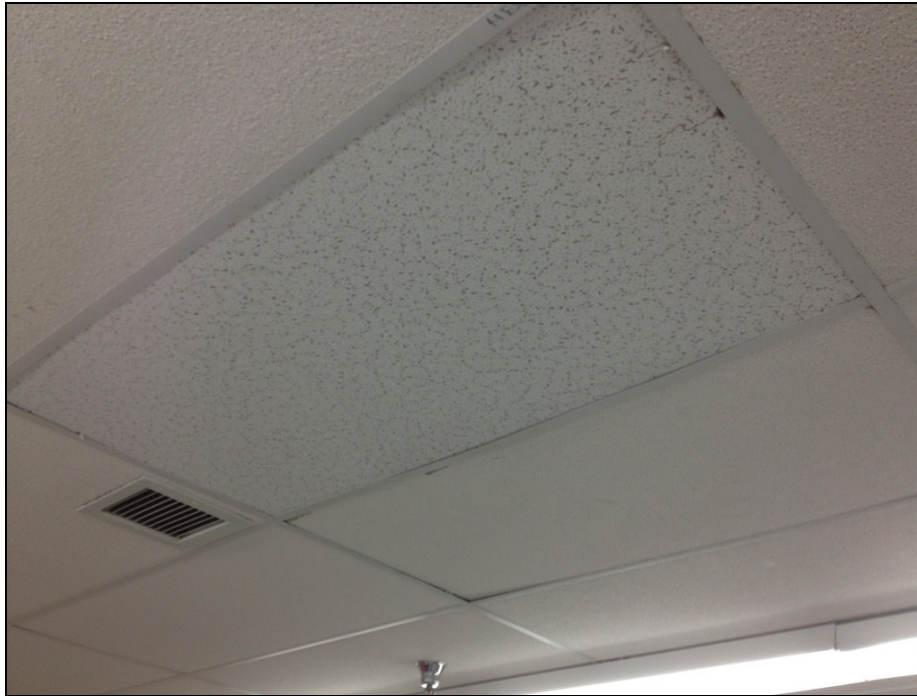
5. Ceiling Example: Mix of different styles and conditions of ceiling tile.  
(Photo from: First floor perimeter classrooms in the 80's wing.)

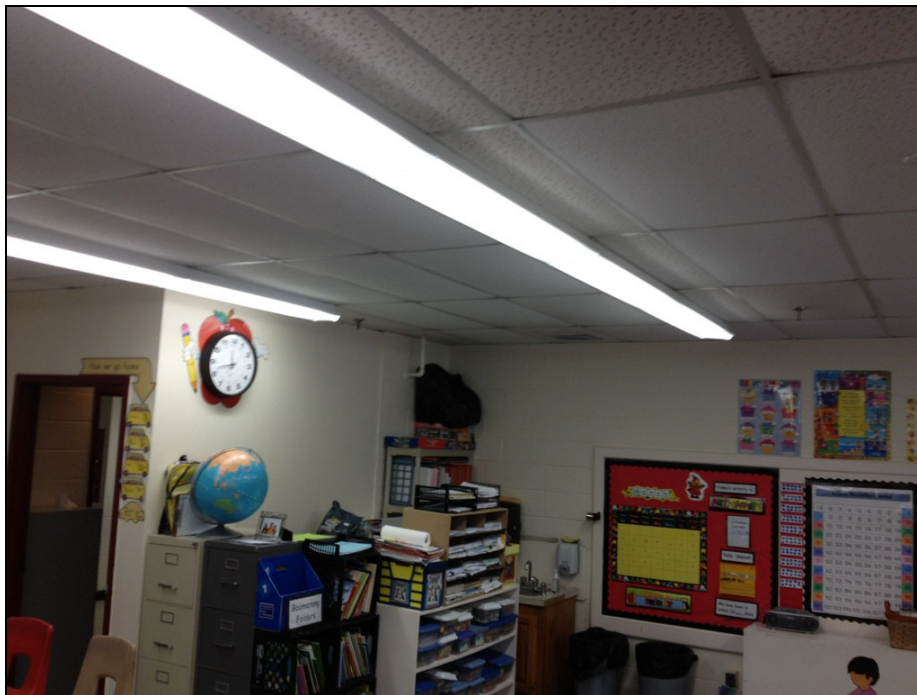
6. Ceiling Example: Several areas of ceiling tiles cupping and curling. Signs of moisture and air leakage about the ceilings. (Photo from: 60's wings.)

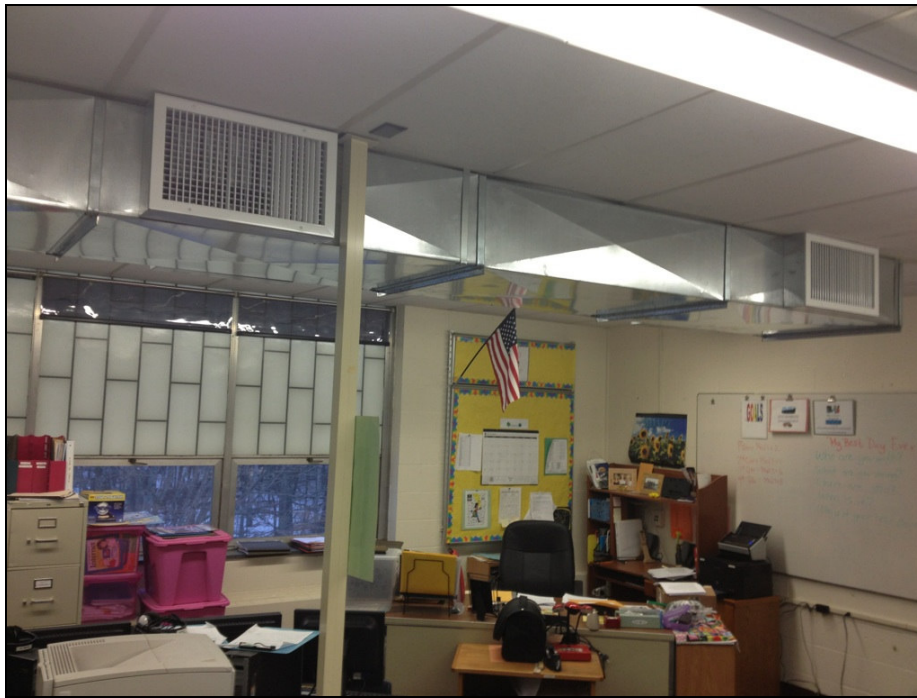
7. Ceiling Example: Exposed ductwork running through classroom.  
(Photo from: Second floor computer lab.)

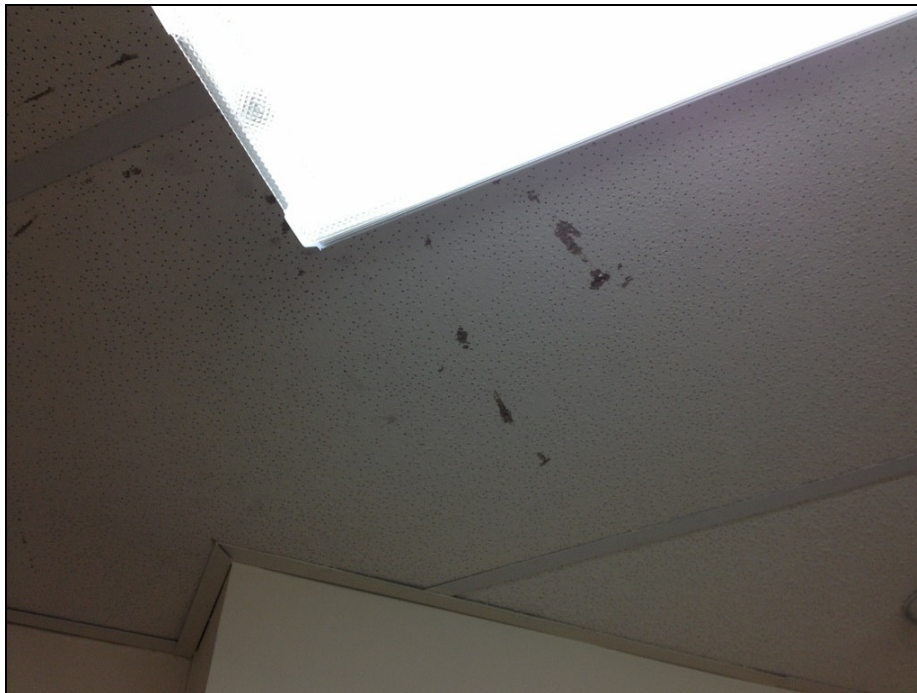
8. Ceiling Example: Most tiles throughout the building are fair condition; however, there are a few that are damaged and stained.

Isolated ceiling tiles that are water stained, dirty, or damaged should be replaced on a yearly basis at the end of each school year. Since appearance is purely aesthetic, replacement is not mandatory. The additional insulation placed above the ceiling should be realigned as it was originally intended.

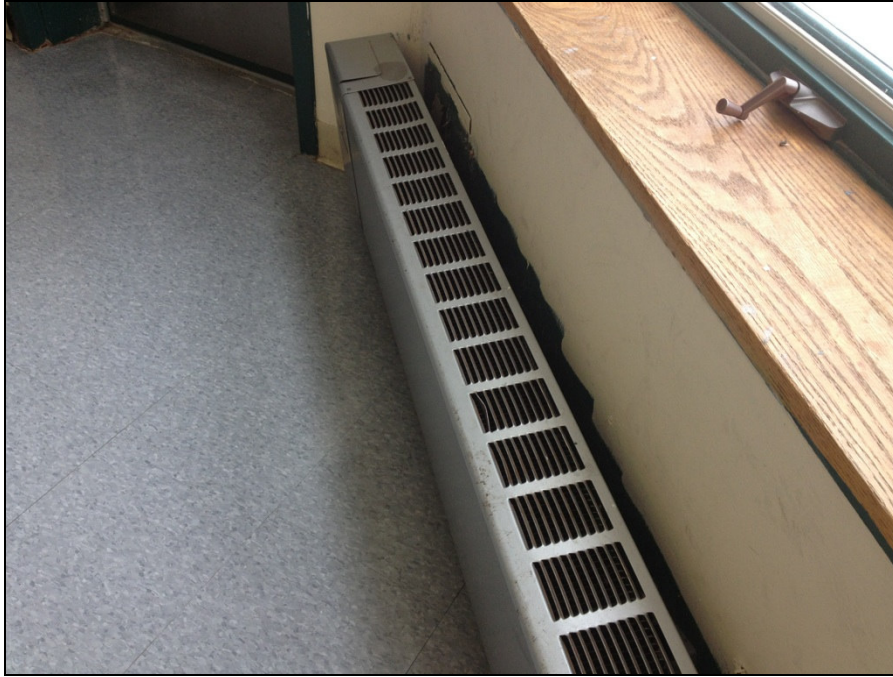
9. Wall Issue Examples: Several areas of fin tube pulling away from the wall. The fin tube is not properly attached to the stud and gypsum walls.  
(Photo from: Lower level classroom - 80's wing.)

In the short-term, we recommend repairing all the holes in the gypsum walls. Sealant failures near the windows should be addressed and the wall areas in back of the radiators should be repaired. The areas behind the radiators will most likely require the addition of blocking to help better support the radiator.

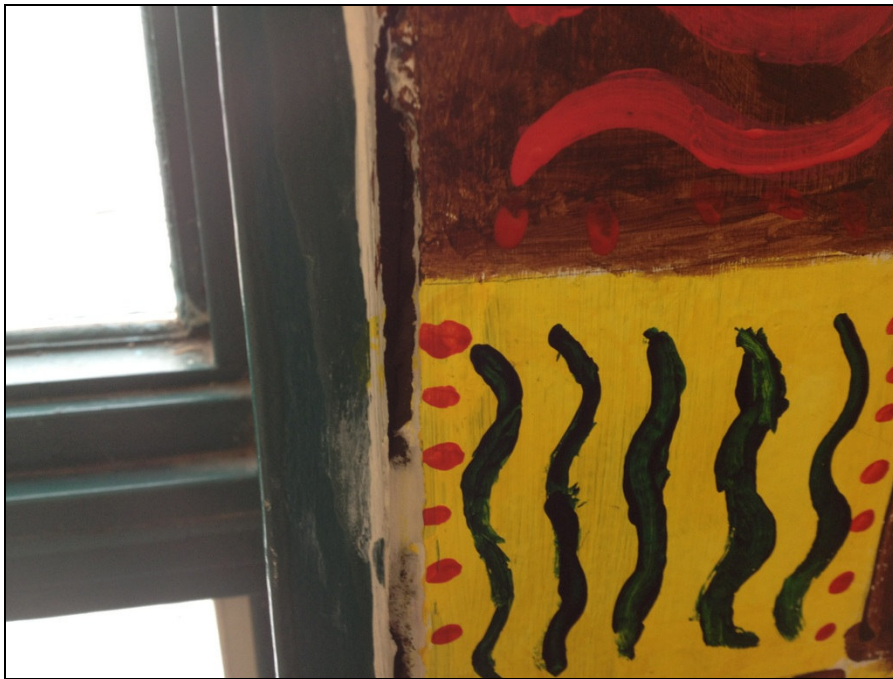
10. Wall Issue Example: Large gaps between interior window trim and gypsum wall board. This shows signs of wood trim warping and sealant joint failures.  
(Photo from: Second floor art room - 80's wing.)

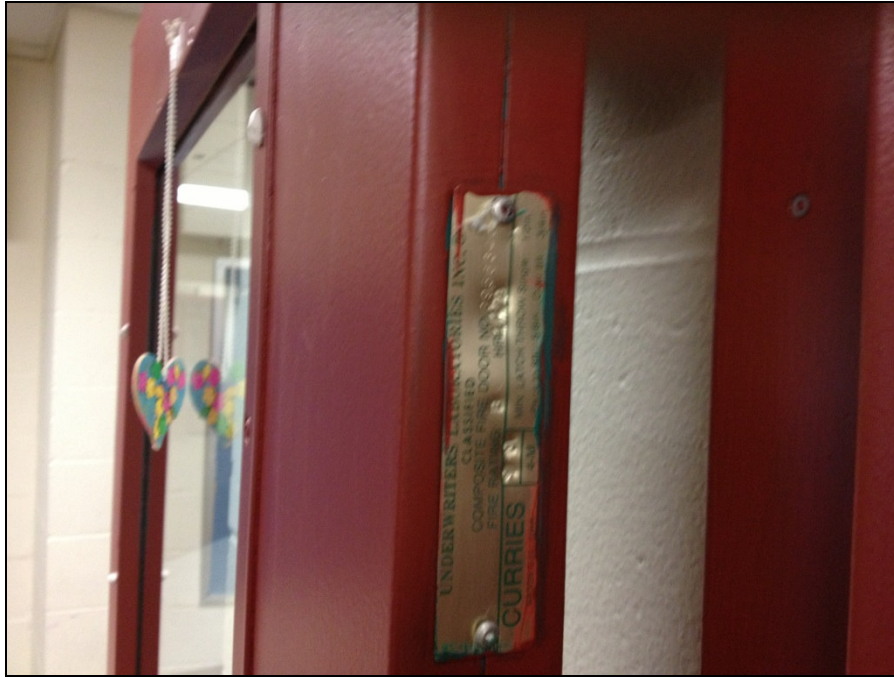
11. Door Rating: Interior classroom doors with 90 minute rated labels.  
(Photo from: First floor perimeter classroom.)

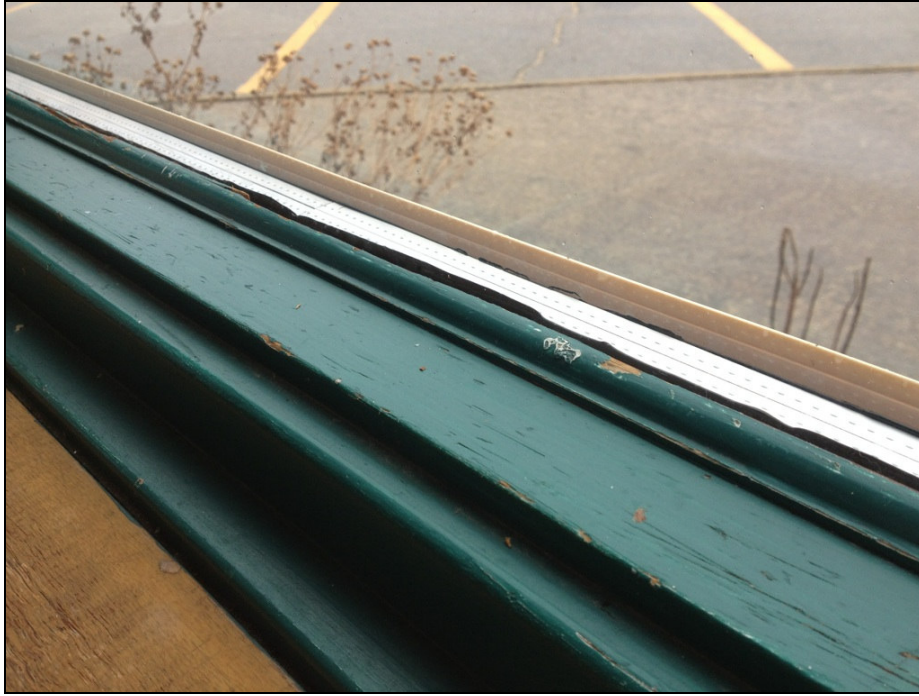
13. Windows: A few windows in the 80's wing have failed or show signs of window failure. (Photo from: Cafeteria windows.)

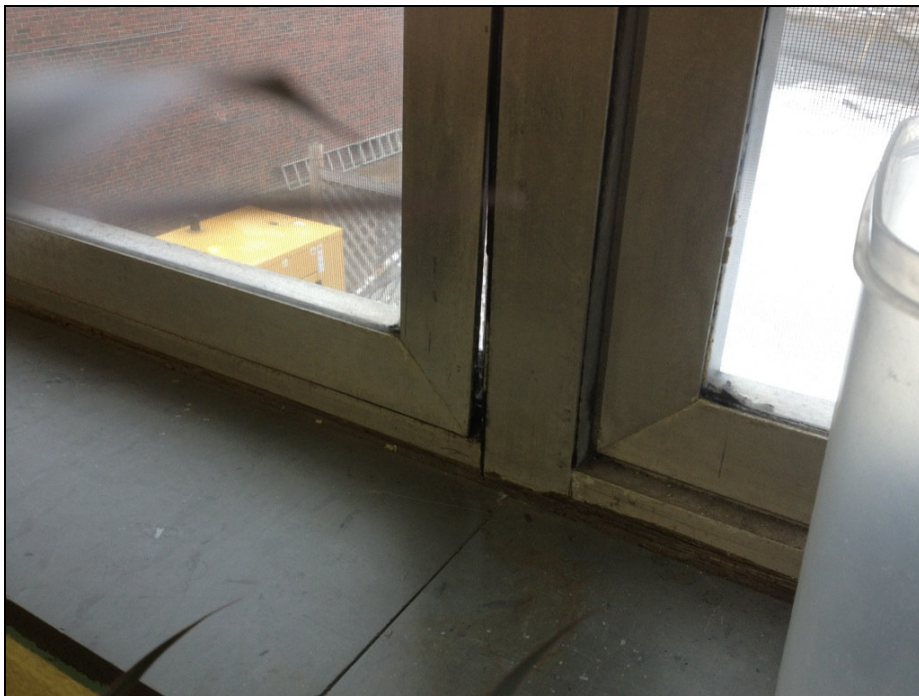
14. Windows: Older 60's windows are single glazed windows and do not shut correctly. (Photo from: Second floor 60's wing.)

In the short-term, the old steel windows and Kalwall panels in the pre-1988 sections of the school should be replaced with new energy saving windows.

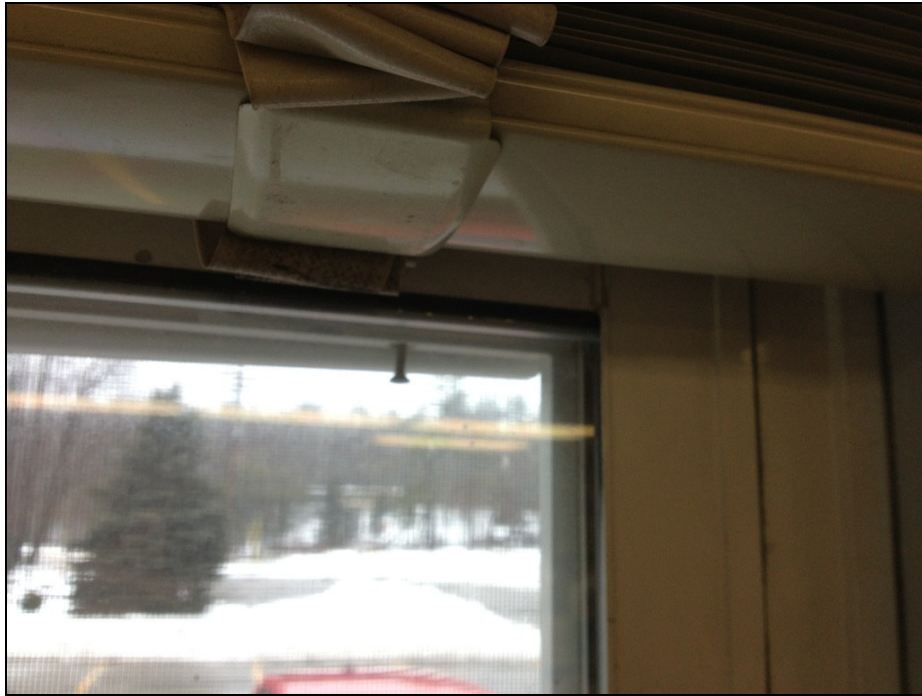
15. Window Example: Some windows in 40's area of building are failing and screws are coming out of frames and grilles. (Photo from: Assistant Principals Office.)

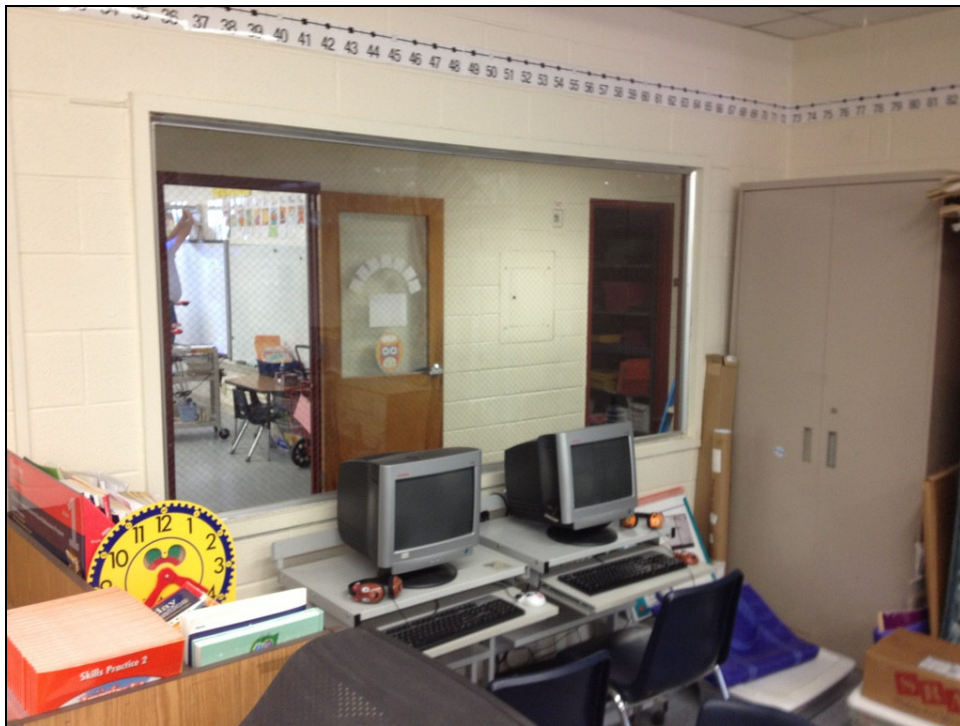
16. Window Examples: Large interior window openings to corridor with wire glass. (Photo from: First floor 60's classroom.)

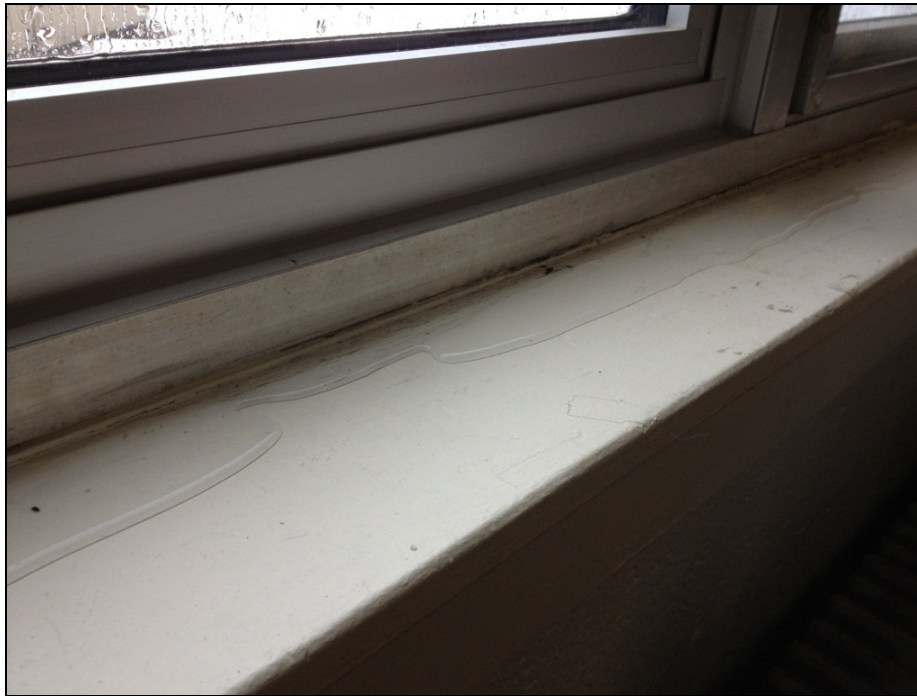
17. Window Leaks: Exterior window has visible water pooling on the window sill from failing windows. (Photo from: 40's classroom.)

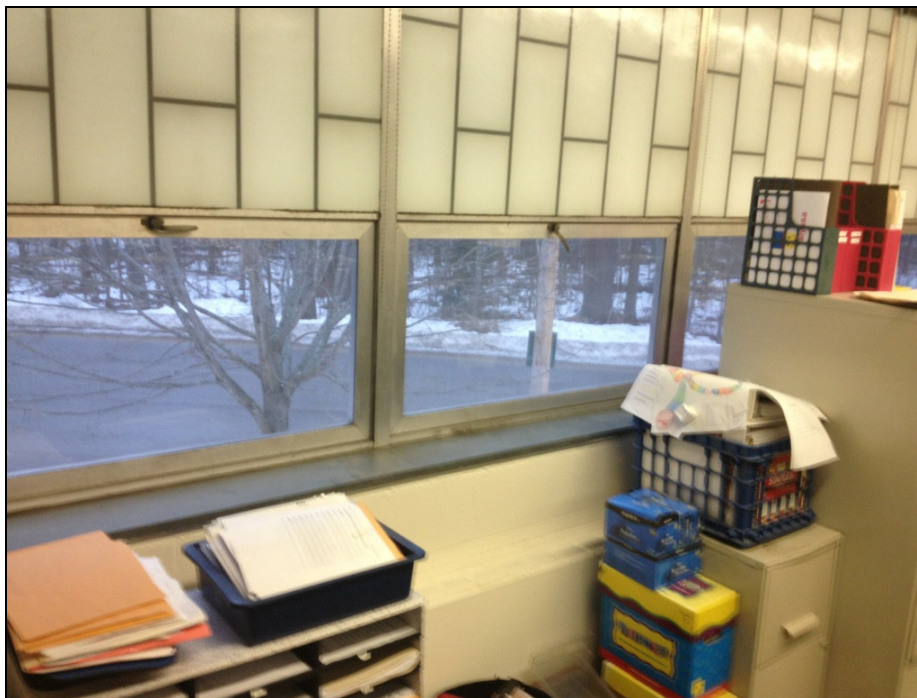
18. Windows: Kalwall panels over single glazed casement windows. (Photo from second floor 60's classroom.)

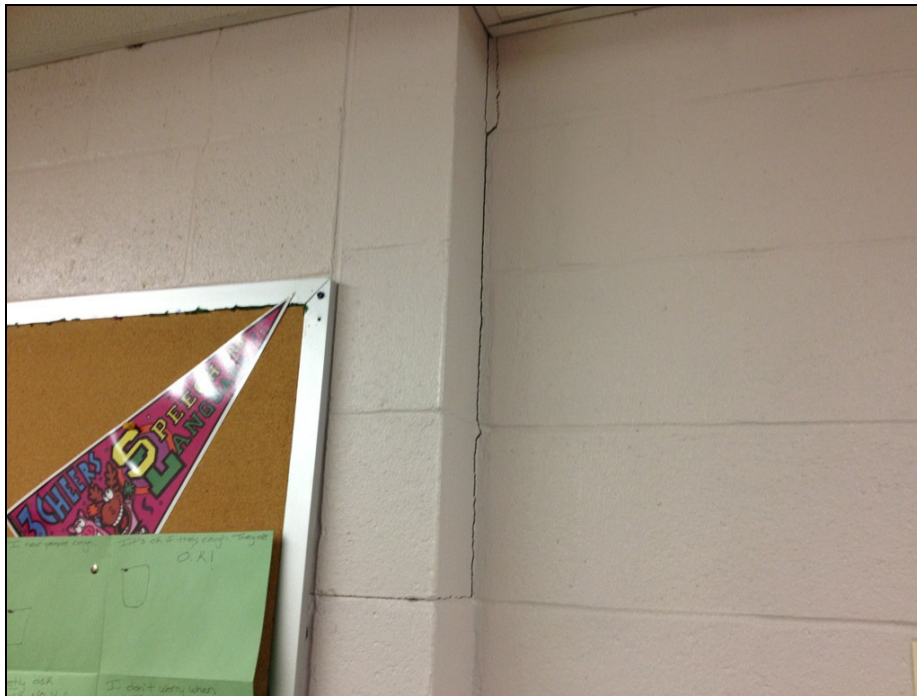
29. Cracking Examples: Settlement and cracking dissimilar materials or eras in construction.

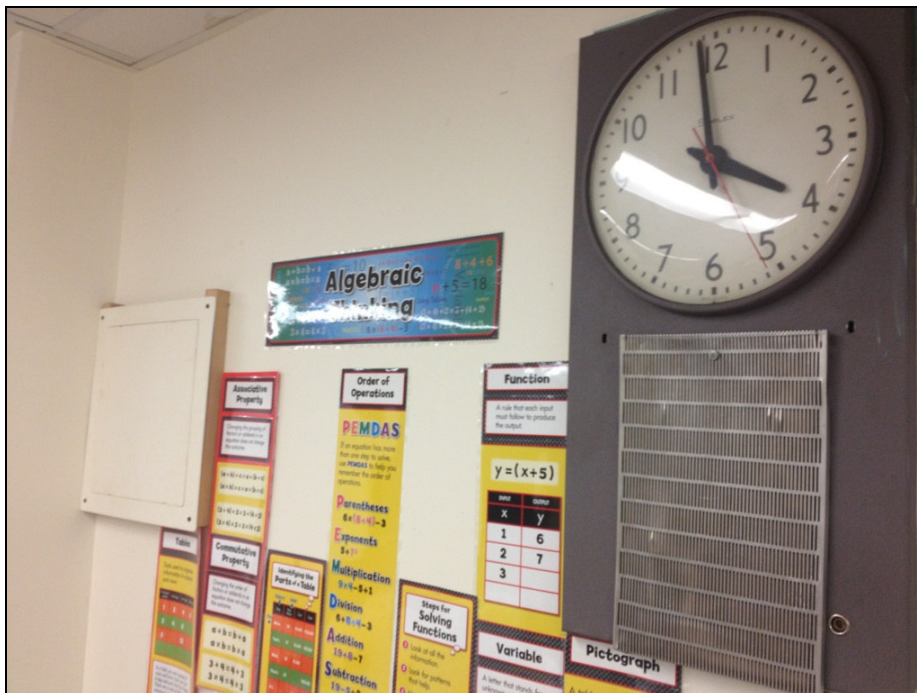
30. Old clocks and PA system. Some do not work and many have already been replaced. (Photo from: Second floor 60's/80's wing.)

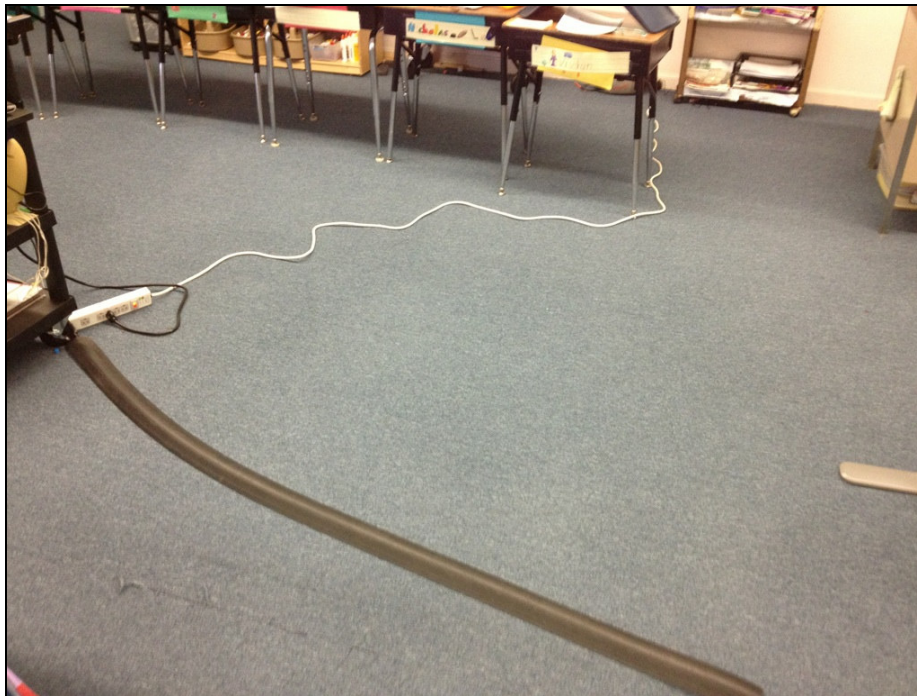
31. Tripping Hazard: Power cords/power strips stretched across the floor.  
(Photo from: Attached modular classroom.)

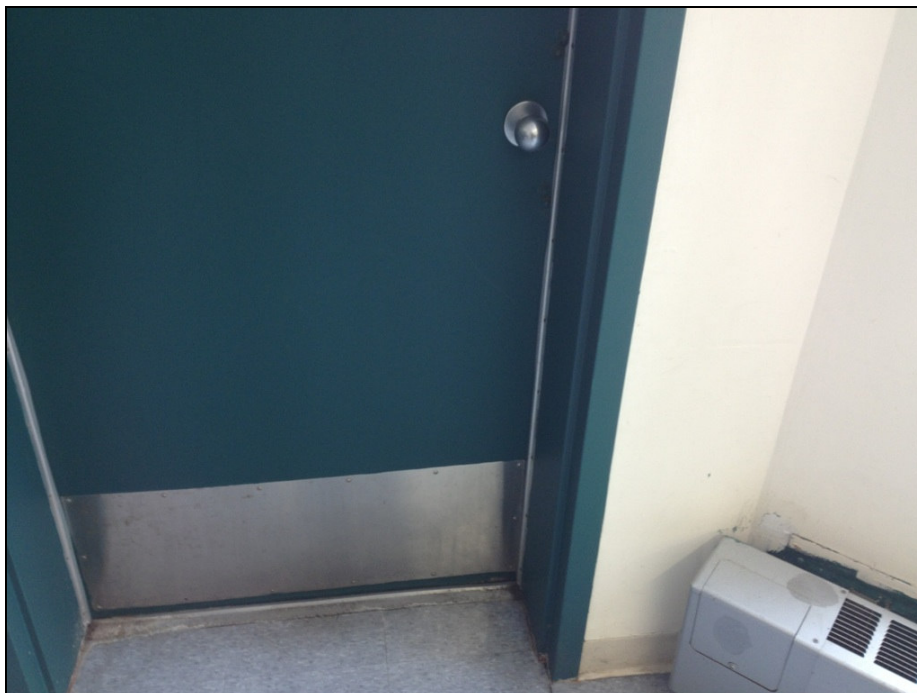
32. ADA Issues: Example of door with non-lever handle at exterior door. Also  
note fin tube coming away from the wall.  
(Photo from: First floor music classroom - 80's wing.)

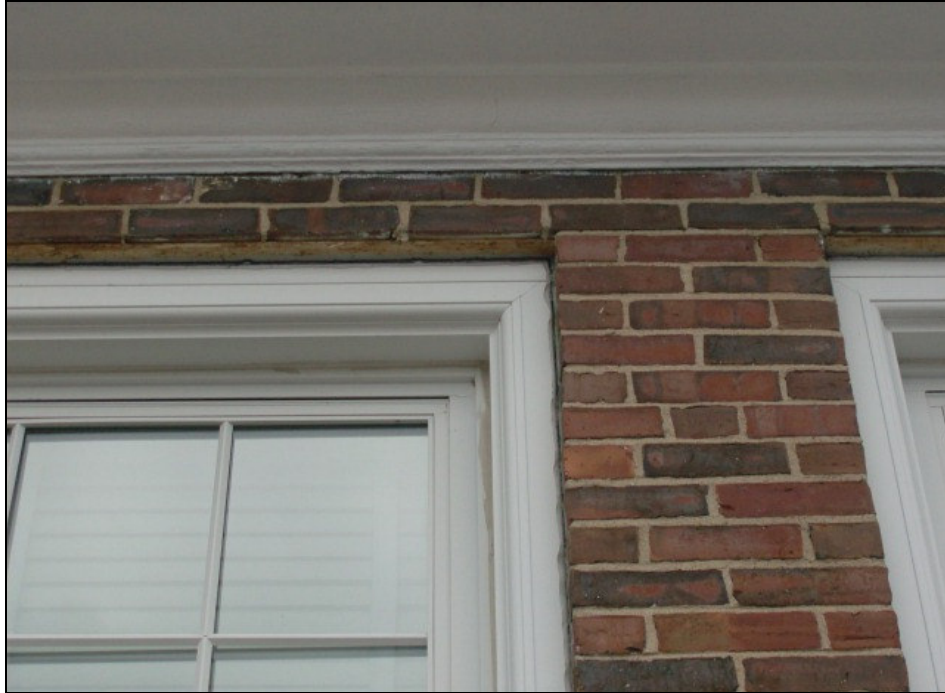
Rusted lintels over windows (1940's wing).

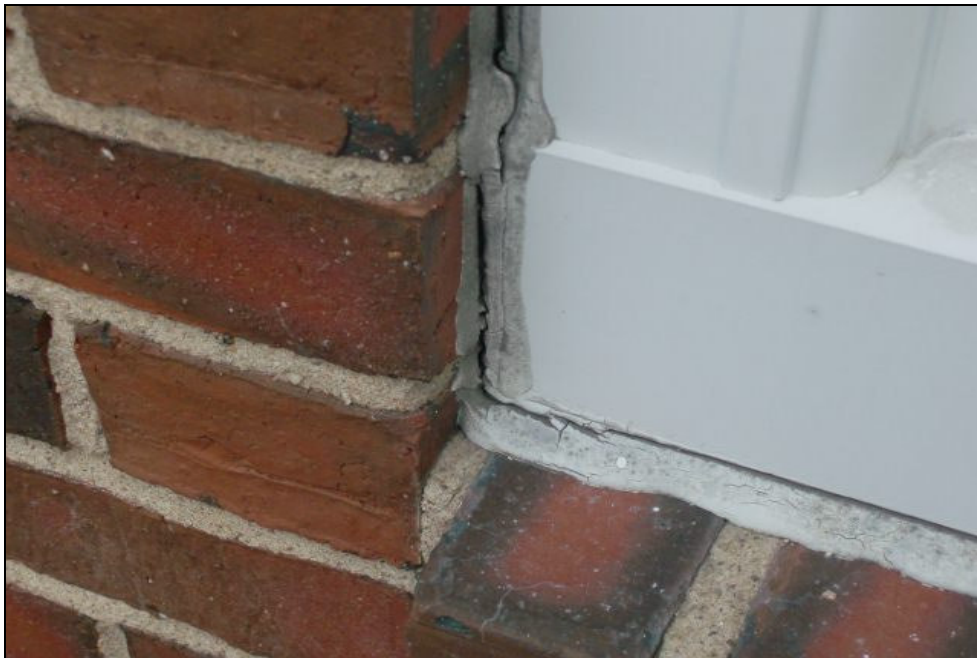
Deteriorated caulking around window (1940's wing).

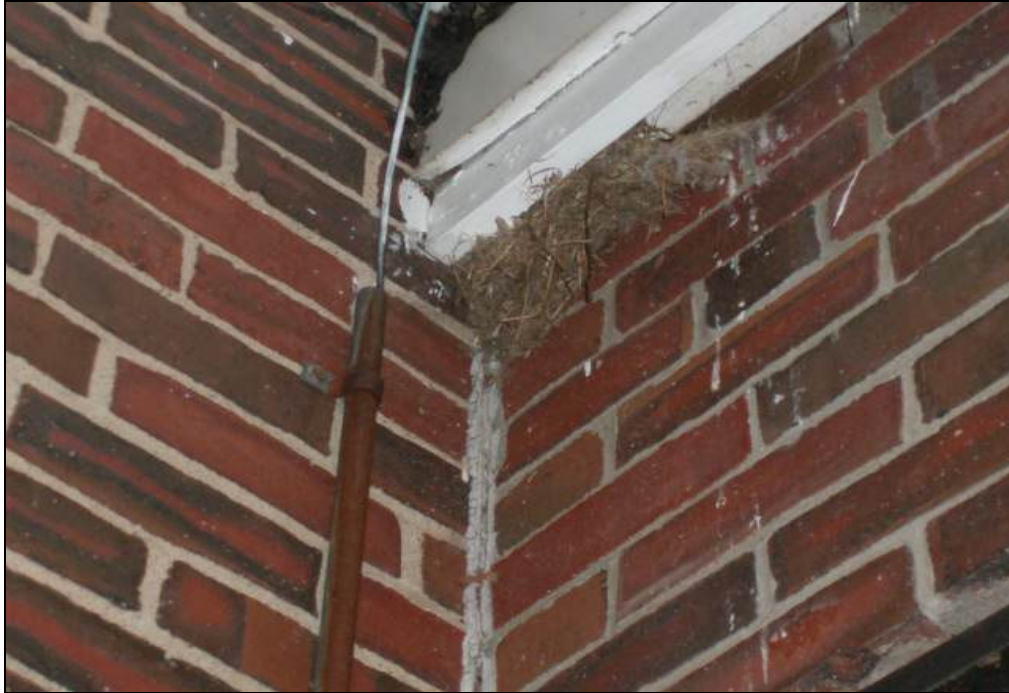
Gaps between trim boards and brick allow birds to nest.

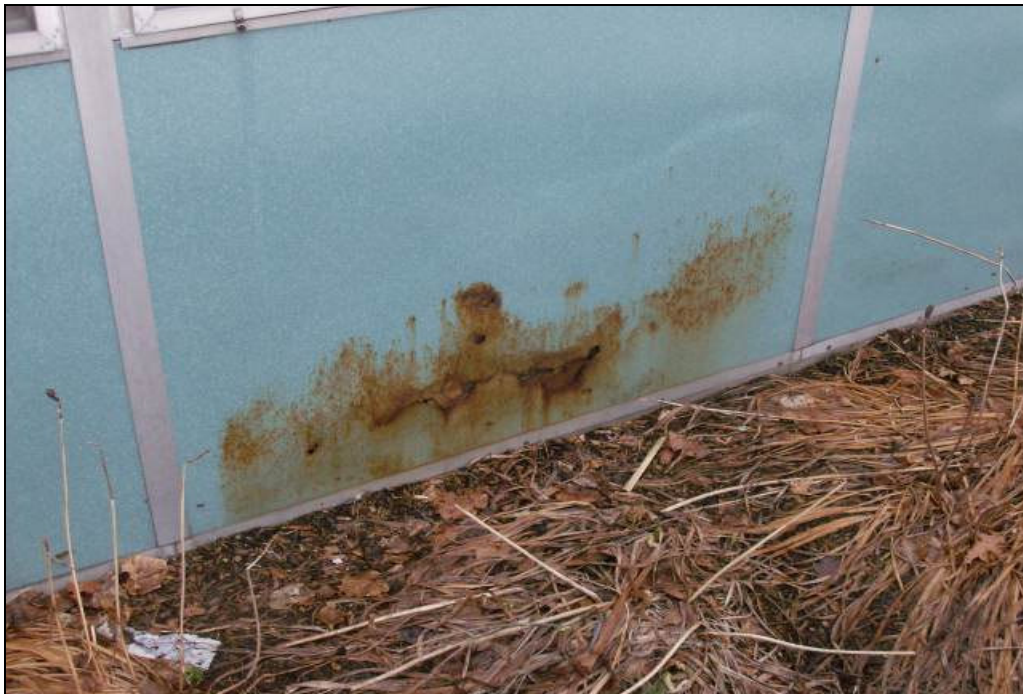
Rusted metal panel below Kalwall window, Eaton Hill Road side.  
Note grade is at bottom of window unit frame.

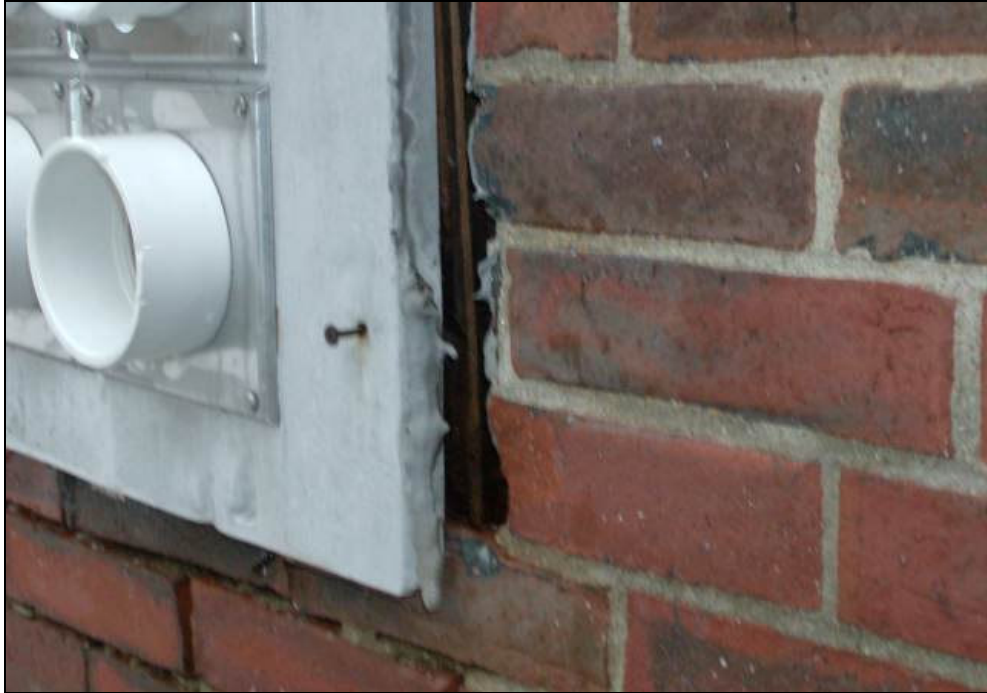
Large gaps at trim around boiler combustion air intake.

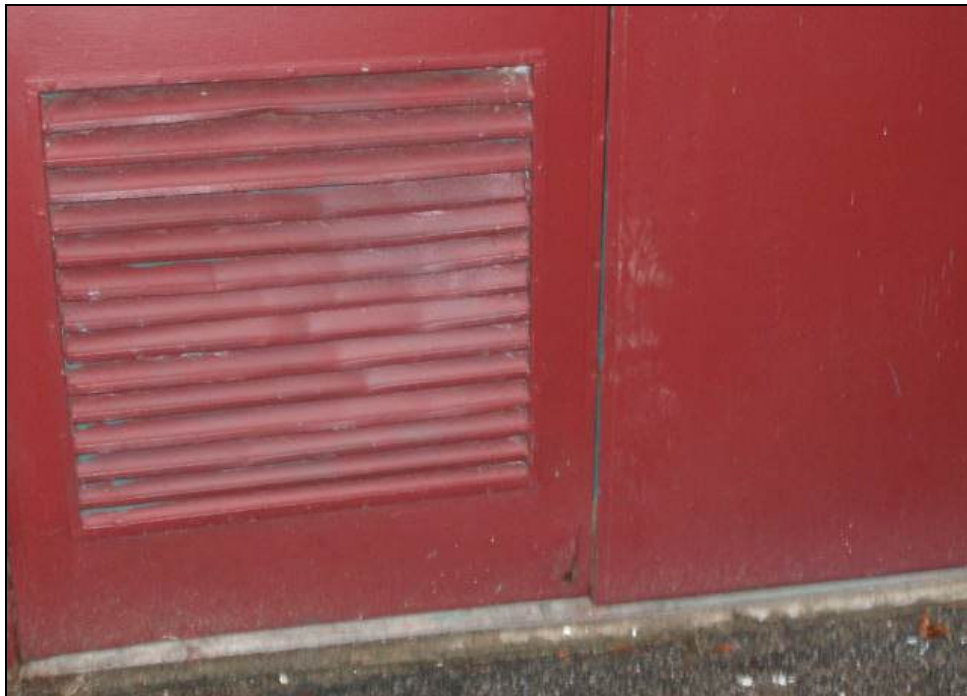
Boiler room door is in need of replacement.

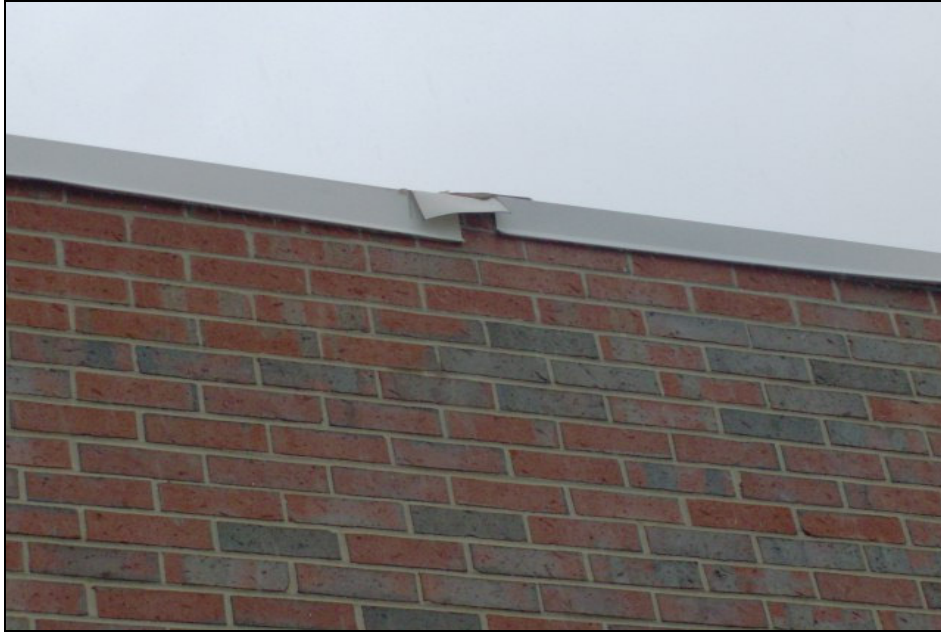
Damaged and missing edge trim at cafeteria.

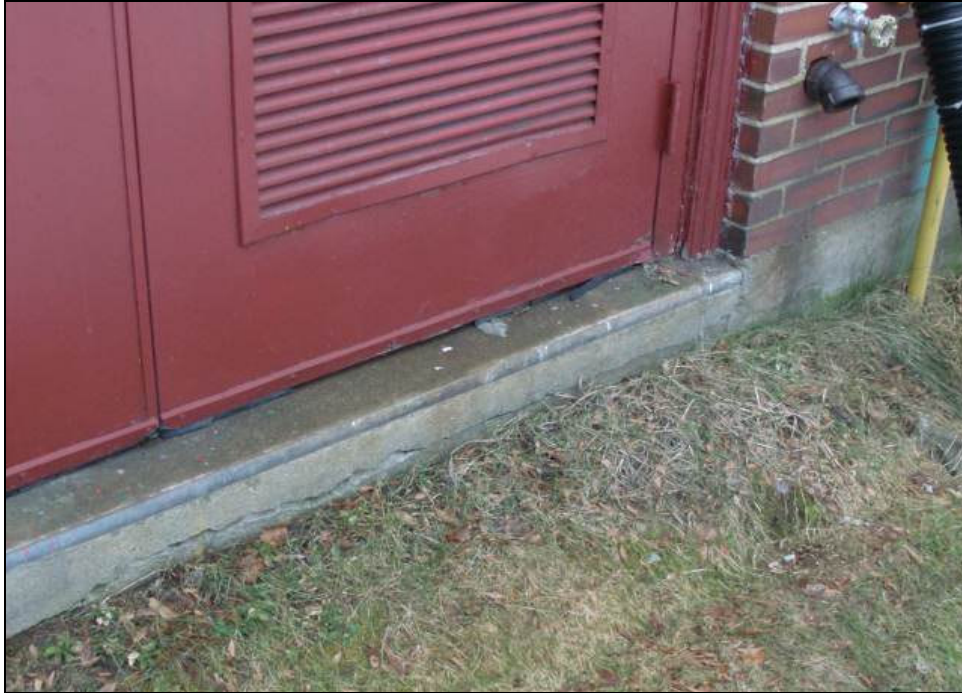
Damaged and deteriorated weather-stripping at door to the original boiler room.

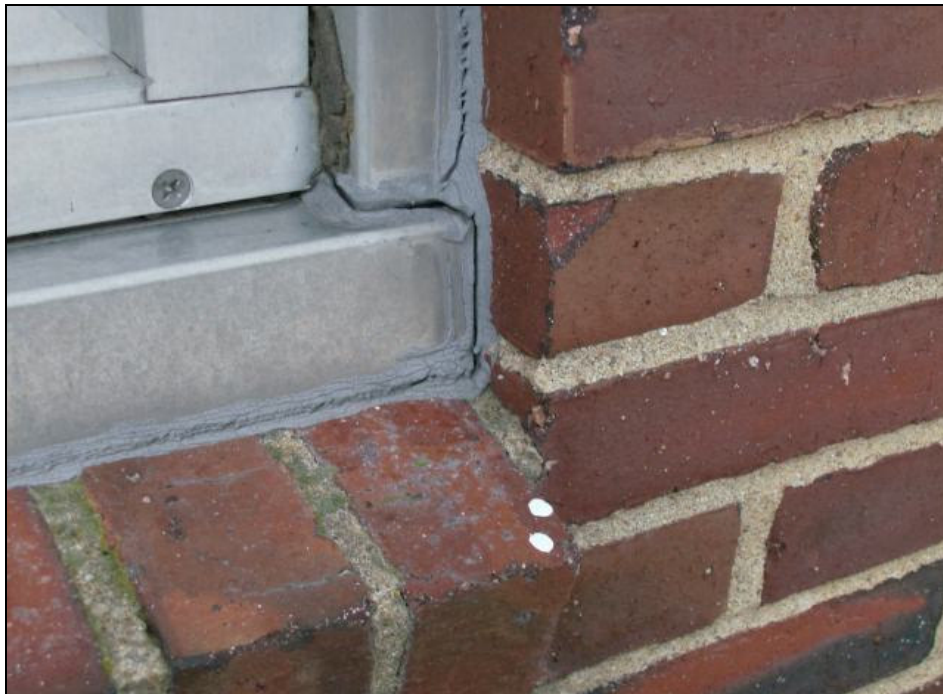
Failed caulking around Kalwall window frame (rear of 1940's wing).

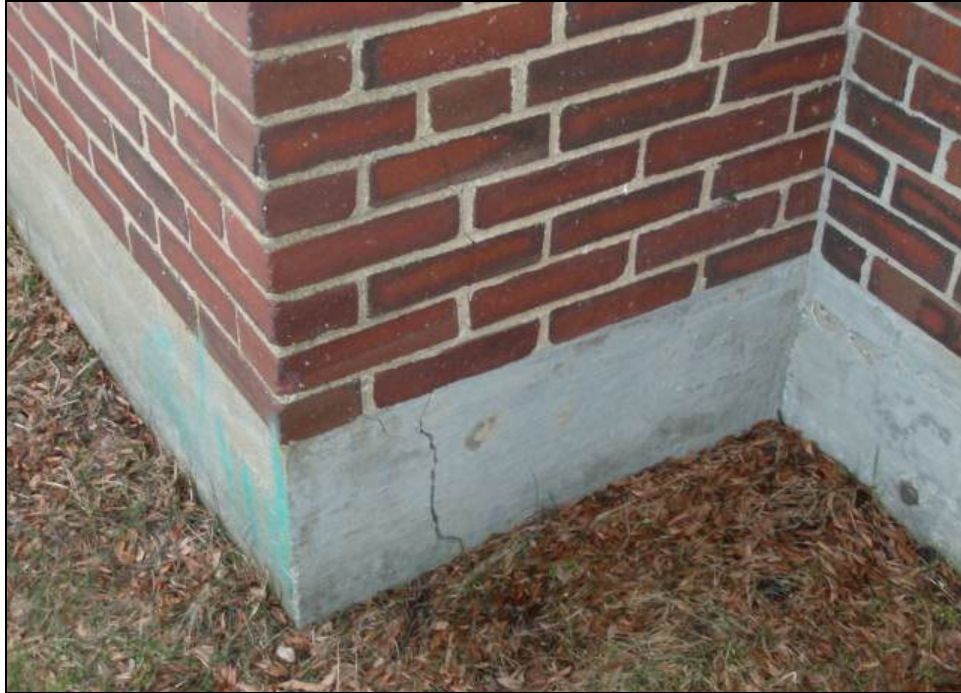
Foundation crack, intersection of 1940's wing and 1960's wing.

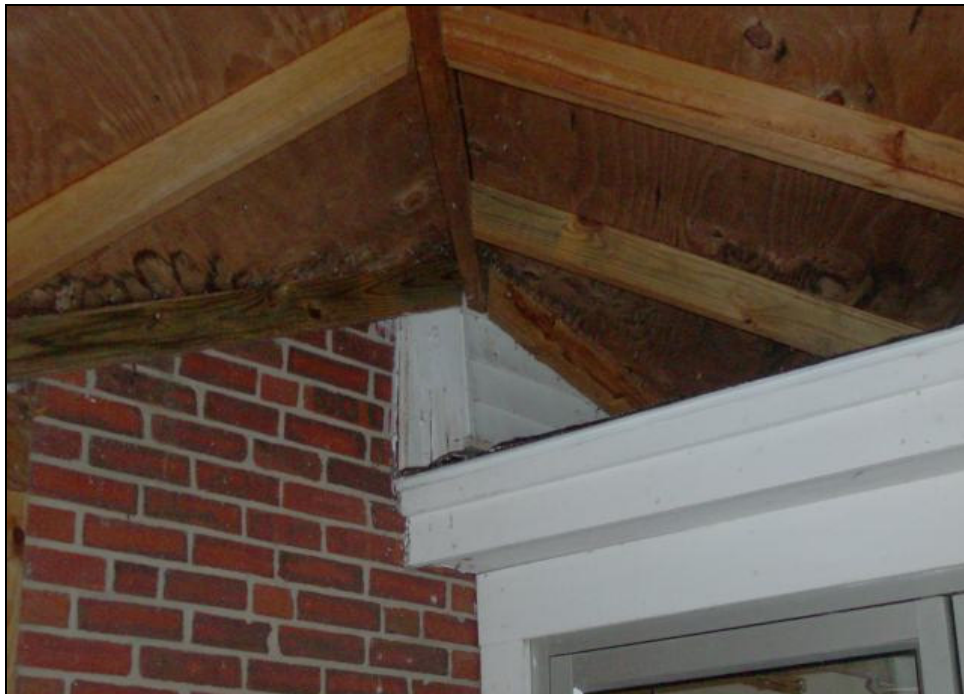
Wood framed roof over walkway to portables.  
Roof is framed directly to the main building.

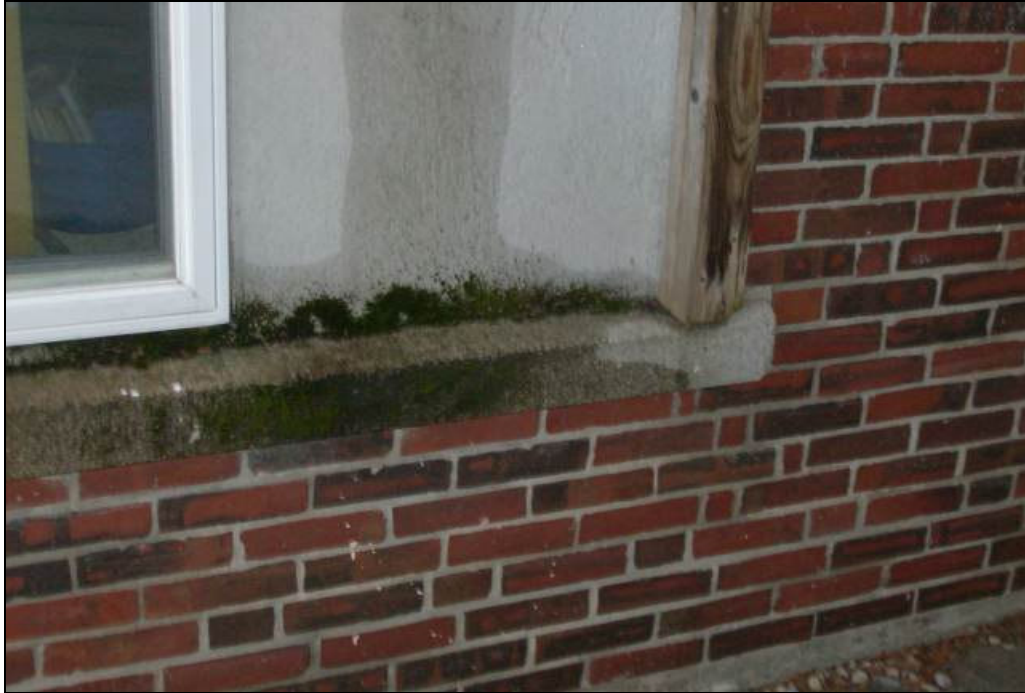
Moss growing on concrete panel. Moisture is from roof over covered walkway.  
Wood post supports walkway roof.

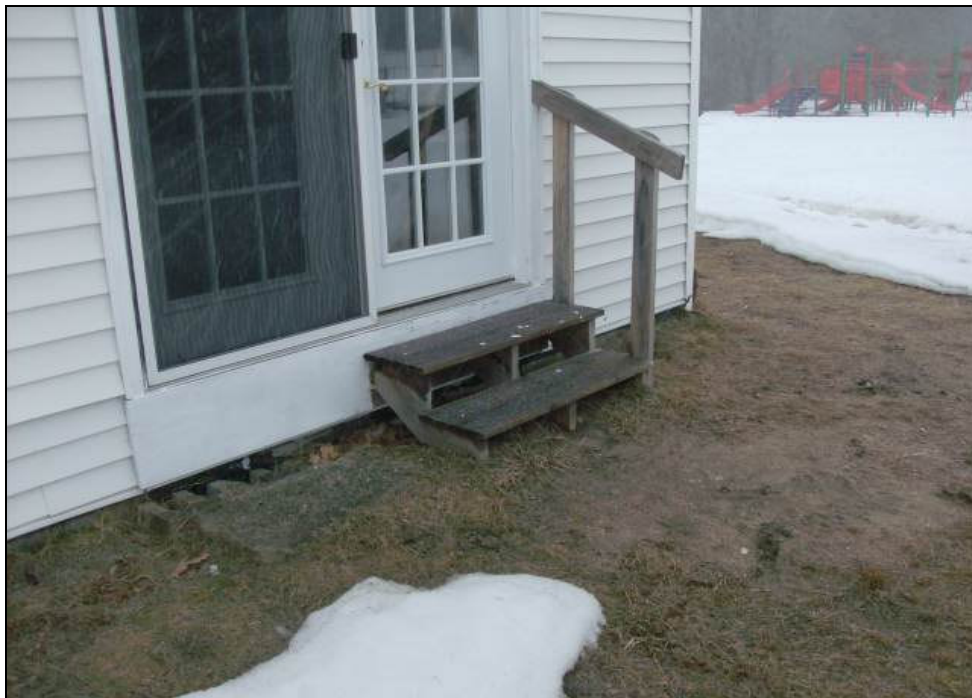
Non-compliant stairway from 1988 classroom.

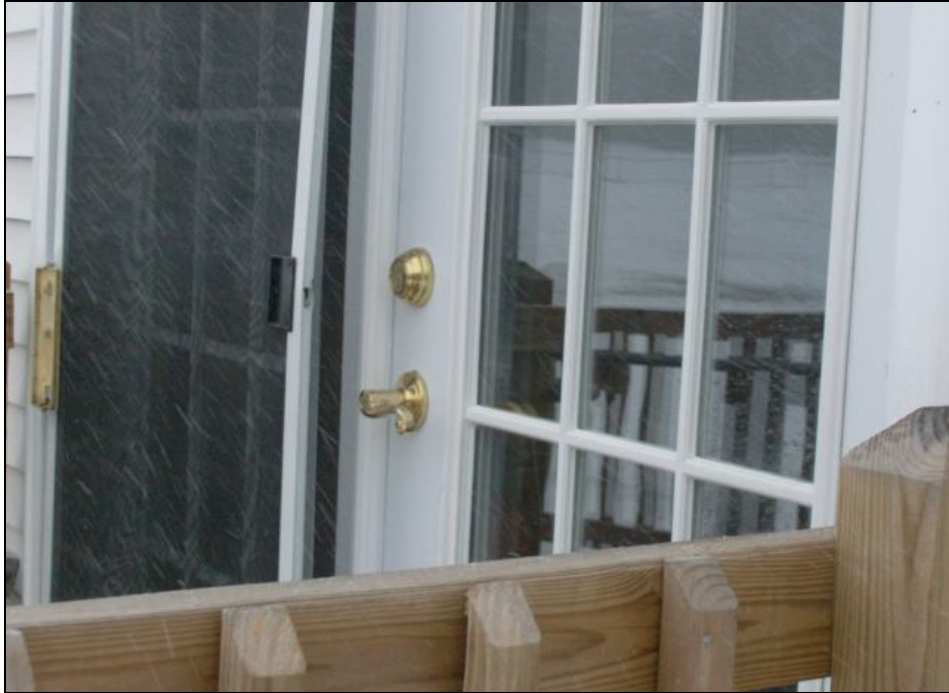
Damaged screen door (1988 classrooms).

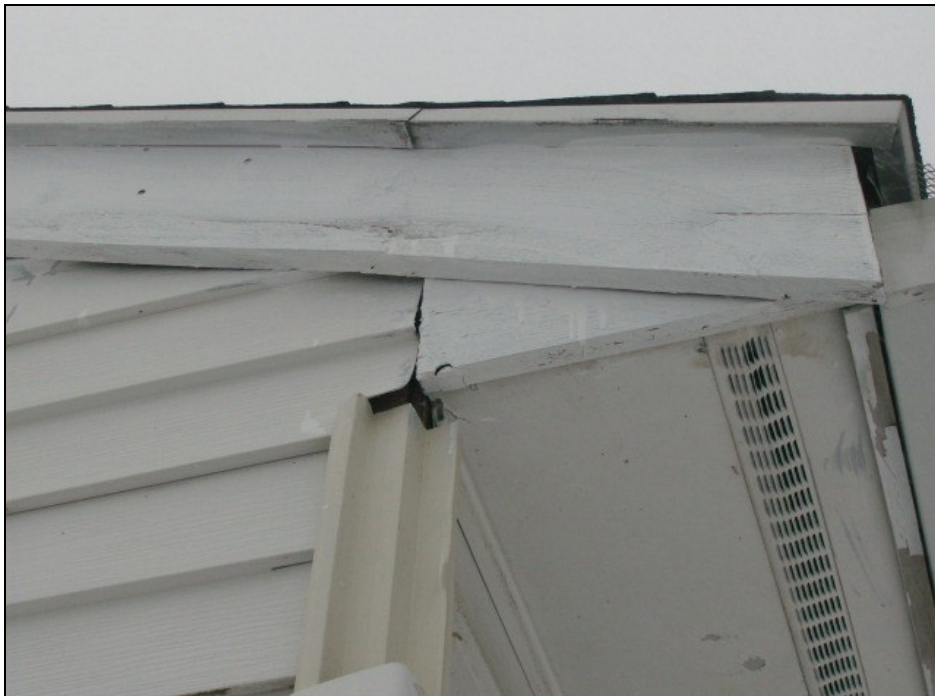
Paint peeling from trim boards at rake and soffit (note open gaps).
