AUBURN VILLAGE SCHOOL  
AUBURN, NEW HAMPSHIRE

## FACILITY ASSESSMENT FINAL REPORT

MAY 13, 2013

Facility Assessment Audit

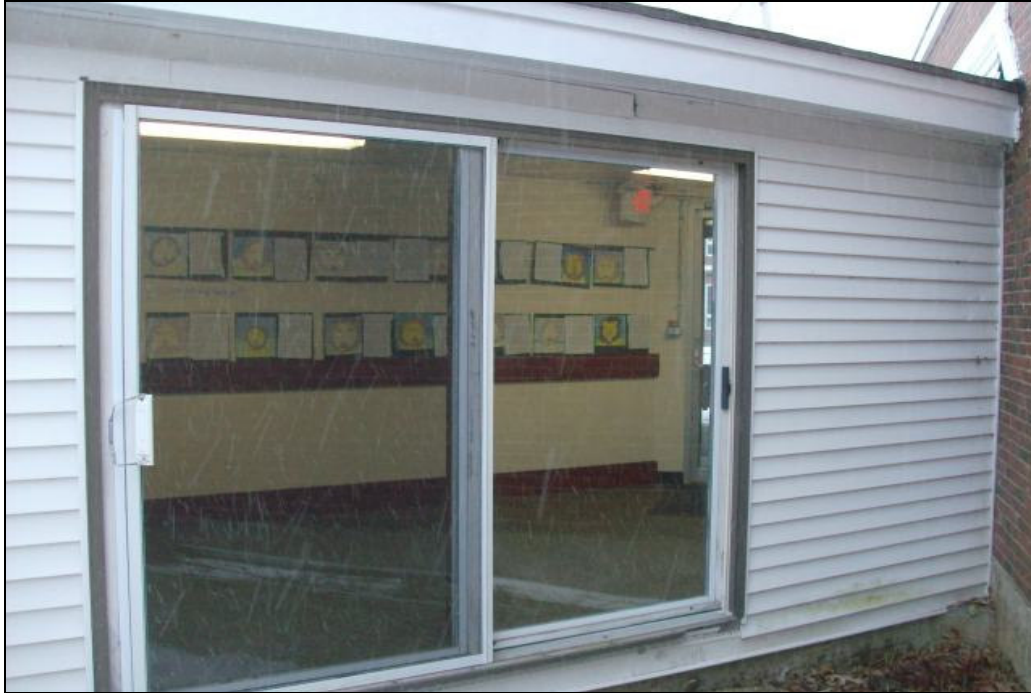
Sliding door in corridor between 1988 classrooms and 1960's wing  
Door is badly deteriorated and is not used as an egress.

Sliding Door in Corridor between 1988 and 1960's Wings	Door is deteriorated and is no longer used as an exit.	Replace door with a window system.	5 years		\$3,500

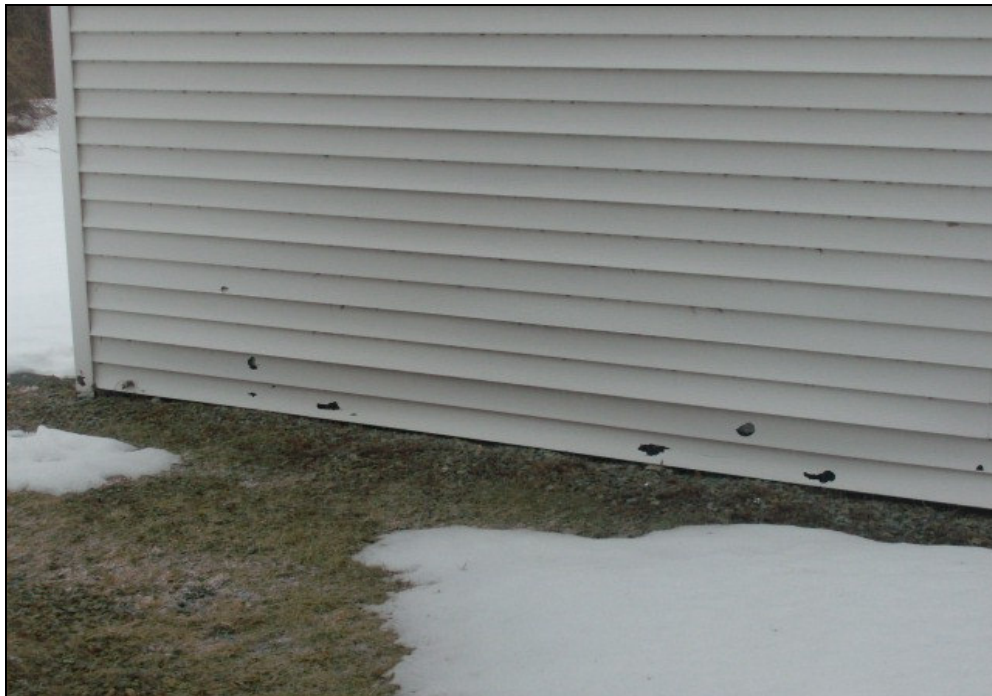
Damaged vinyl siding along lower sections of 1988 classroom wing.

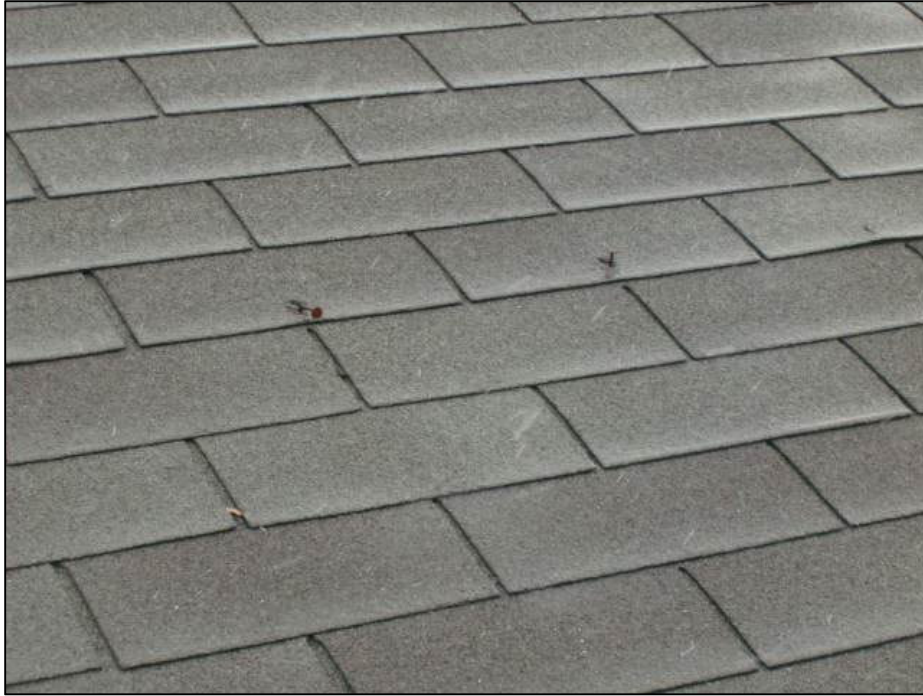
Roof over stick built classrooms – nails popping.

- Within the next two years, replace the shingles on the 1995 stick-built classrooms and replace the membrane roofing on the cafeteria, and the roofing on the 1988 classroom wing.

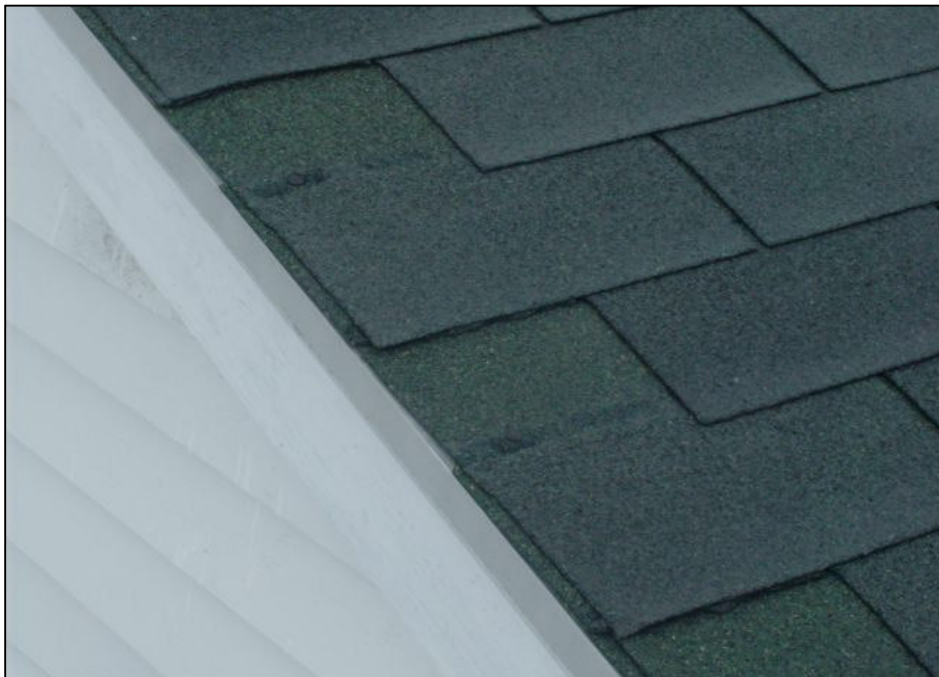
Roof over stick built classrooms – missing shingles along edge.

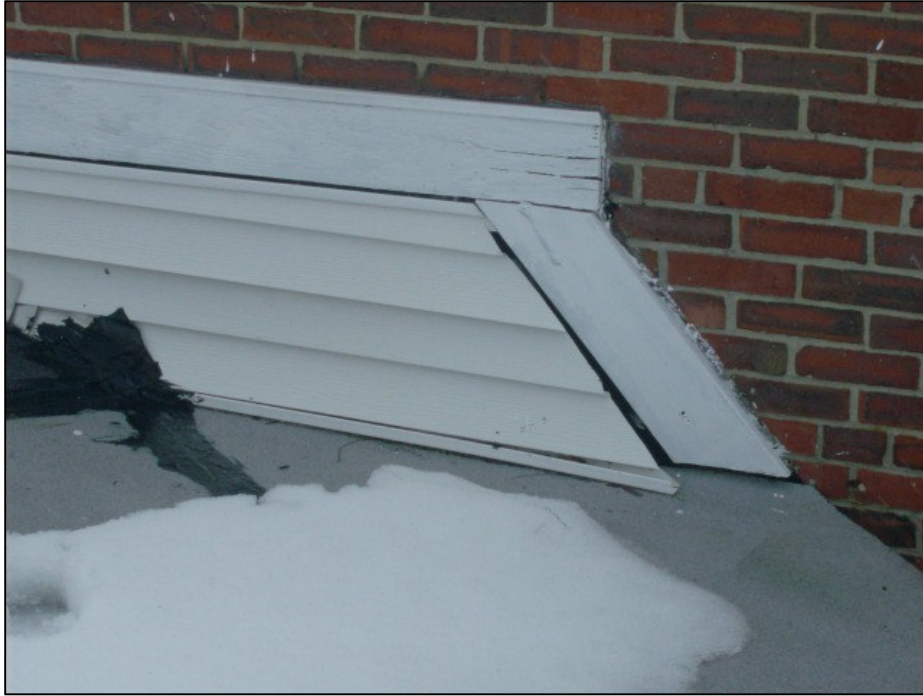
Deteriorated trim and loose siding where walkway roof joins classroom.

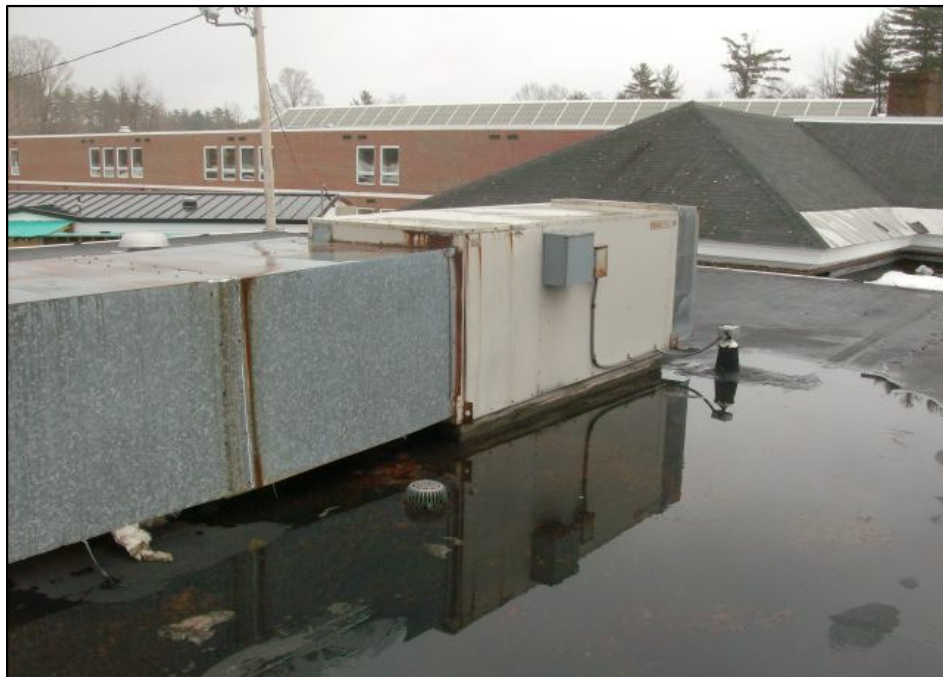
Water ponding around AH unit. Low room of 1960's wing.

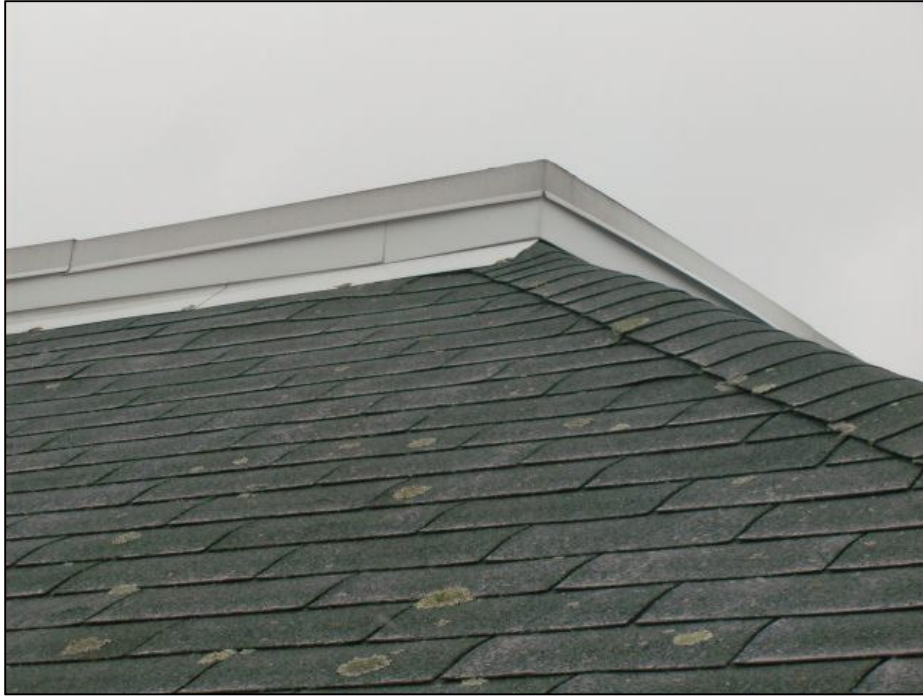
Shingles on 1940's wing, worn and covered with lichen.

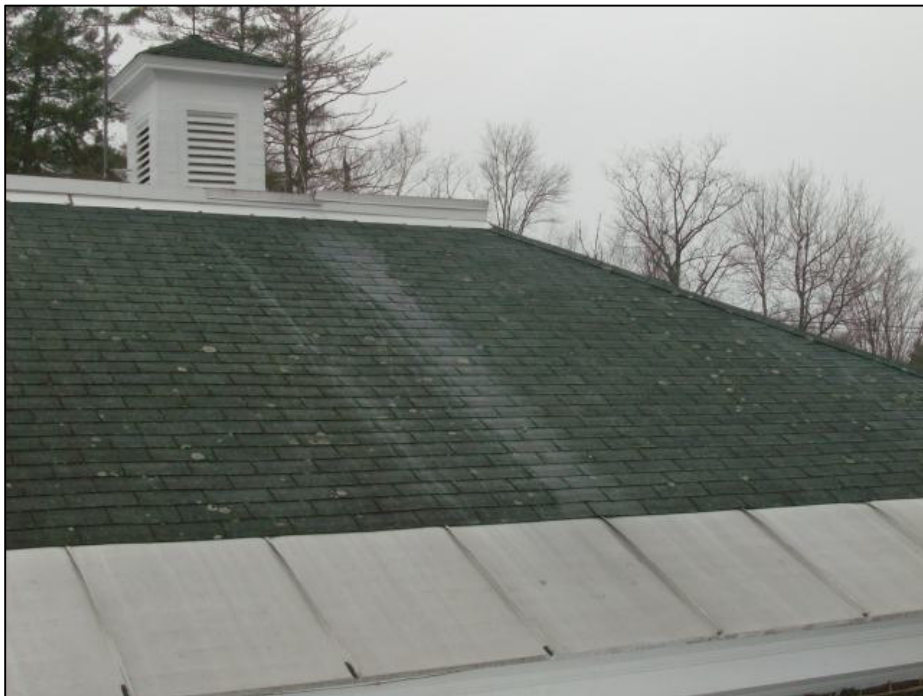
Overview of shingles on 1940's wing, granules and edges are worn.

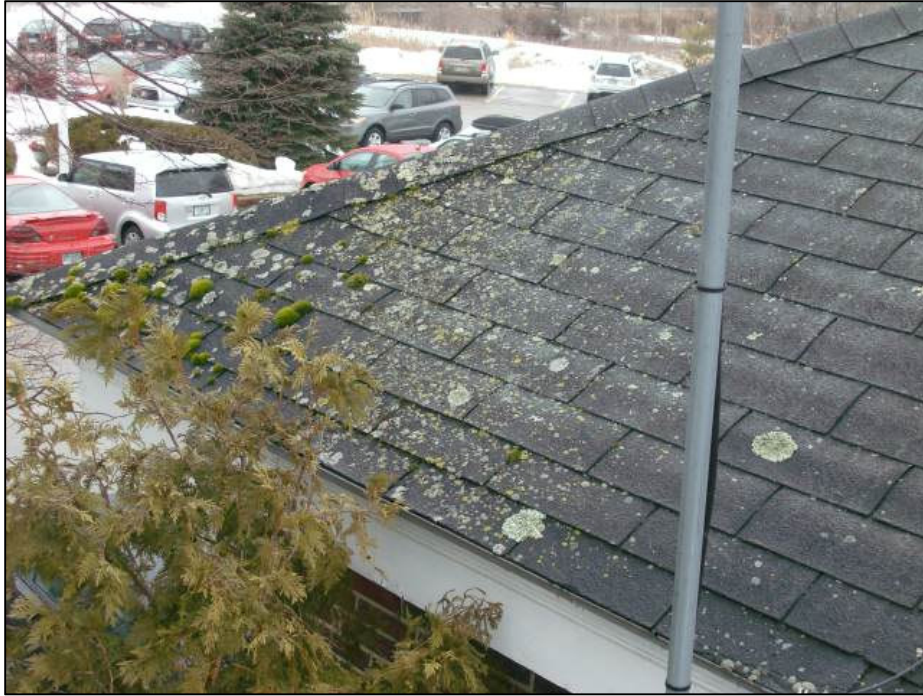
Lichen and moss covering shingles (1940's wing).

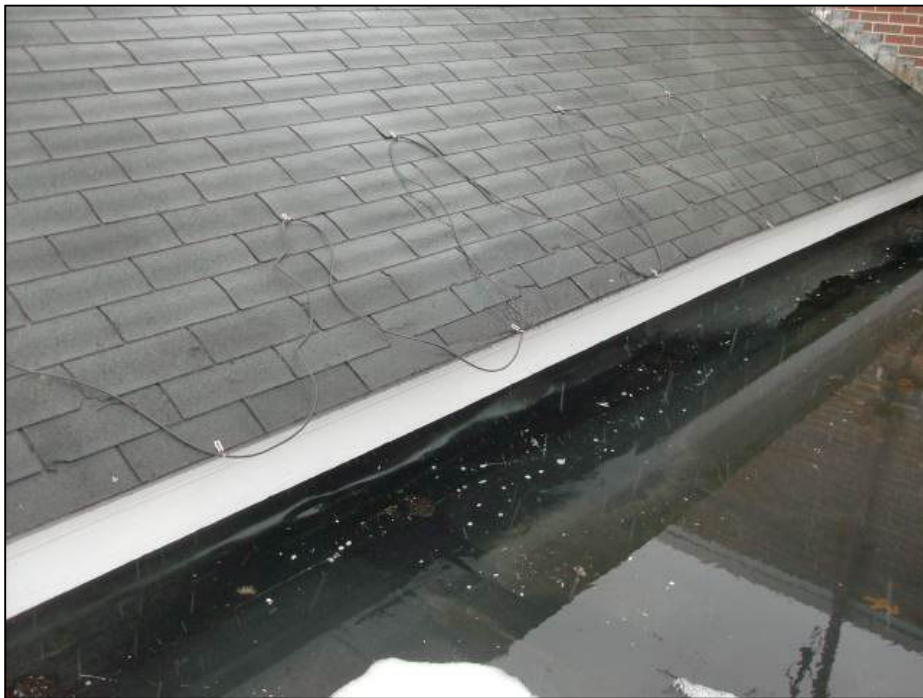
Flashing and trim under overhang requires replacement (re-attach het cable).

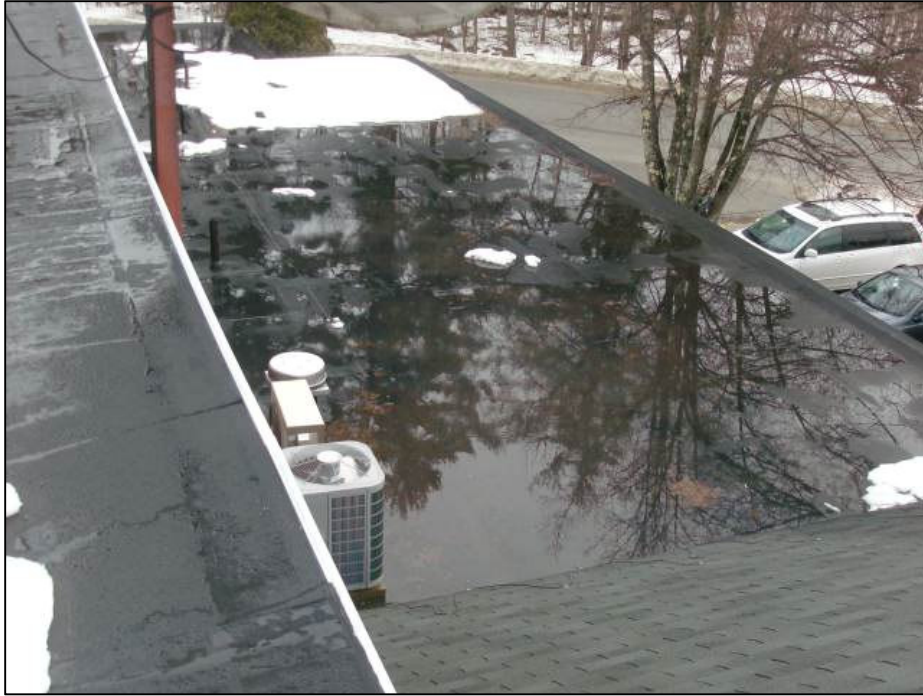
Water ponding on low roof over physical therapy classroom.

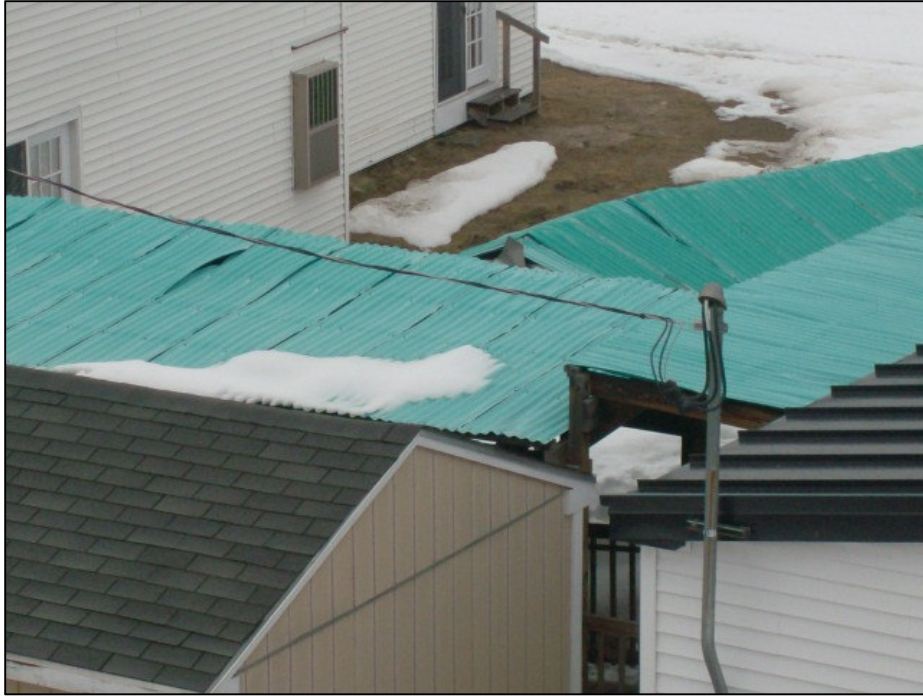
Corrugated fiberglass roof panels over walkway to portables are in poor condition.

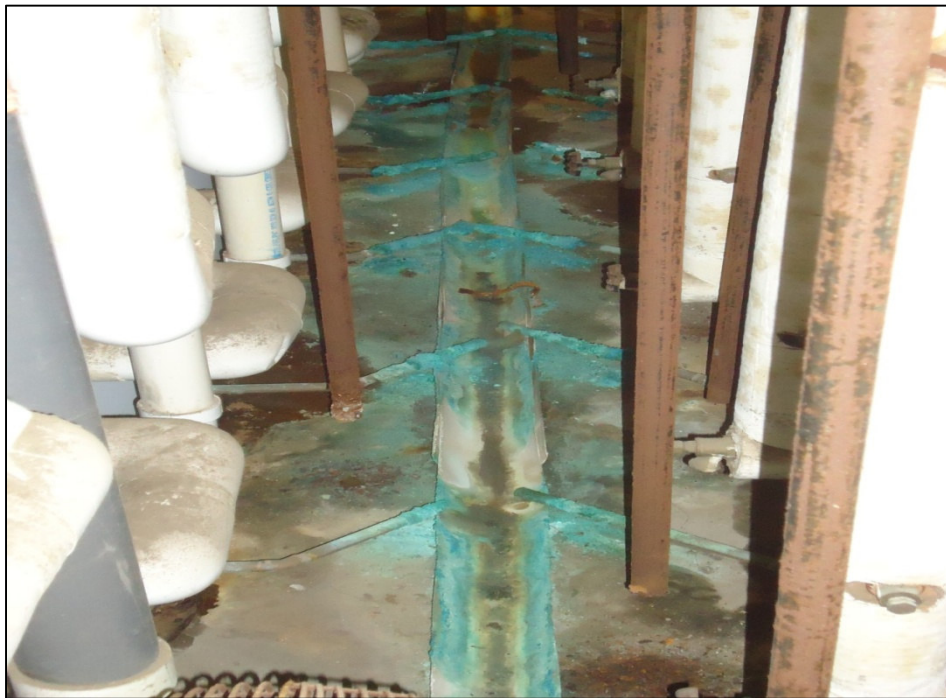
Deteriorated copper boiler condensate pipes.

- Replace the existing boiler plant and combustion air intake system. The boilers are at the end of their useful life, the condensate lines are badly corroded, and the combustion air, which is taken directly from the boiler room, does not meet code.

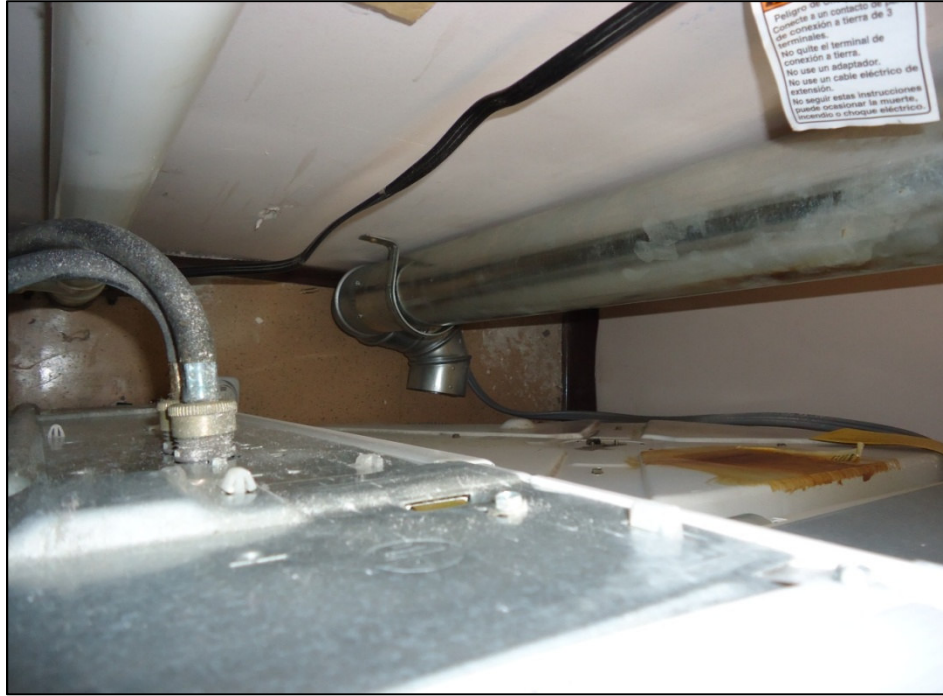
Disconnected dryer vent in Room 214.  
(Note, We were informed the dryer is out of service and will be replaced in summer of 2013.)

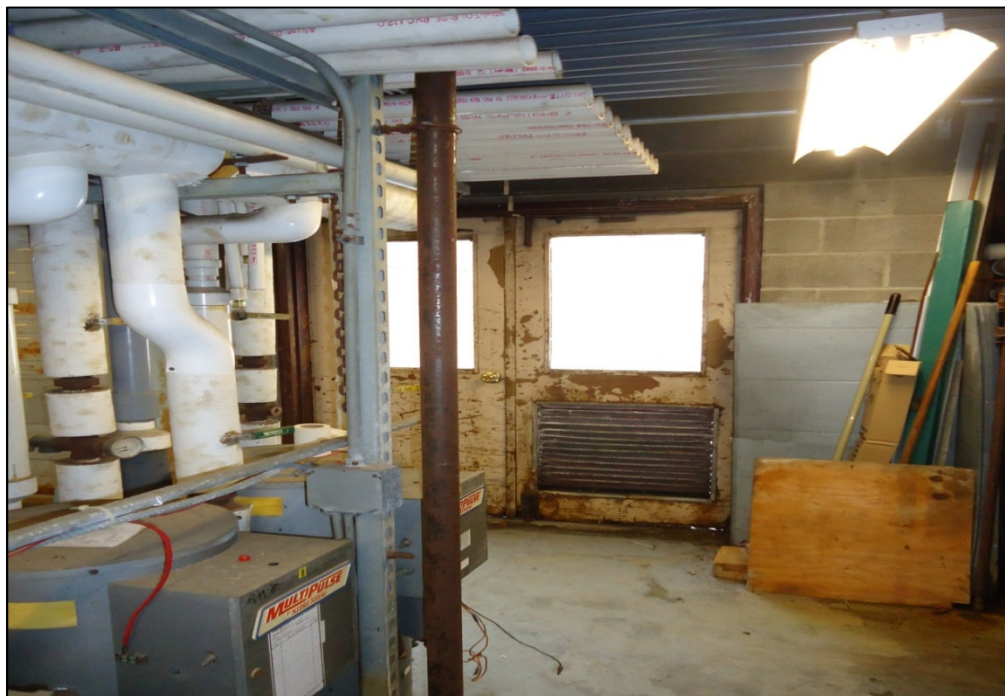
Disconnected PVC intake pipes and louver in door.

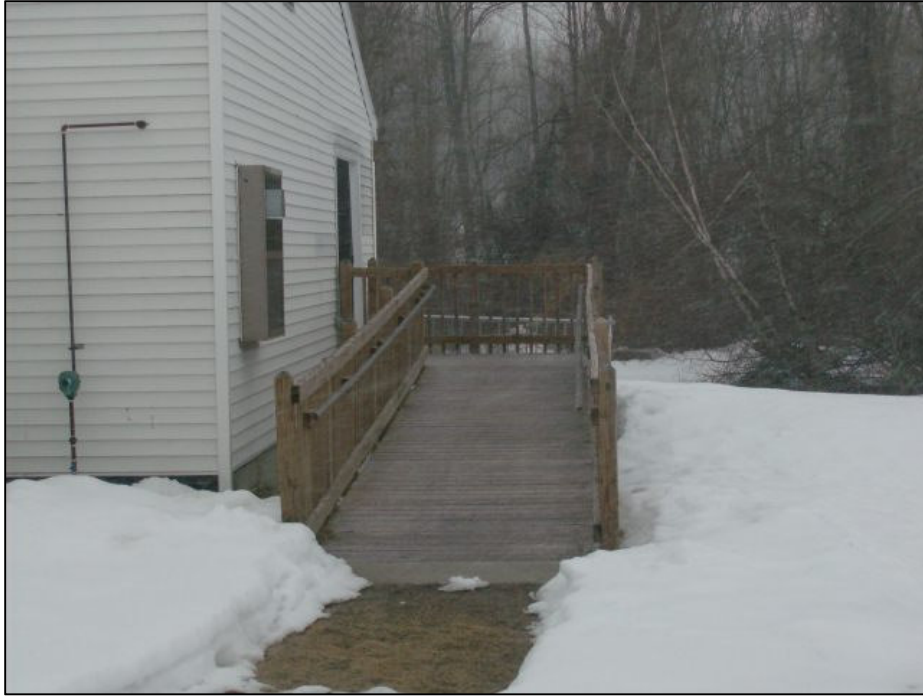
21. Ramp is non-compliant with ADA due to slope, handrail configuration, and absence of paved access route (typical conditions). Note unprotected propane feed.

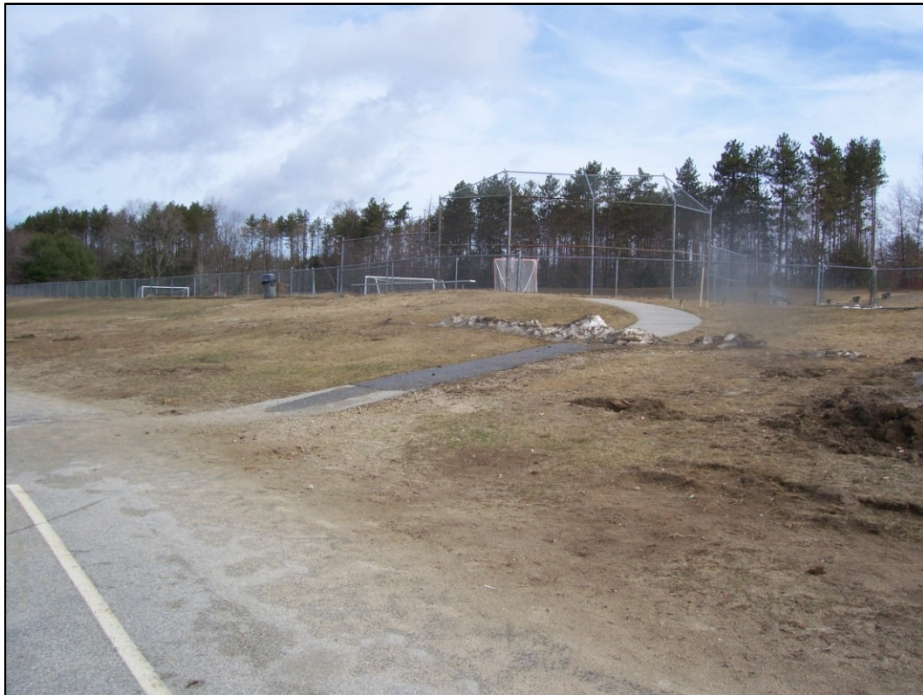
22. Non-compliant ramp to athletic fields.

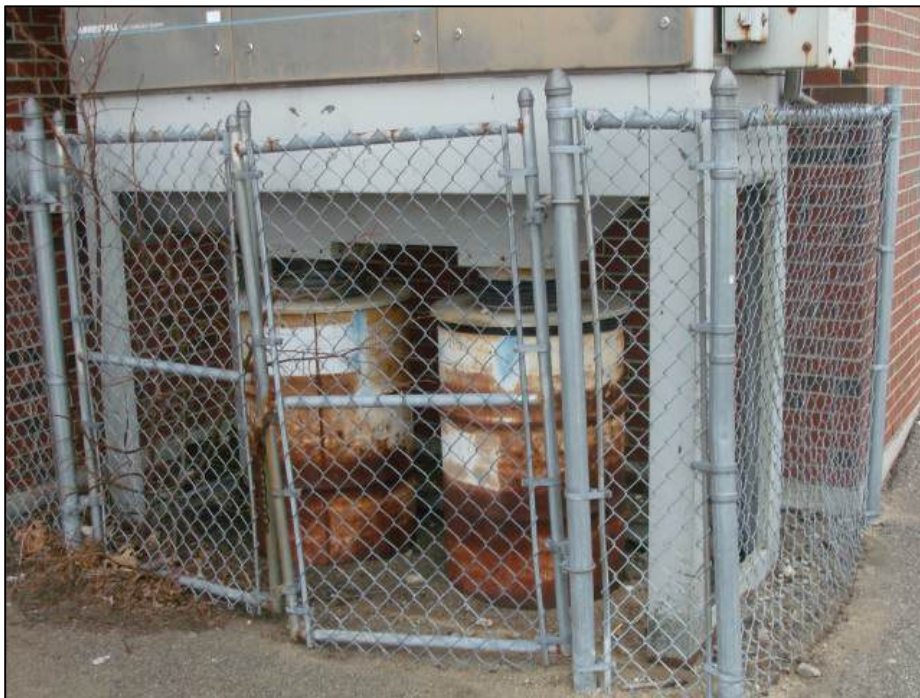
24. Rusted barrels, fence is in poor condition.

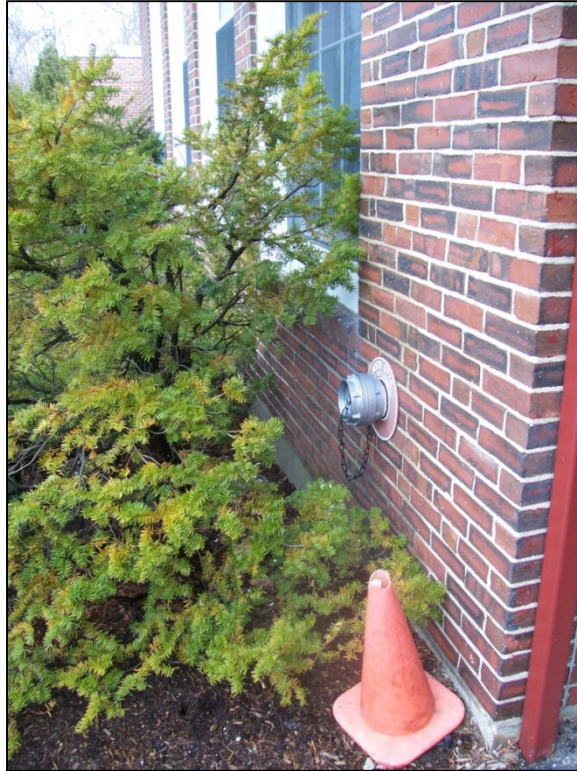
25. Tree growing up against building exterior.

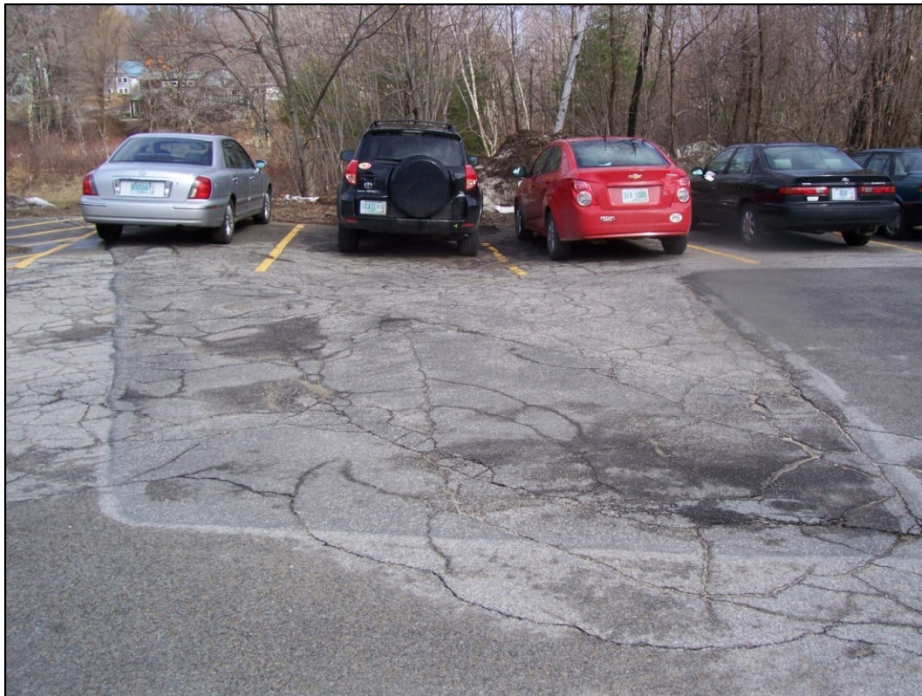
28. Pavement and base gravel deterioration.

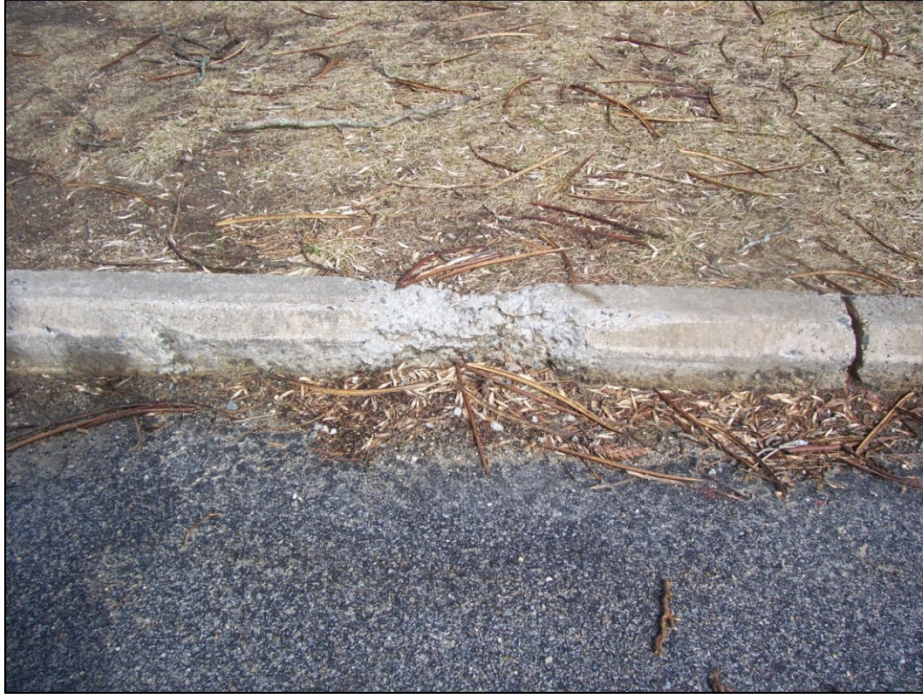
29. Deteriorated precast curb segment.
