AUBURN VILLAGE SCHOOL  
AUBURN, NEW HAMPSHIRE

## FACILITY ASSESSMENT FINAL REPORT

MAY 13, 2013

Facility Assessment Audit

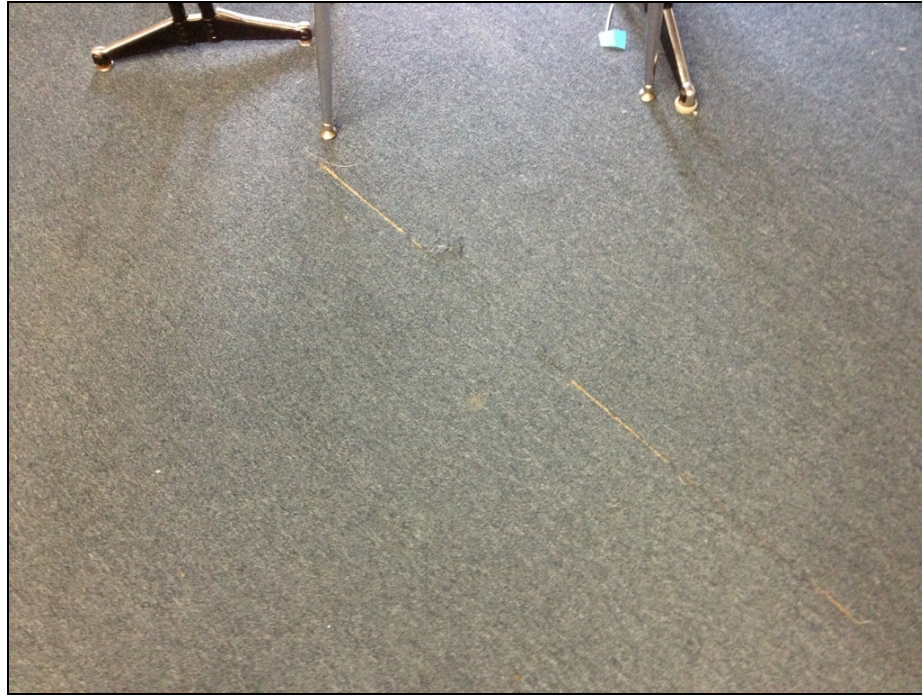
3. Flooring Example: Several areas of carpet with fray/delamination.  
(Photo from: Attached modular classrooms.)

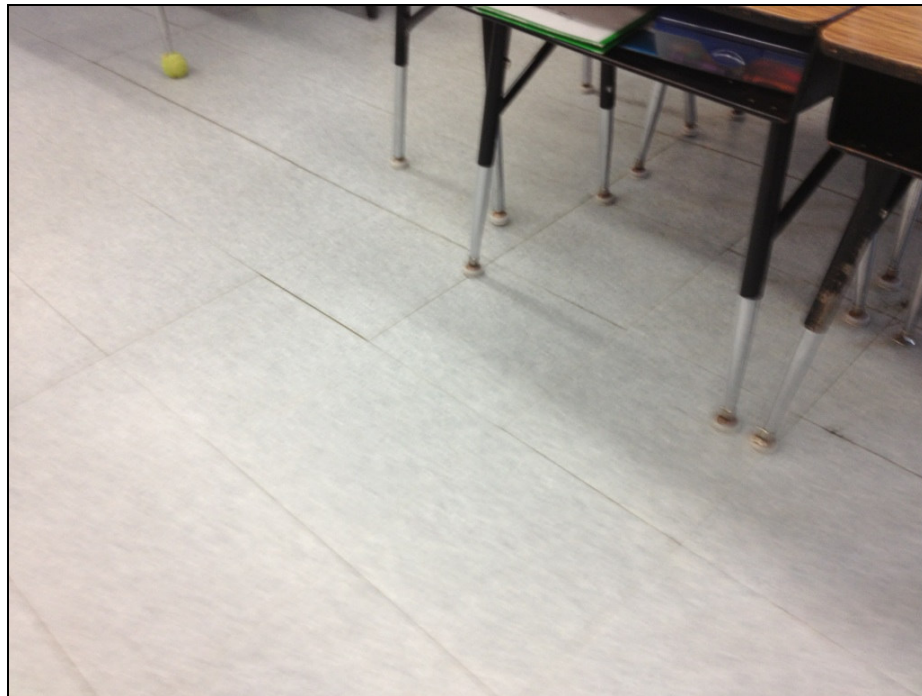
4. Flooring Example: Areas of tile joint separation.  
(Photo from: Second floor interior classrooms - 80's wing.)

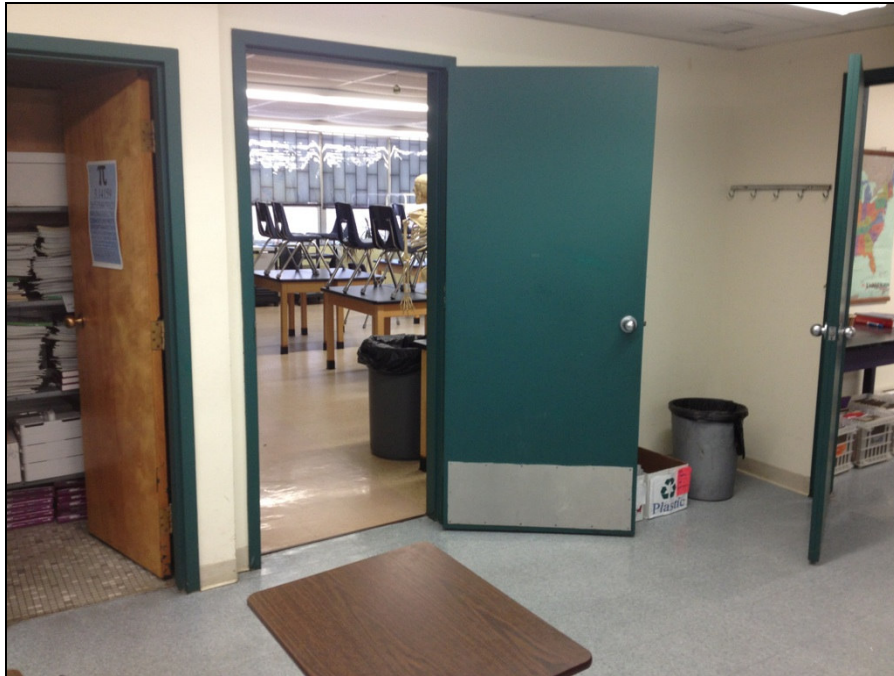
12. Doors/ADA: Most interior communicating doors do not have lever handles as required by ADA standards. (Photo from: Second floor interior classroom. Renovated 80's classroom.)

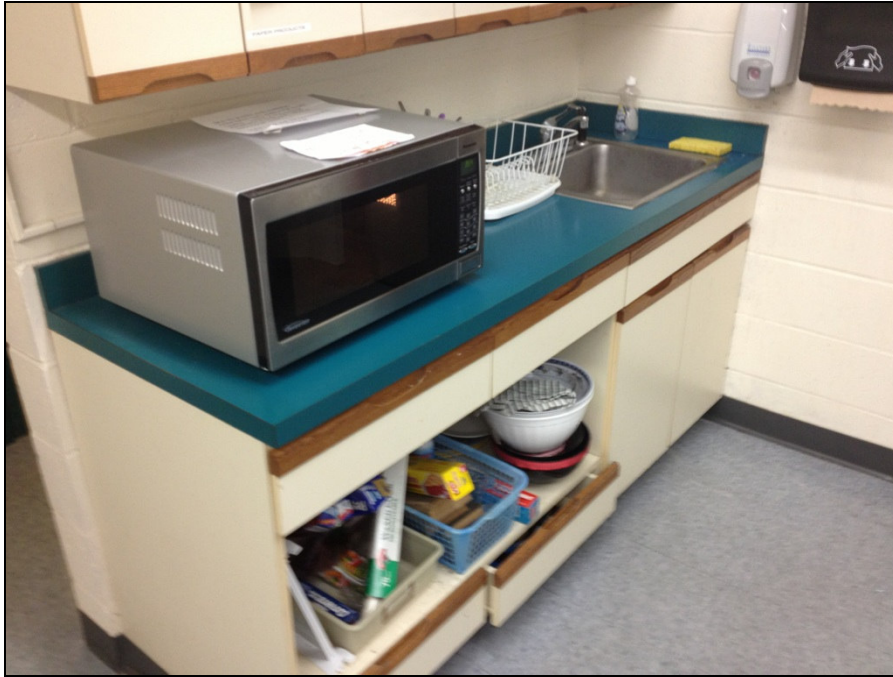
19. ADA Issues: Lack of knee clearance at sinks.  
(Photo from: First floor teacher's break room.)

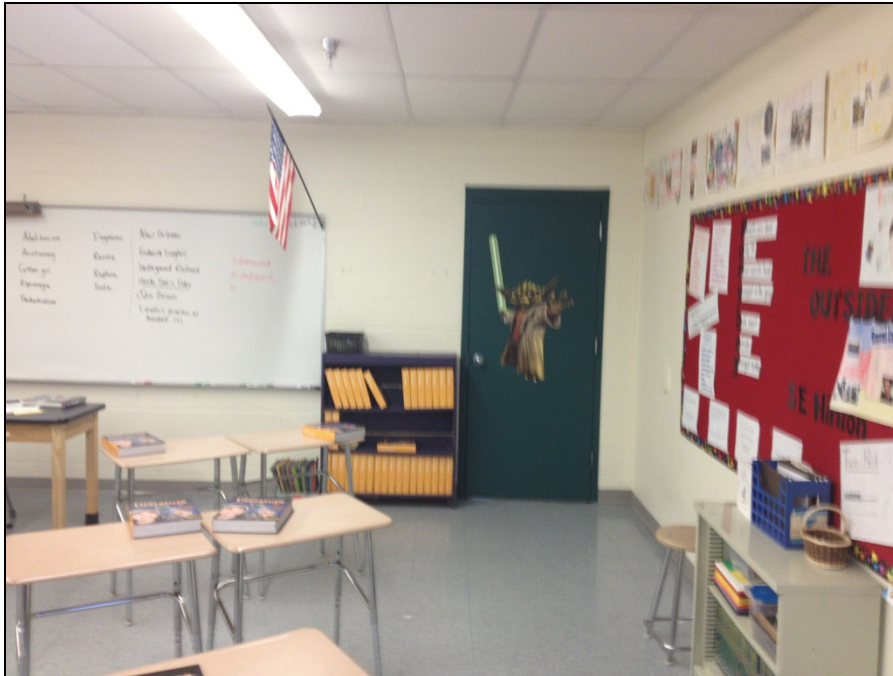
20. ADA Issues: Furniture impacting the required clearance near door and no door lever handle. Rule of thumb: 18" on pull side and 12" on push side.  
(Photo from: Second floor perimeter classroom.)

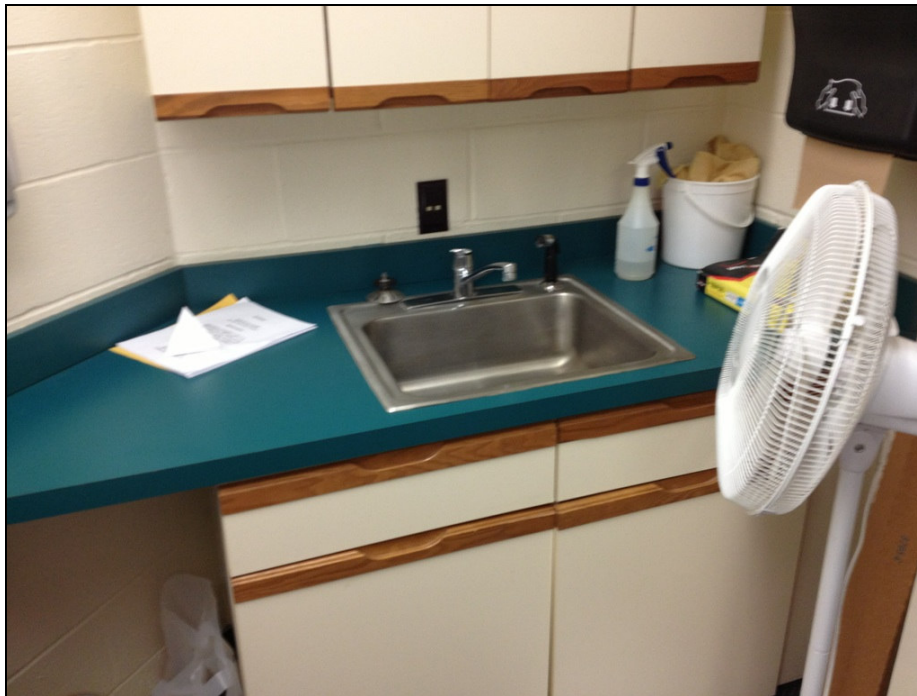
21. ADA Issue: Countertop height and no knee clearances at sinks.

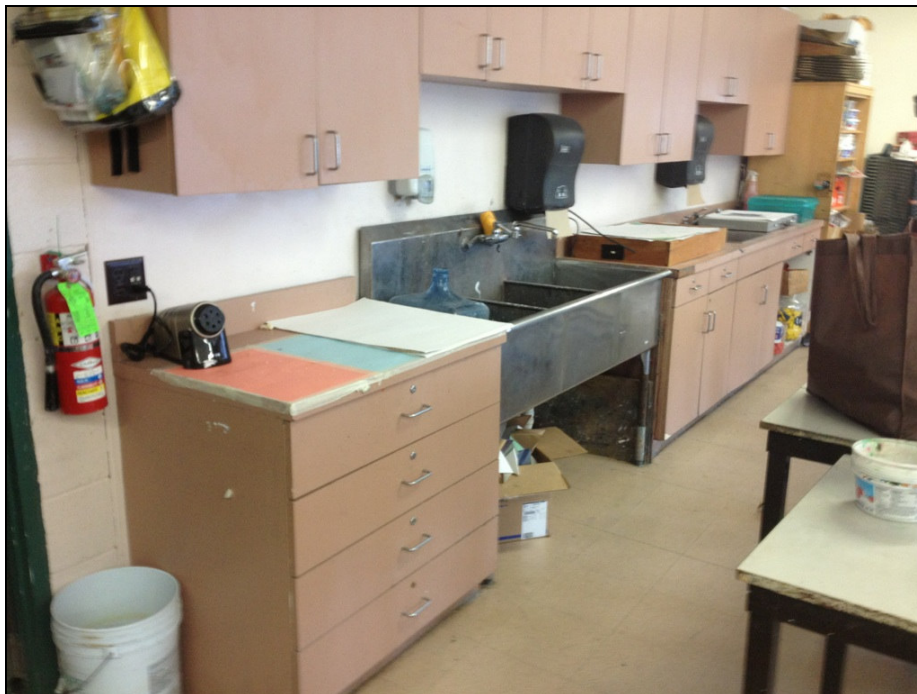
22. ADA Issues: Large deep sink in art room does not meet current ADA requirements for depth. (Photo from: Second floor art room.)

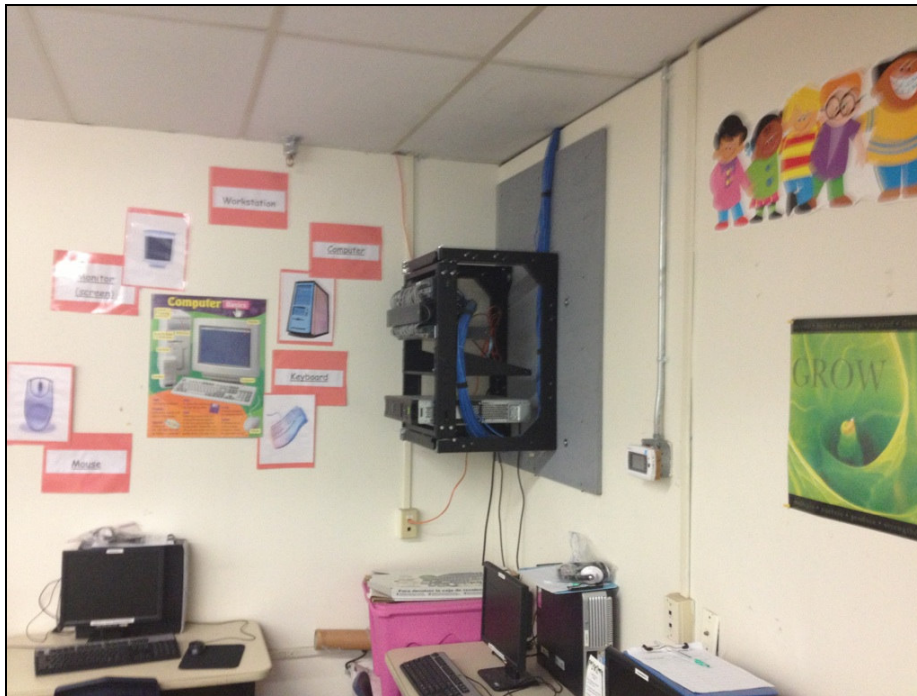
23. IT Example: Exposed wiring that should be in a secure IDF room.  
(Photo from: Second floor computer room.)

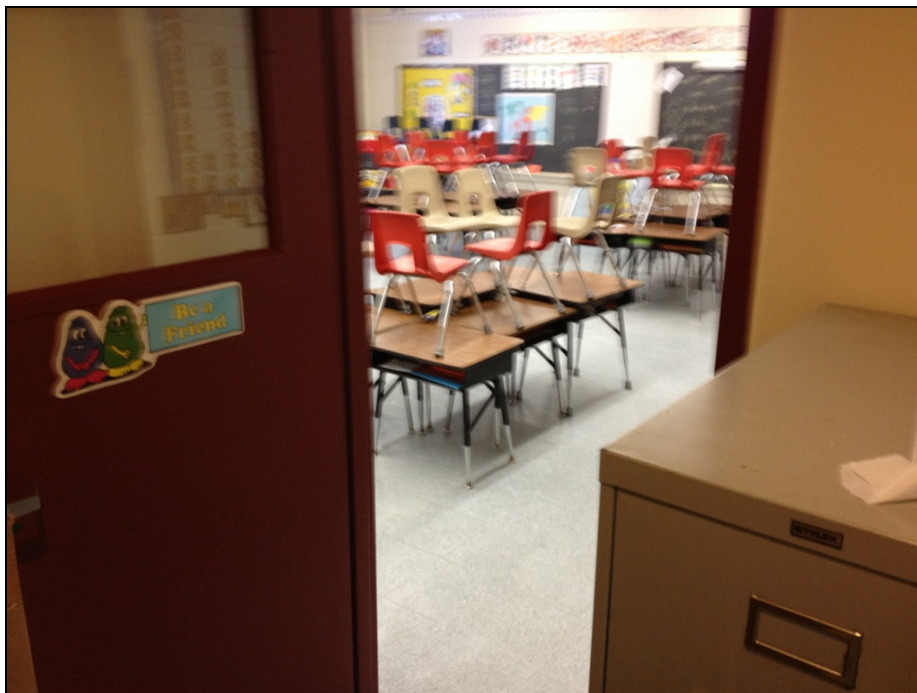
24. ADA Clearances: Furniture/file cabinets in the way of clear space required for door swings. (Photo from: First floor 60's classroom.)

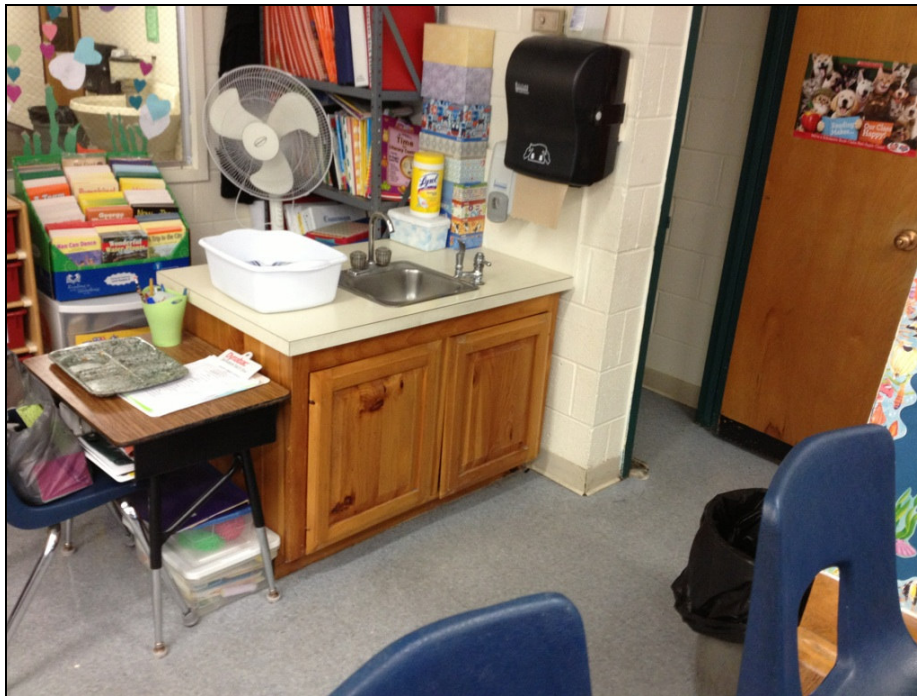
25. ADA Issues: Sink height for ADA/“Kiddie ADA” not met. Restrooms are small.  
(Photo from: First floor 60’s era classroom.)

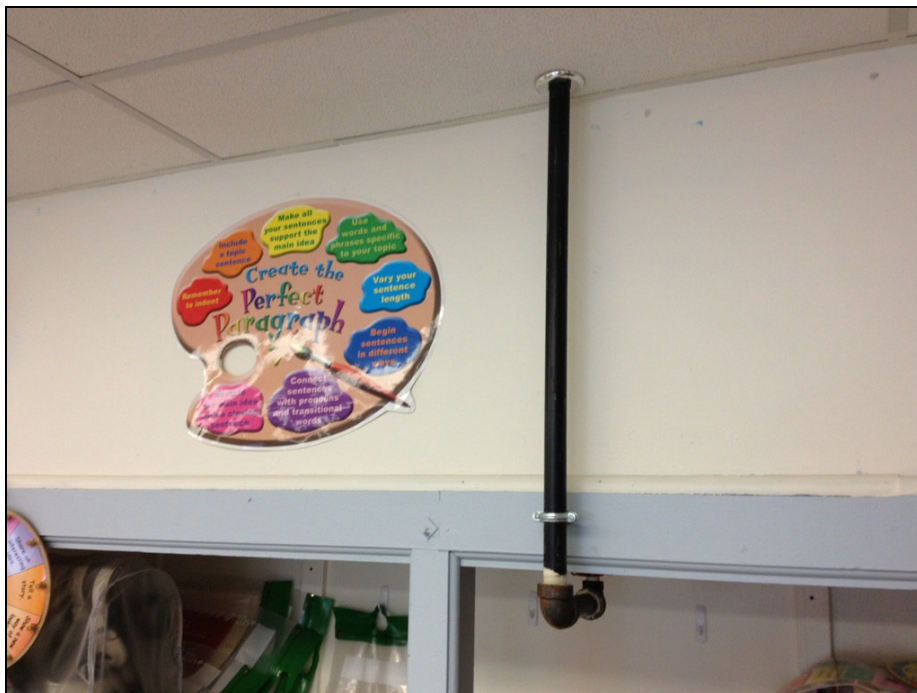
26. Fire Protection Example: It appears that all closets have sprinkler piping; however, the location of the pipe is not ideal.  
(Photo from: First floor 40’s classroom.)

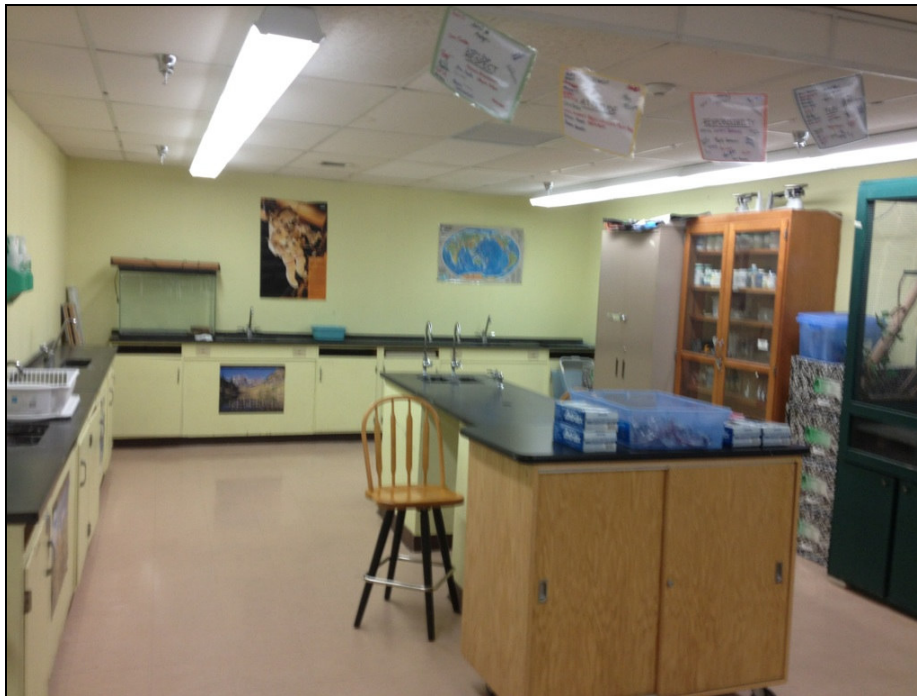
27. ADA Issues: Science labs do not have lower area for ADA required work station. (Photo from: Second floor renovated 60's wing.)

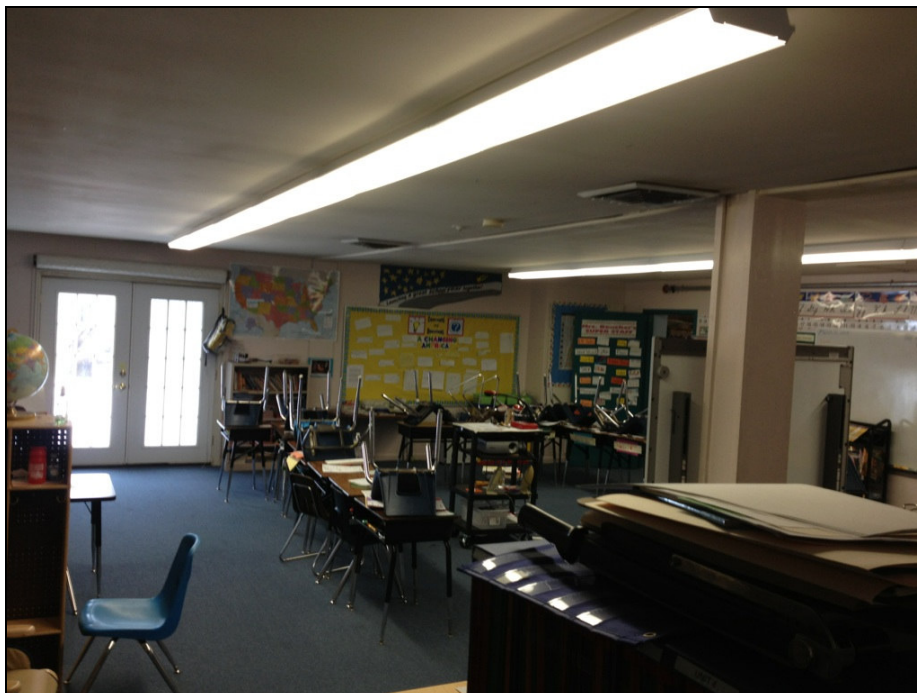
28. Lack of windows in attached modular classroom. These spaces only have double doors with blankets to stop draft and extra insulation. (Photo from: Attached modular classroom.)

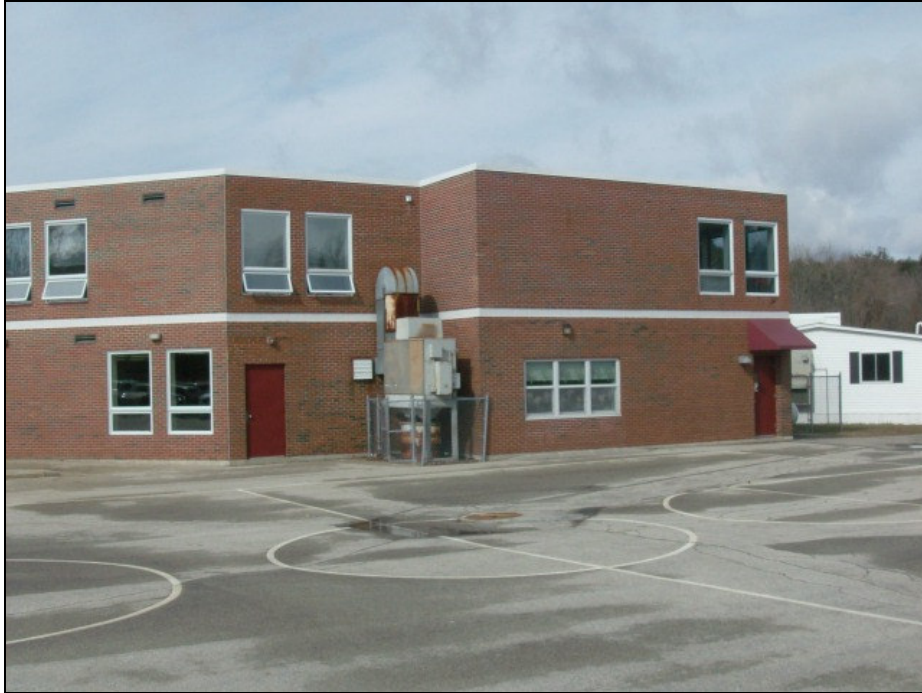
Rear of school – Old dust collection system at center.

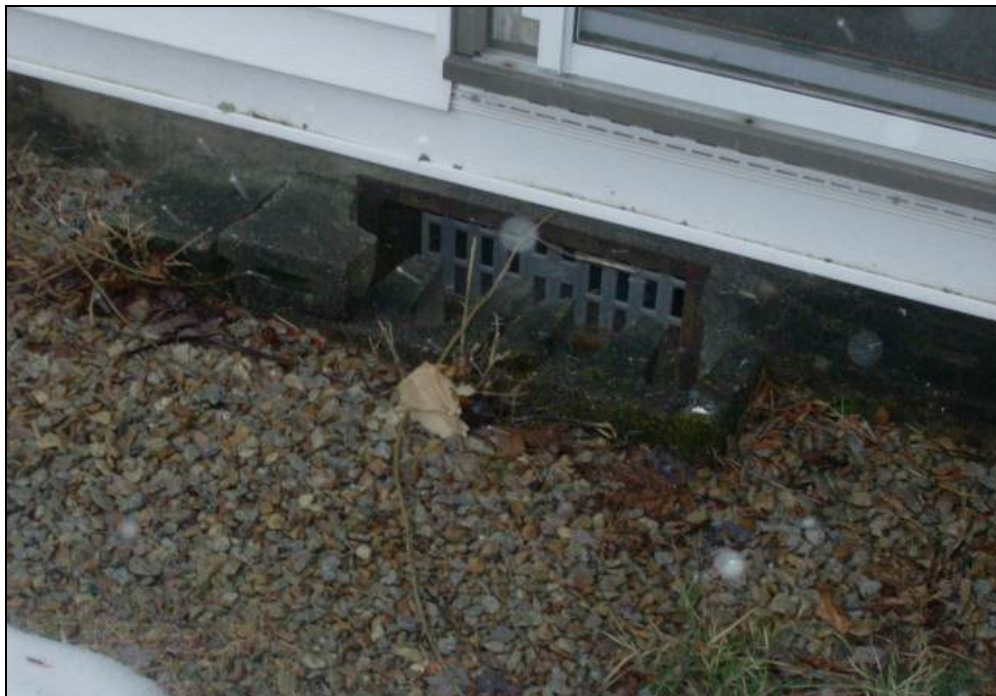
Typical crawlspace vent opening below 1988 classrooms.

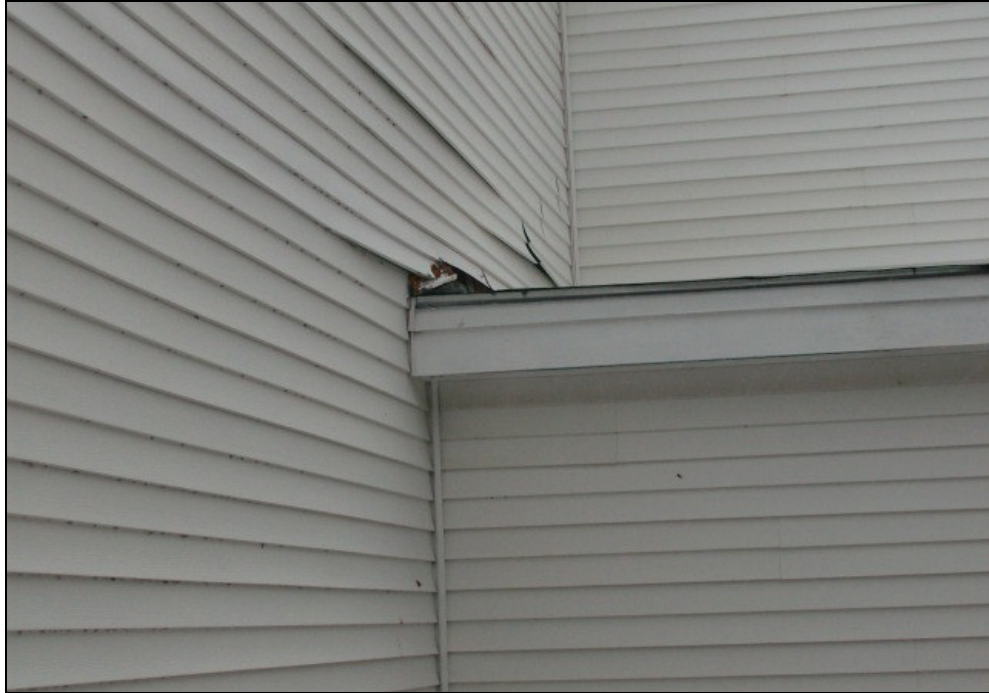
Distressed vinyl siding (1988 classroom wing).

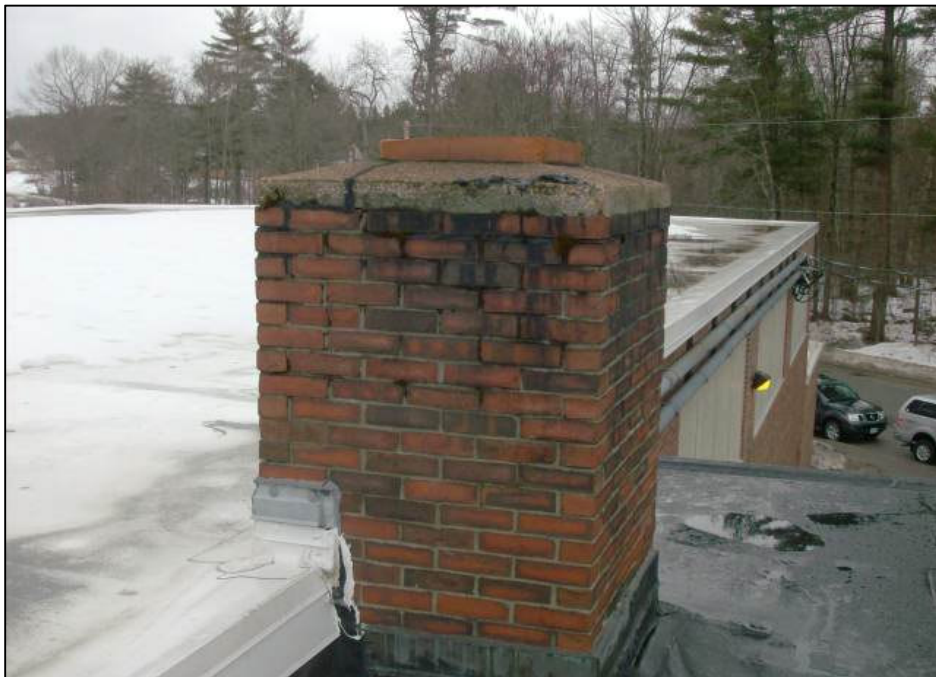
Chimney near gym needs repointing and cap restoration.

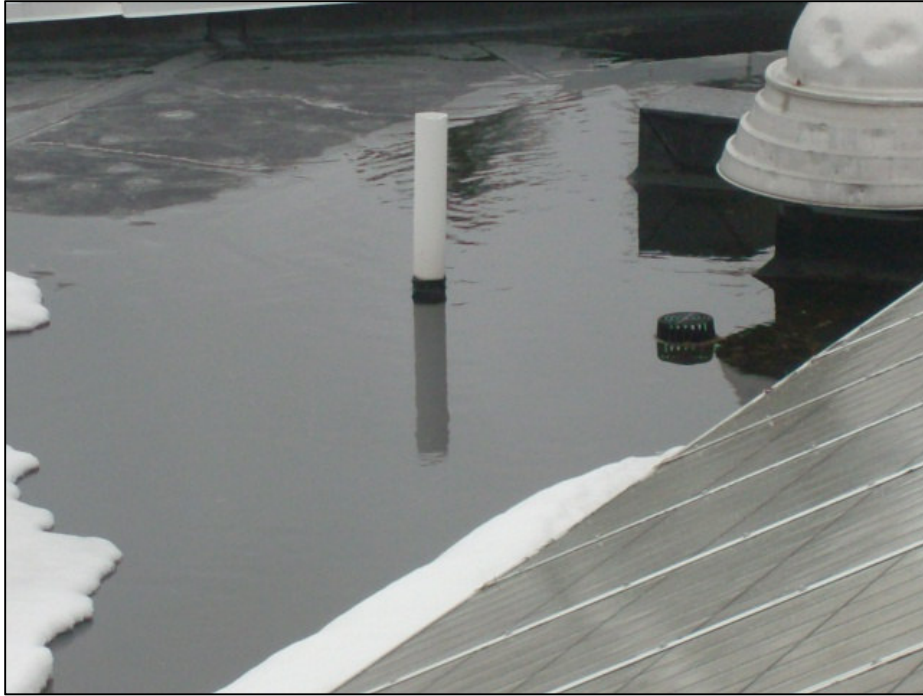
Water ponding on low roof over cafeteria.

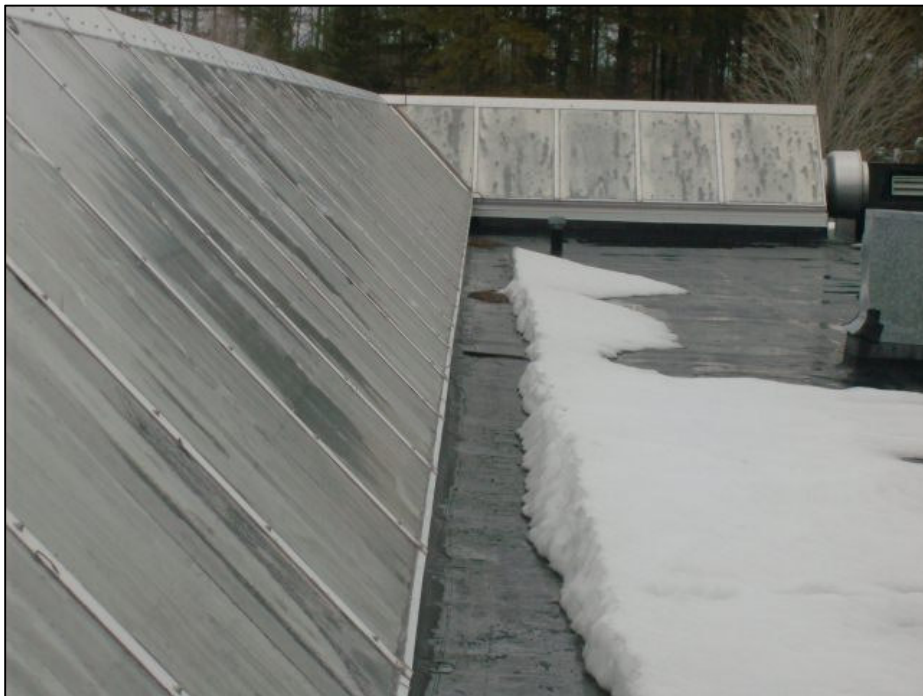
UV blocking low E film on skylights is breaking down.

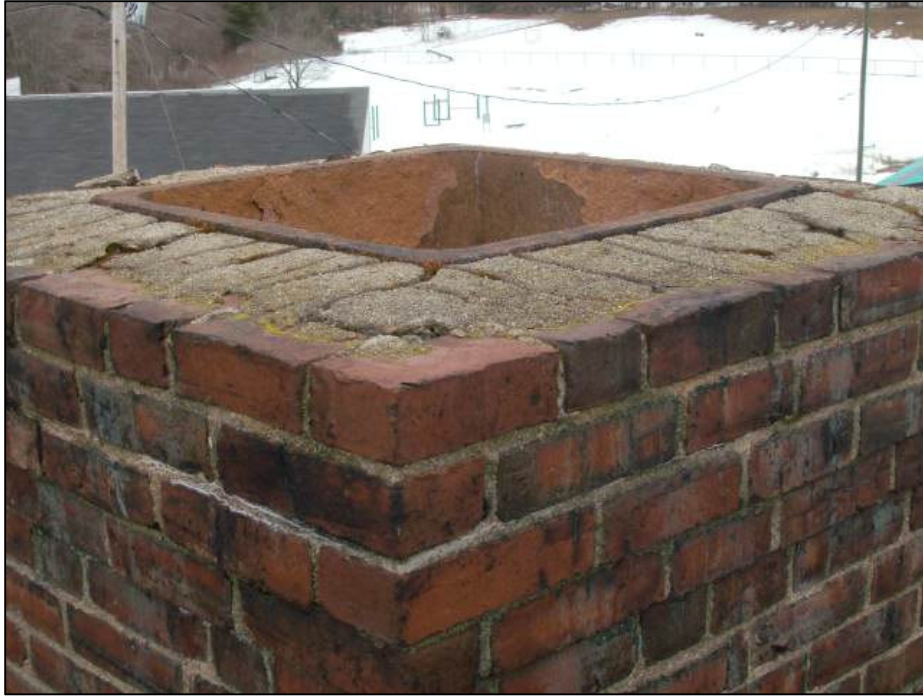
Chimney no longer in use, should be capped.

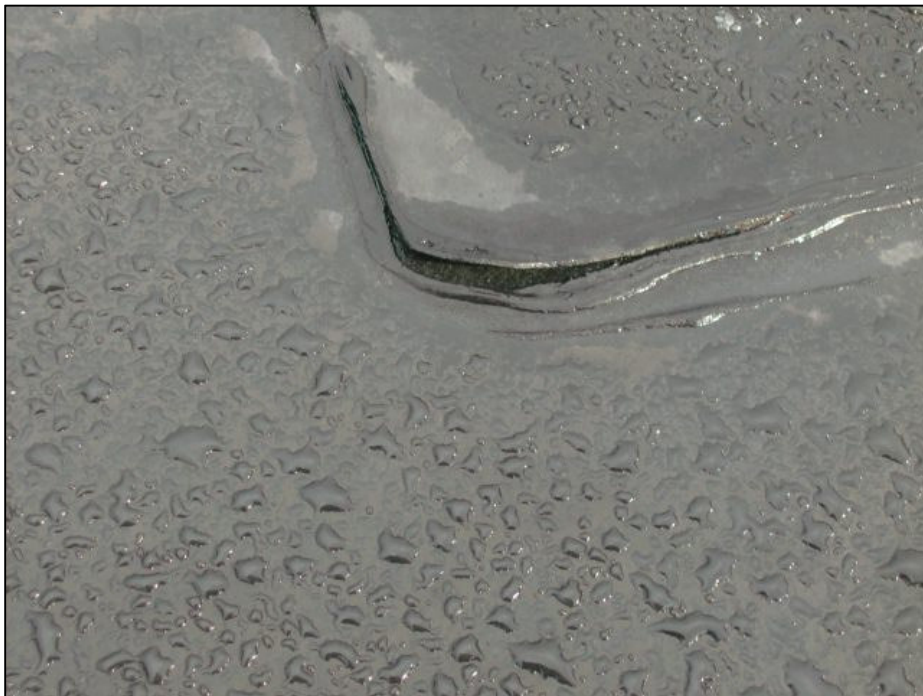
Membrane overlay is delaminating.

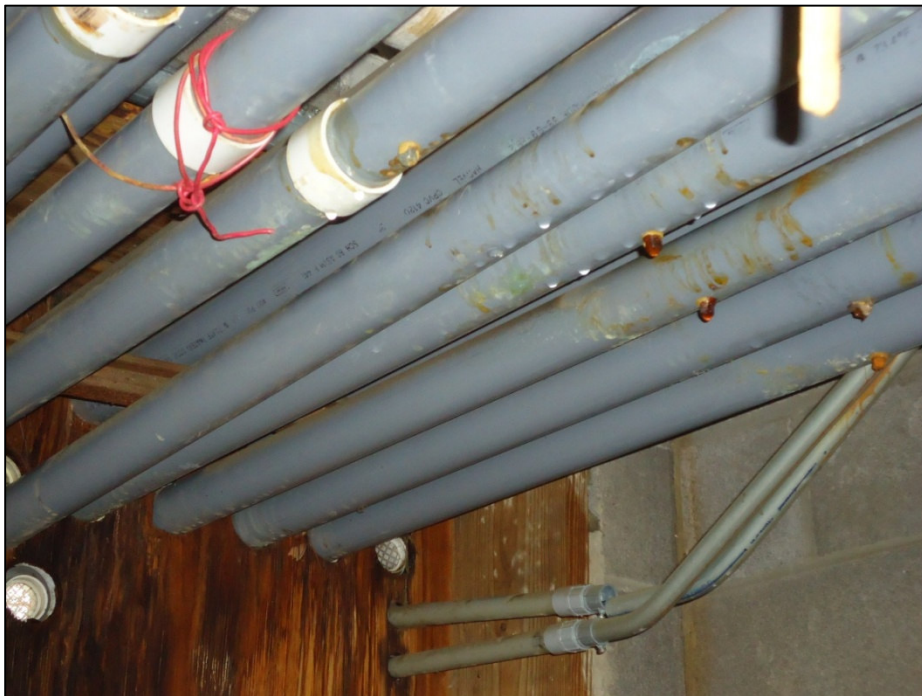
Condensation on exterior of CPVC boiler exhaust pipes.

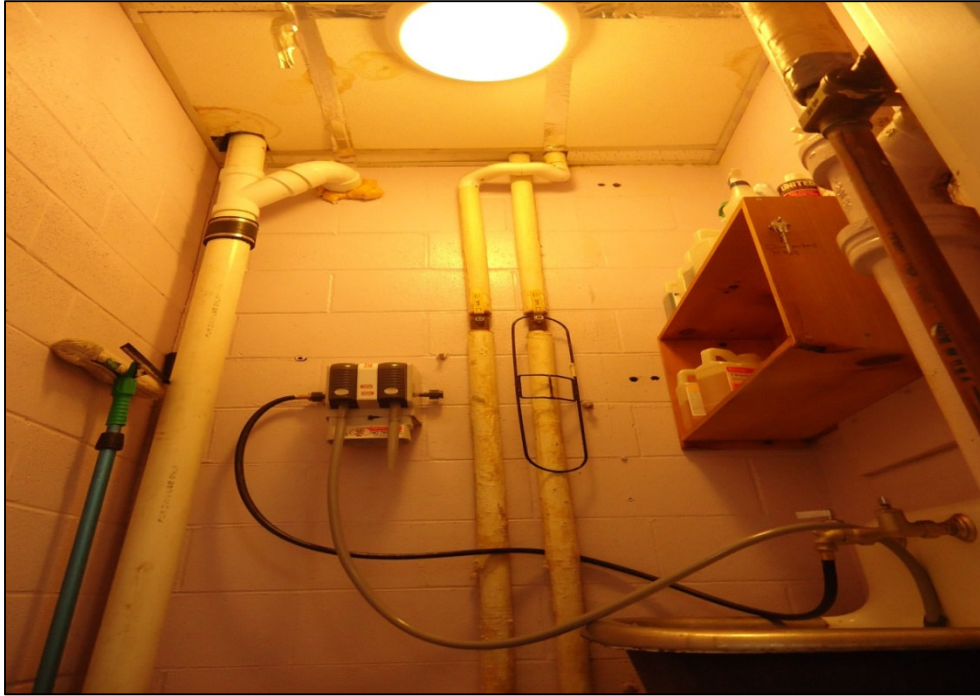
Custodial closet in kitchen with no exhaust.

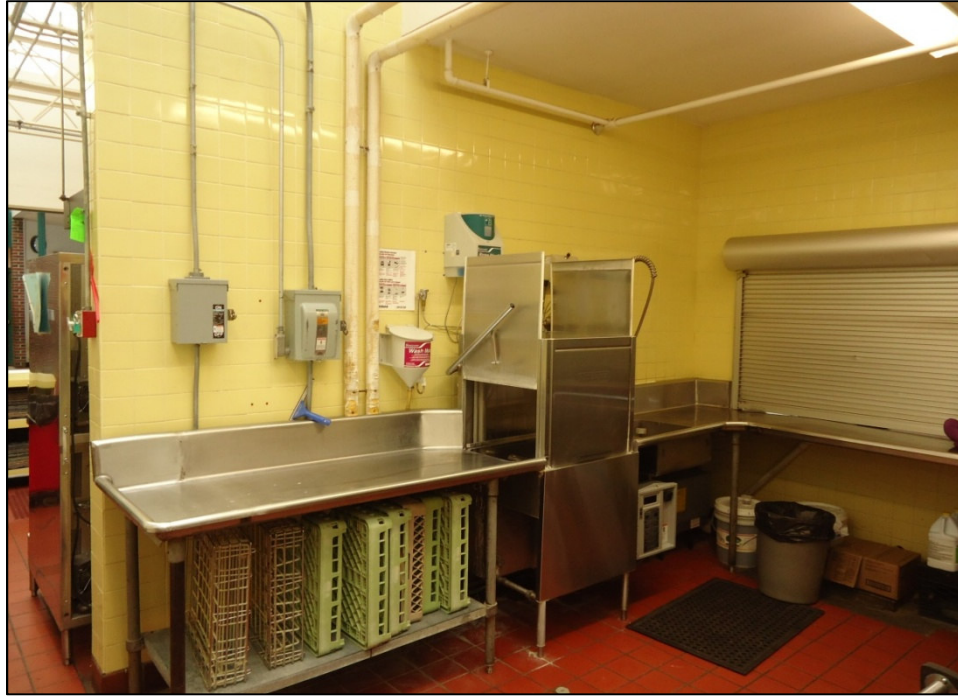
No condensate hood over dishwashing equipment.

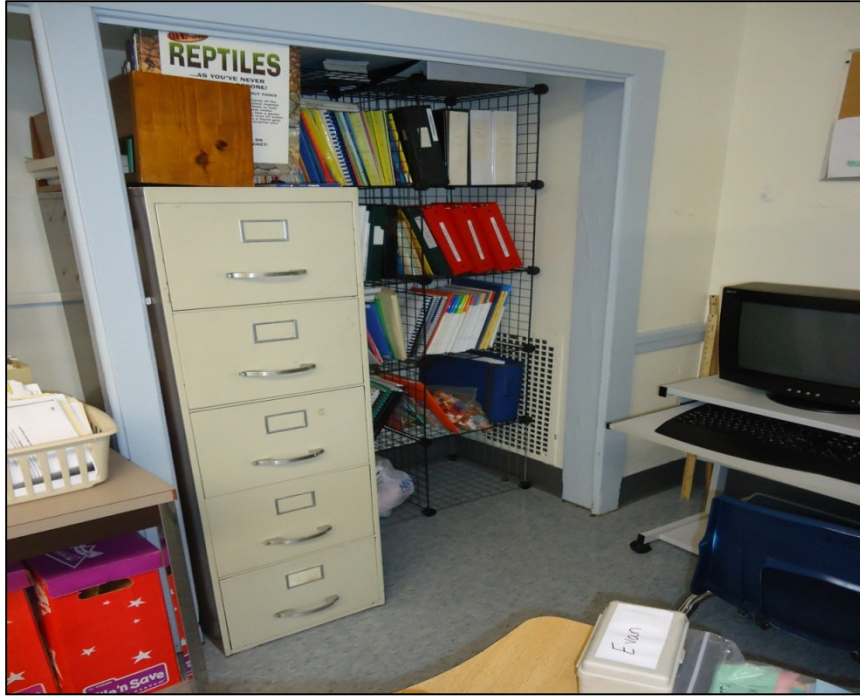
Exhaust in closet of 1940's wing.

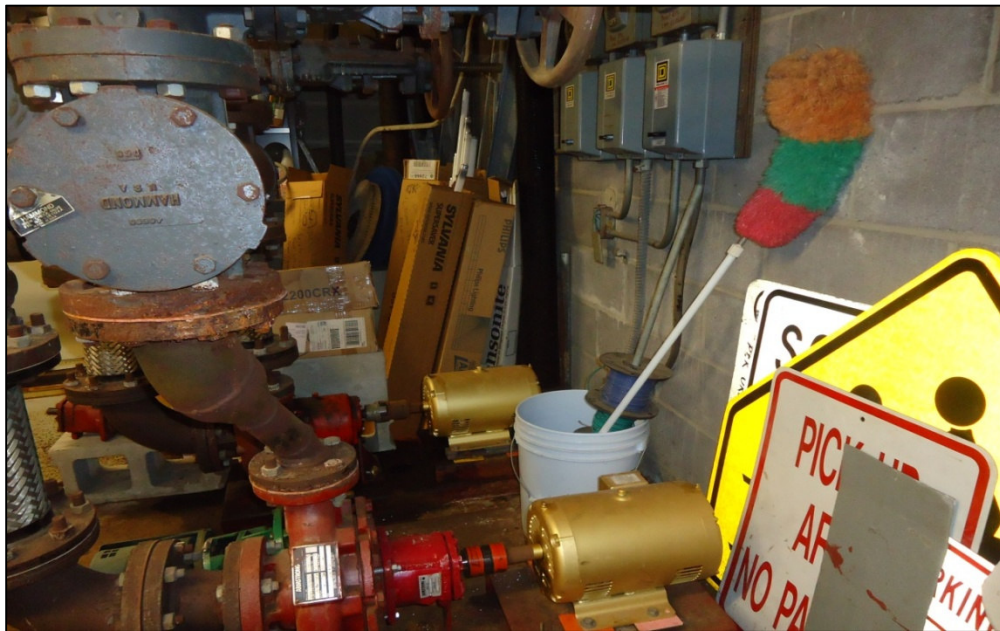
Main hot water circulating pumps.

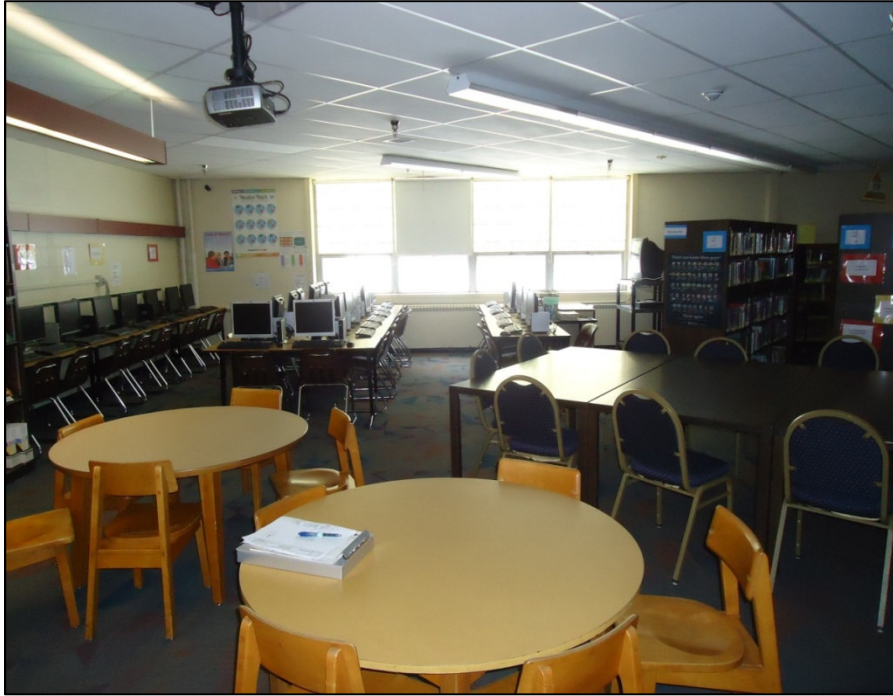
Media Center with small supply grille at top center.

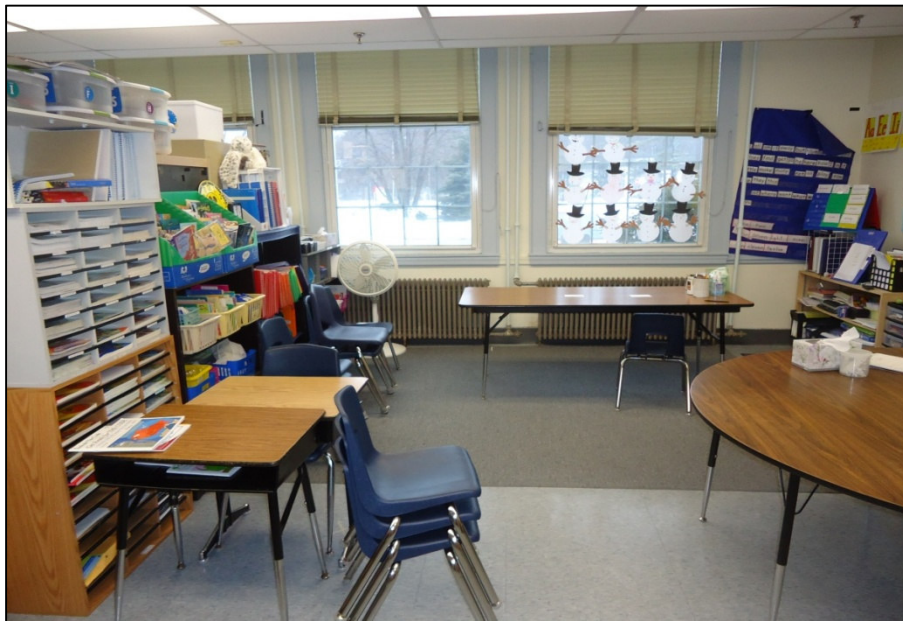
Radiators in 1940's section of school.

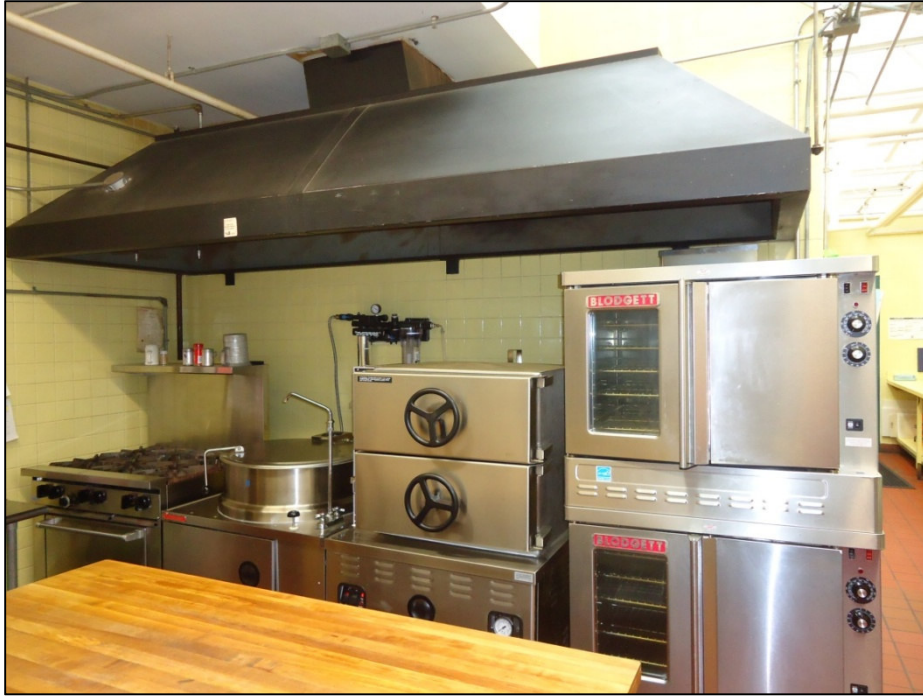
Range hood not covering appliances - no grease baffles.

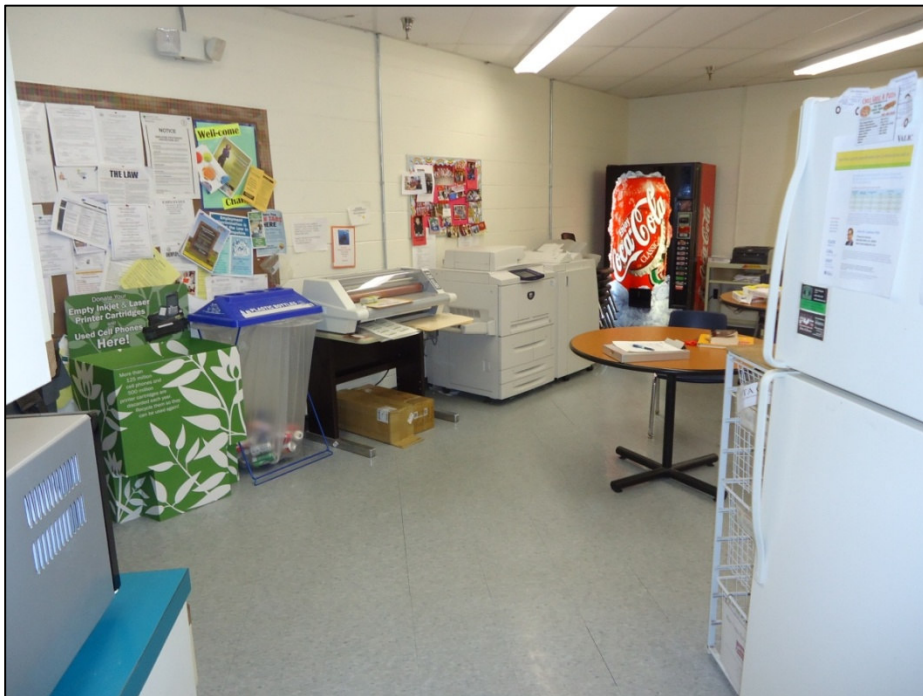
Teacher's room with heat generating equipment.

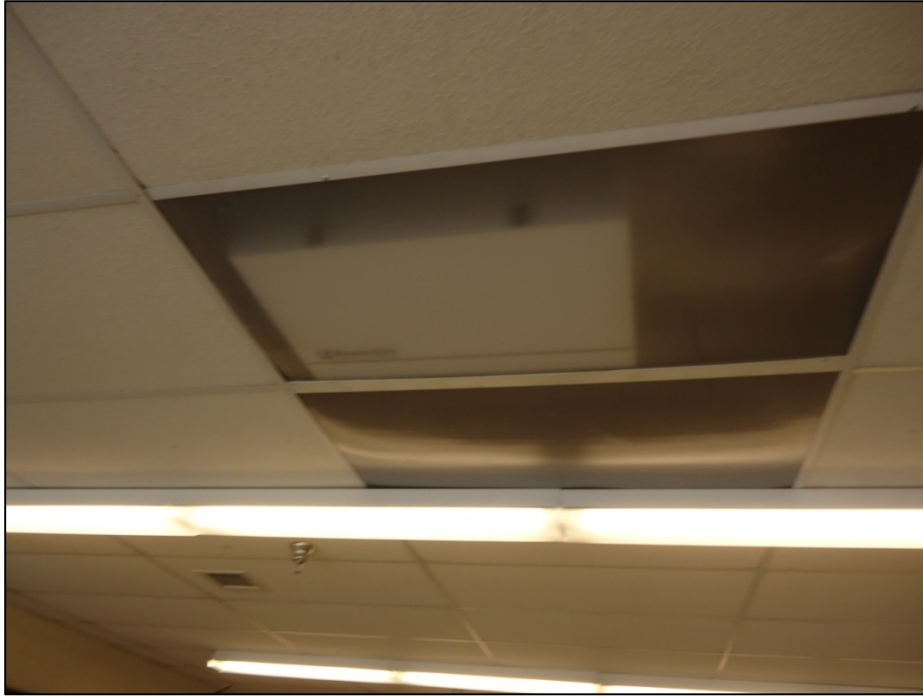
Typical ERV above ceiling in classroom.

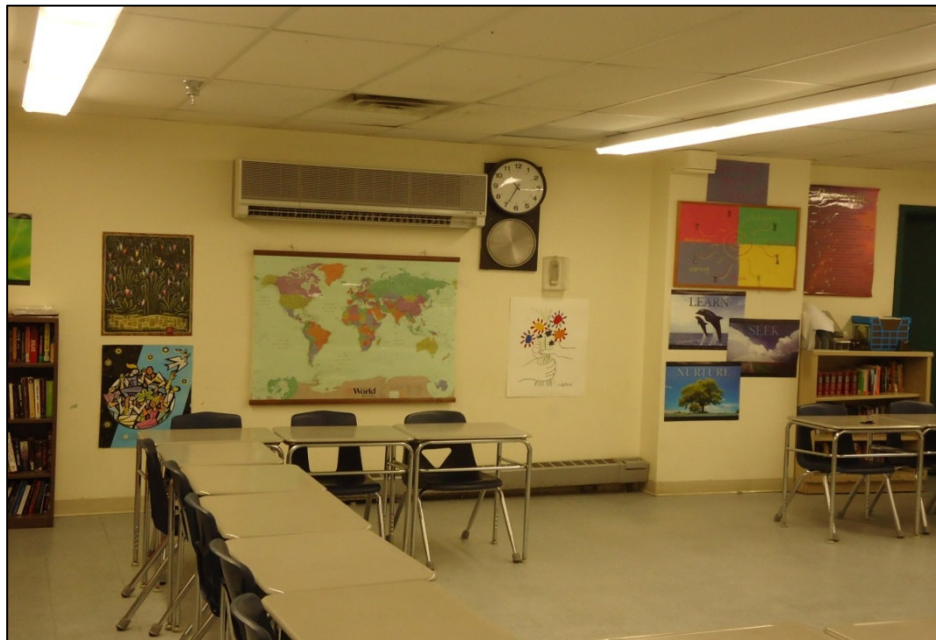
Typical interior classroom with ceiling supply grille, fin tube radiator and Sanyo ductless split AC unit.

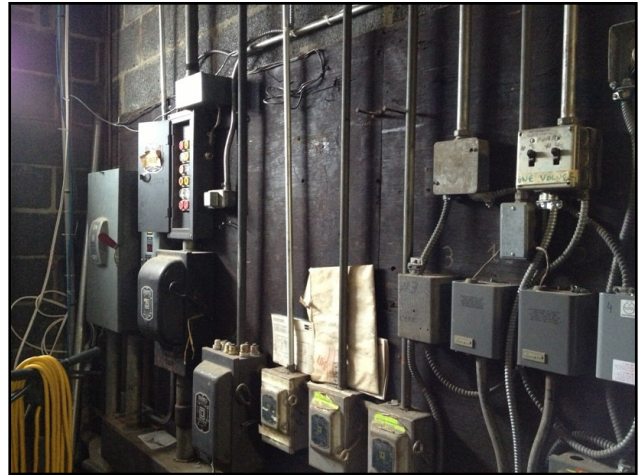
**Main Building Electrical Service 1 of 2  
200A Main Service Disconnect & Wire Trough**

The Auburn Village School has two main electrical services for the main building. There are four overhead electrical services and exterior utility meters for the modular classrooms and stick building. The original building, constructed (ca. 1940's), has a 200A, 120/240V, 1-phase, 3-wire electrical service. The service enters electrical room 1 of 2 from underground and terminates in a 200A, 240V main service disconnect. The peak demand data for the 200A, 1-phase service was not available in the PSNH utility bill information that was provided. The 200Amp main building electrical service disconnect feeds a wire trough which is tapped to feed a couple of panelboards and various mechanical equipment disconnects. There is a 2-pole circuit breaker panel and a 100A, 12-fuse load center located directly above the wire trough. There is a 200A, 120/240V, 1-phase, 3-wire, 22-pole, GE recessed panel located in the main building 1<sup>st</sup> floor corridor which is fed from the 200Amp service. Most of the electrical service equipment is original to the buildings construction (ca. 1940's) and well beyond its useful life expectancy. Overall, the switchgear is old, in fair condition and there is no potential for future expansion.

The existing 200A electrical service in electrical room 1, including the switchgear and panelboards for the original (1940's) building are old and have reached the end of their useful life. Therefore, it is recommended that the equipment be replaced in their entirety. The existing equipment service disconnects that are old and in fair condition should be replaced as needed. The existing electrical incoming service including secondary conductors from pad mounted transformer should be replaced when new switchgear is provided. At that time a new 3-phase service should be provided and properly sized for future expansion. The existing 800A MDP in electrical room 2 has corrosion on the enclosure. At a minimum, the switchboard terminals and breakers should be tested for integrity and conductor insulation resistance test for leakage currents. It is

Replace existing corroded 800Amp MDP (service 2 of 2) with weatherproof rated equipment. At a minimum, an infrared scanning and conductor insulation resistance test should be completed. Replace existing 200Amp electrical service (1 of 2) equipment with new switchgear.

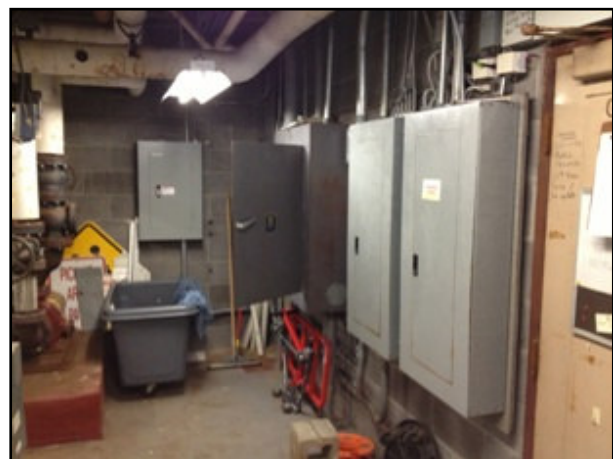
**Original 400A Electrical Service Distribution**  
**for Addition and Generator Panelboards**

The original 400A electrical main distribution panel along with a couple of original power and lighting panelboards (ca. 1965) are located in the boiler room. These panels as well as the stage panel are original to the addition (ca. 1965) and are in fair condition. There are several newer recessed panels located in the 1<sup>st</sup> and 2<sup>nd</sup> floor corridors that are in good condition, but don't have a lot of spare circuit breakers and space. Also, there are three (3) generator panelboards located in the boiler room that feed various standby loads including server room computer equipment, telephone equipment, 1<sup>st</sup> floor corridor and gym lighting, fire alarm control panel, sewer ejector pump, boilers and associated pumps, miscellaneous main office and nurse station outlets and equipment, kitchen lights and outlets. The generator panels are fed from a 40kW exterior generator located outside the boiler room via an automatic transfer switch (ATS). The 40kW exterior generator is newer and in good condition.

proof rated switchboard should be provided if located in same damp ambient conditions or the new electrical switchgear should be segregated from the boiler room equipment. Also, an infrared scanning test should be performed on all old (original) panelboards and switchgear (including disconnects, contactors, etc.) to detect heat build-up at weak termination points.

Hot spots (heat build-up) at termination points in panelboards and switchgear should be tightened, connections repaired or switchgear replaced as required. An insulation resistance test should be performed on all old switchgear feeders to detect any leakage currents as a result of poor/degraded conductor insulation due to age, corrosive atmospheres, moisture and heat or excessive heat or cold.
