AUBURN VILLAGE SCHOOL  
AUBURN, NEW HAMPSHIRE

## FACILITY ASSESSMENT FINAL REPORT

MAY 13, 2013

Facility Assessment Audit

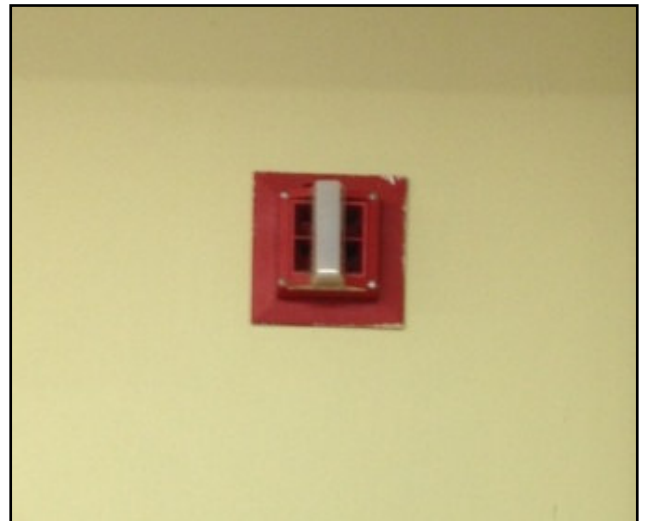
**Horn/Strobe Notification Device**

The existing fire alarm system is a conventional (zoned) fire alarm control panel (FACP), located in the side entrance vestibule. The FACP is manufactured by Pyrotrol. The FACP is in good condition, but it is original to the 1988 addition. It is approaching the end of its useful life expectancy and does not have room for future expansion. Detection consists of heat detectors throughout the classrooms and smoke detectors in the corridors, cafeteria, media center, common areas and stairways. Heat detectors are also utilized in utility closets, kitchens and boiler rooms. Since, the building is protected with sprinkler heads throughout, the smoke and heat detection coverage is adequate. All exit doors had required pull stations. On the other hand, the notification device coverage was inadequate in some areas. To be specific, all common (gang) restrooms and gym locker rooms should have strobe notification. Some of the corridors on the 1<sup>st</sup> and 2<sup>nd</sup> floors need more horn/strobe coverage.

It is recommended that the existing fire alarm control panel be replaced in the near future with a new addressable panel that is compatible with existing conventional devices and system wiring. Also, it is recommended that more notification devices are added throughout the common areas including corridors and restrooms per NFPA 72 and NFPA 101. Furthermore, strobe devices should be added to the boys and girls locker rooms.

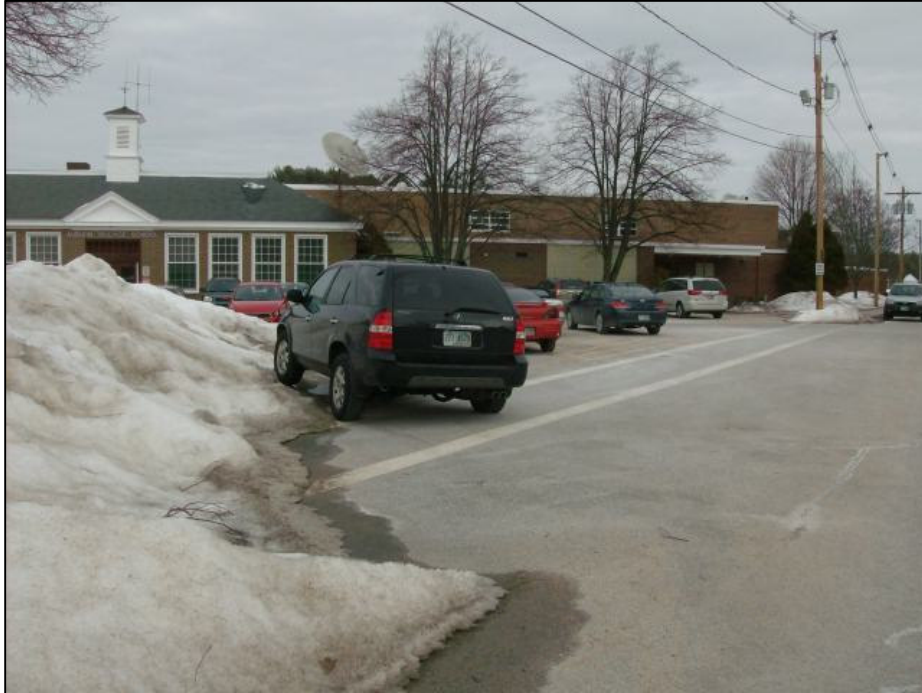
1. West Side Parking Lot: Note vehicle intruding into lengthy crosswalk, snow piled on sidewalk, and minimal separation from street.

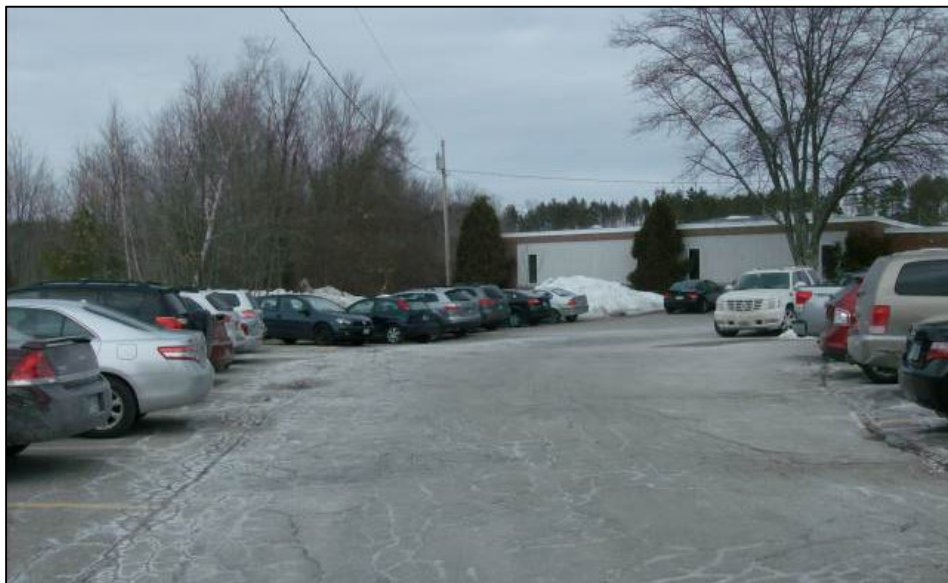
2. Spaces on the left half of this photo are completely or partially on Manchester Water Works property.

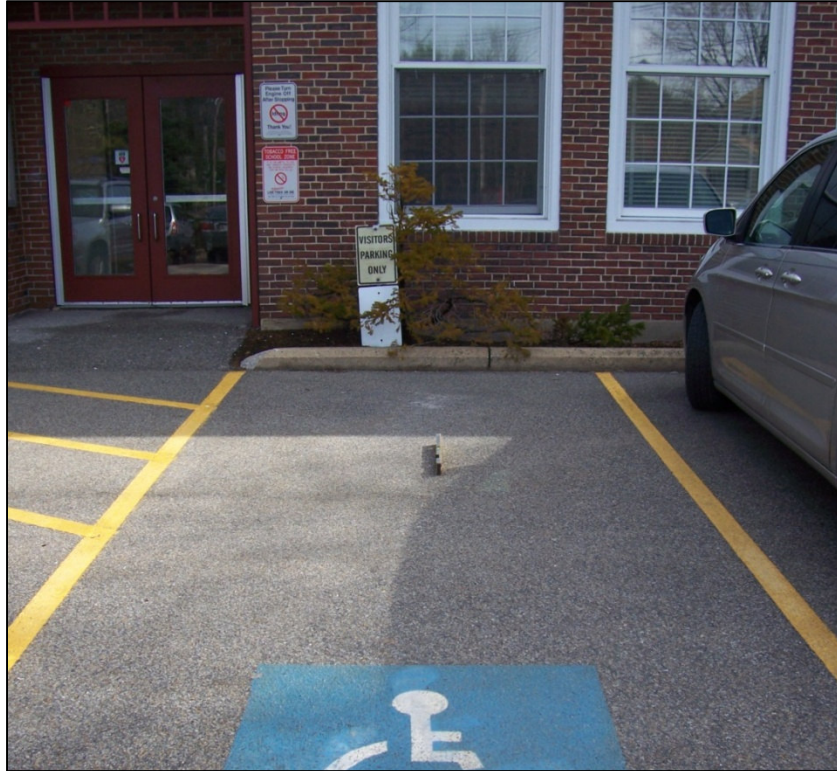
3. Accessible sign mounted too low and is unreadable.

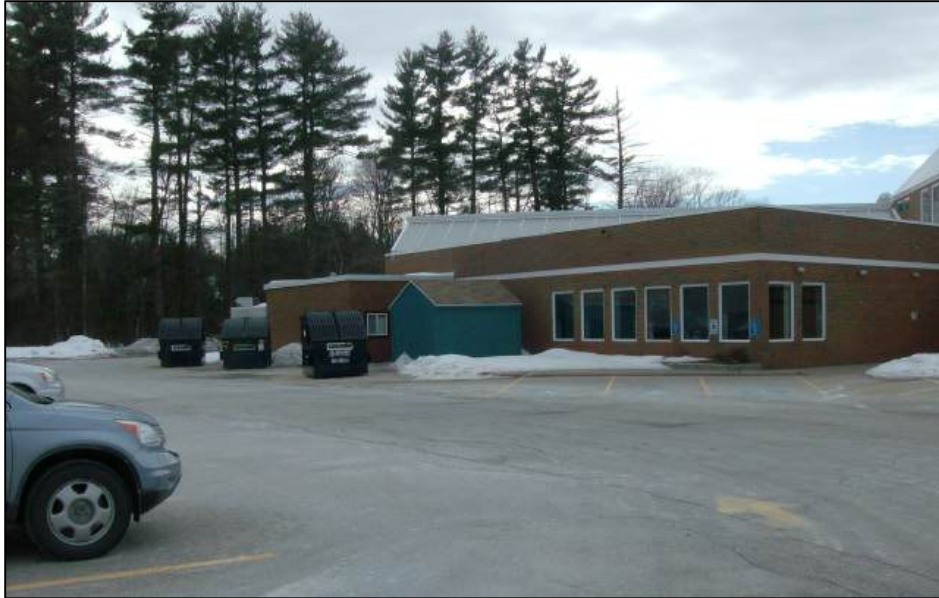
5. Non-compliant spaces on the East Side and dumpsters set on pavement.

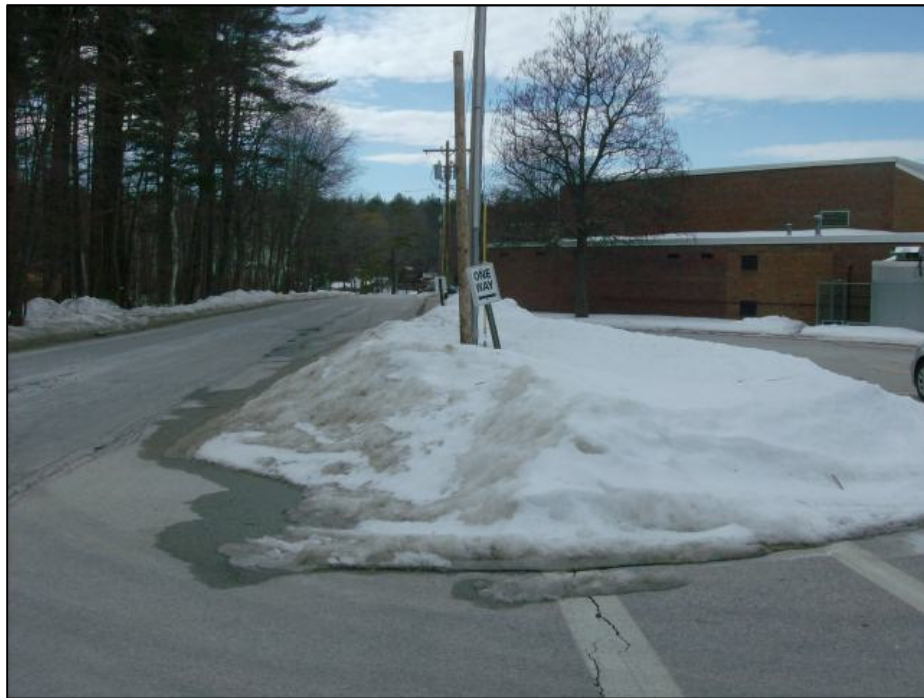
6. Obstructed sidewalk and parking space reduction due to snow stockpile.

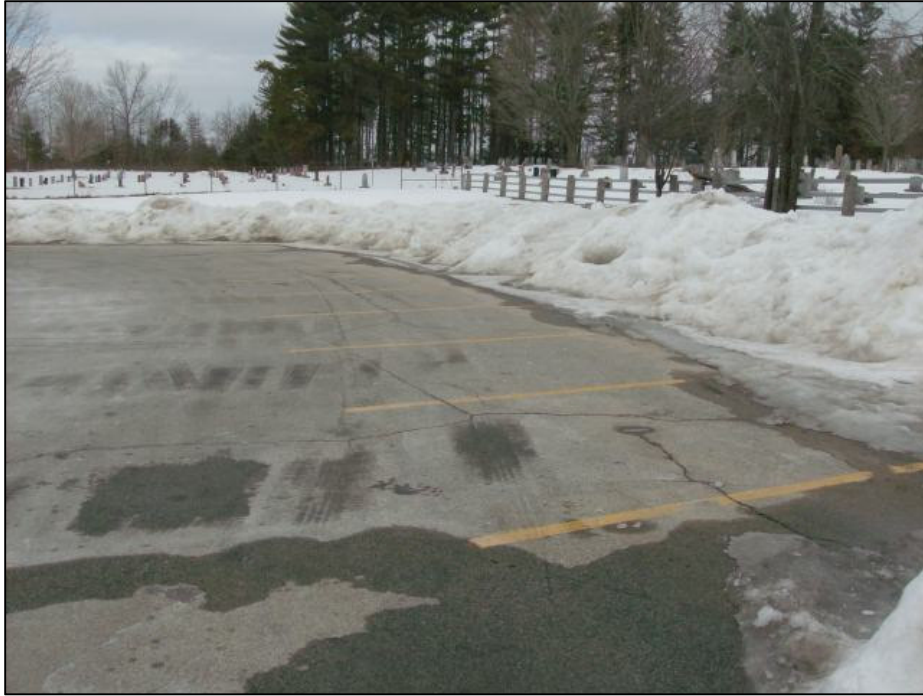
7. Snow stockpile eliminating usable parking spaces.

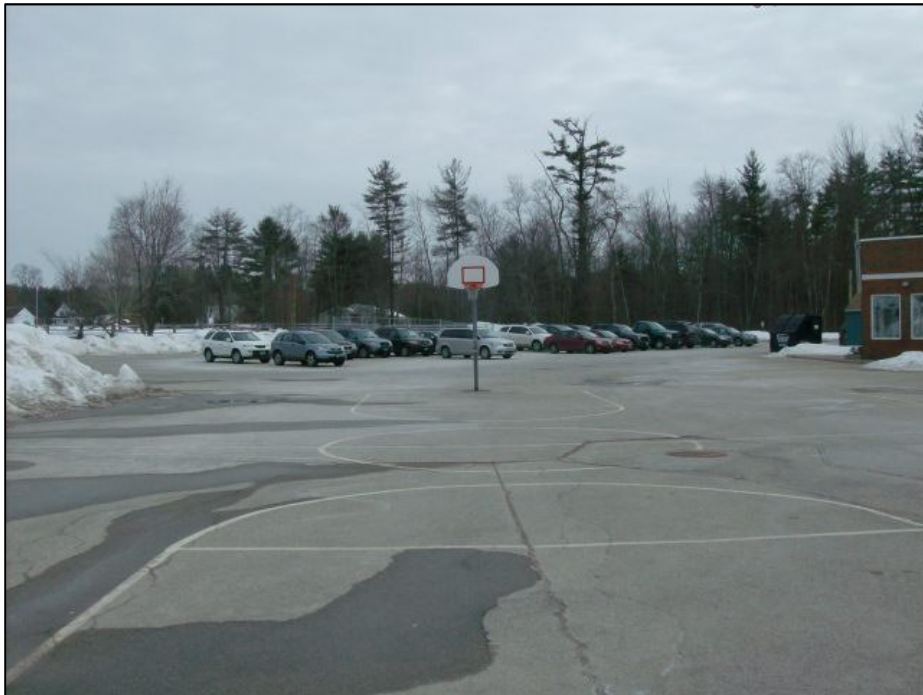
8. No separation between playground and parking lot.

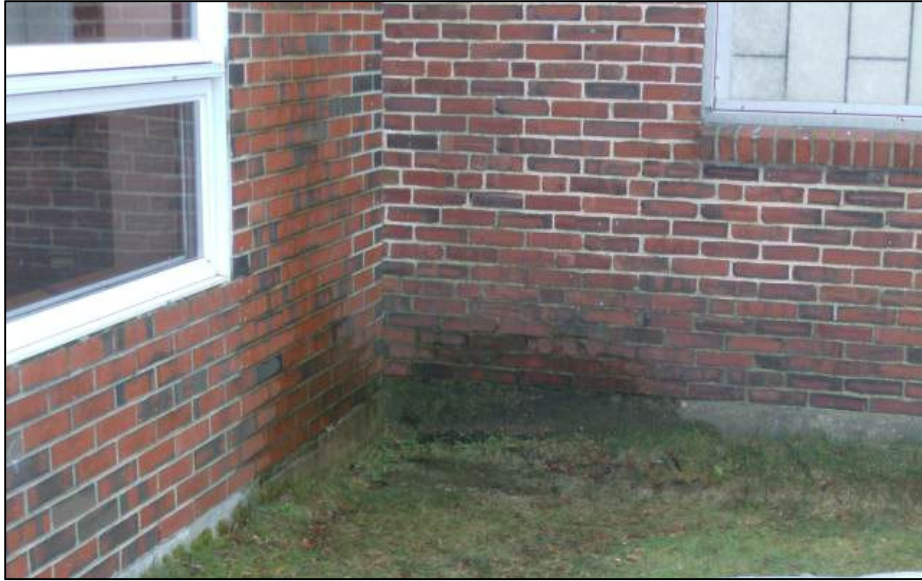
9. Water splashing against building and matted vegetation indicates need for a drip edge and surface drain system.

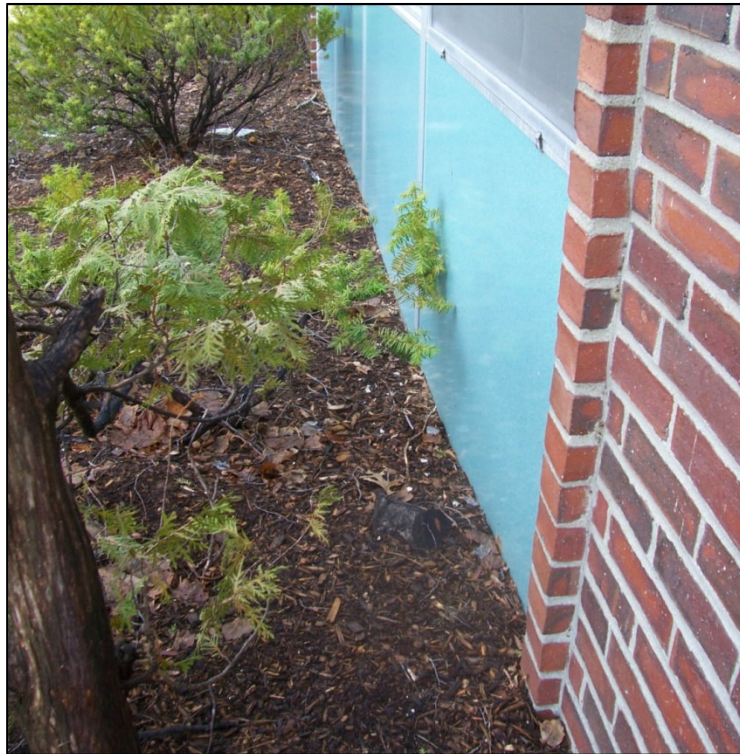
In many locations around the building perimeter there are pervious areas (landscape beds and grassed surfaces) that cover the lowest courses of masonry and the at-grade aluminum sills. This condition not only permits water to penetrate the building through the masonry joints and sill openings, but it prevents water inside the cavity wall from draining out through the masonry weep holes.

10. Landscaping bed covering brick courses and window sill.

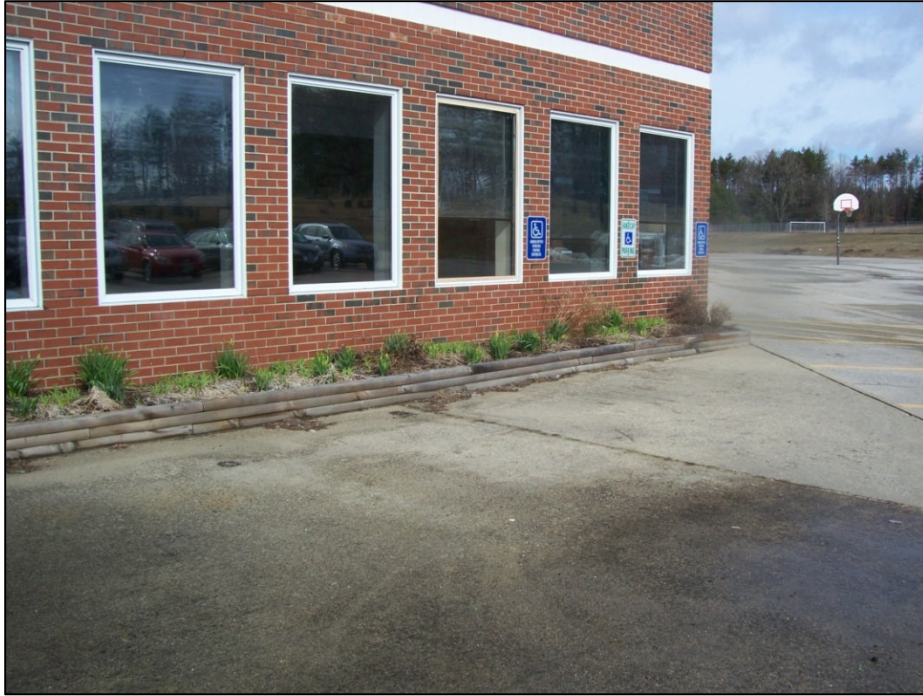
11. Landscaping bed covering brick courses.

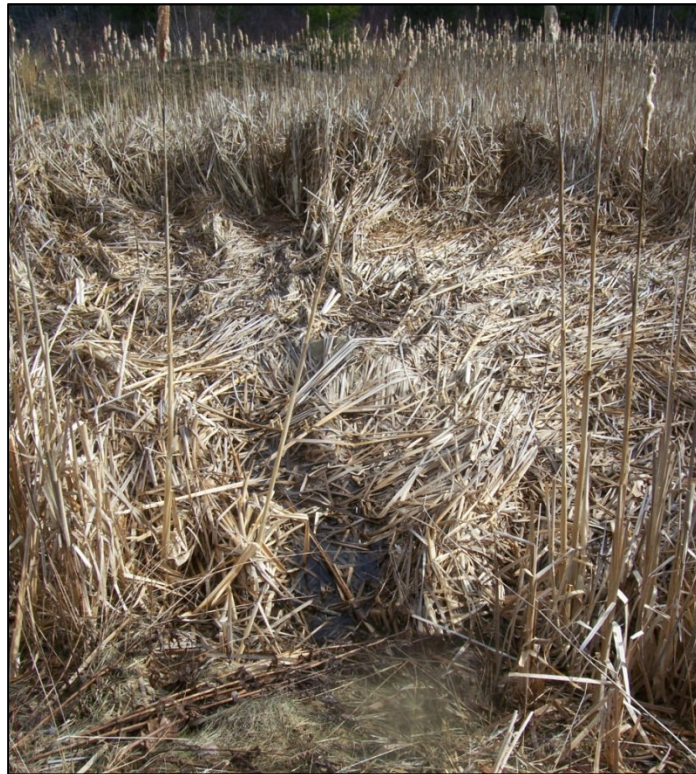
12. Overgrowth at detention pond (located off-site).

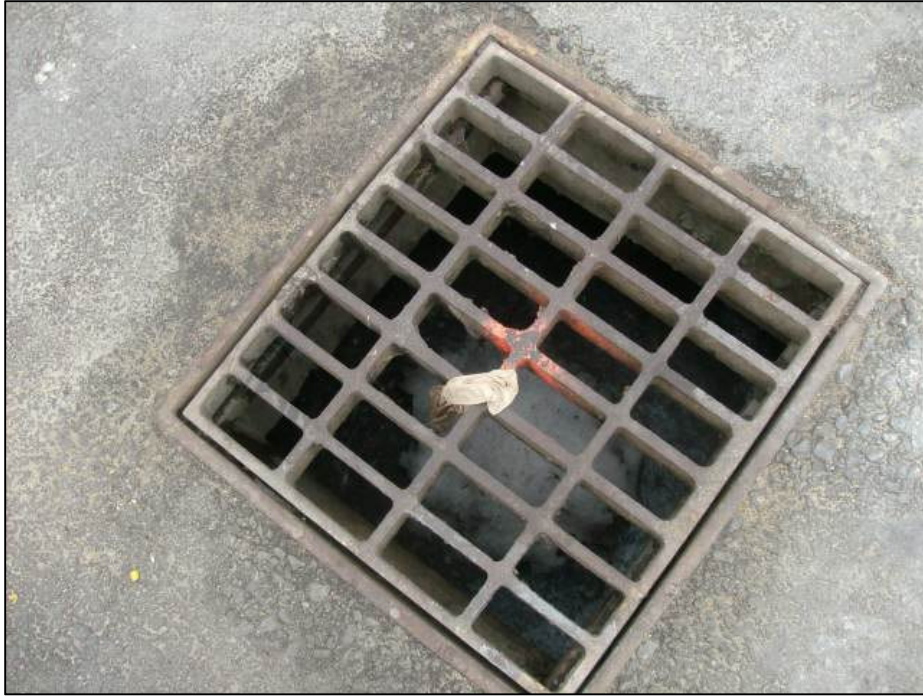
13. Shallow, snow-filled catch basin in east side parking lot.

- Replace existing catch basins with deep sump catch basins, installed with debris hoods over the outlet pipes.
- Construct a means of collecting and distributing the runoff and snowmelt that ponds along the edge of pavement between the parking lot and the cemetery.

- Vacuum out the sumps of the existing catch basins. Inspect the basins for signs of cracking or groundwater infiltration. Establish a maintenance schedule to perform this service at least once a year, or with greater frequency if needed.

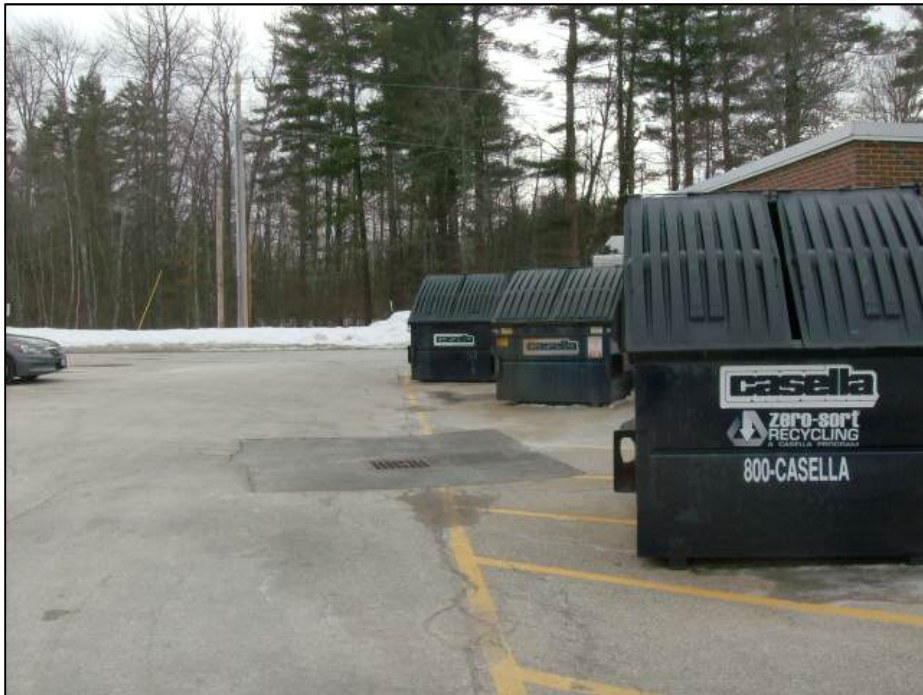
14. Dumpsters with no debris containment upslope of catch basin grate. Note absence of opaque screening and concrete equipment pad beneath the containers.

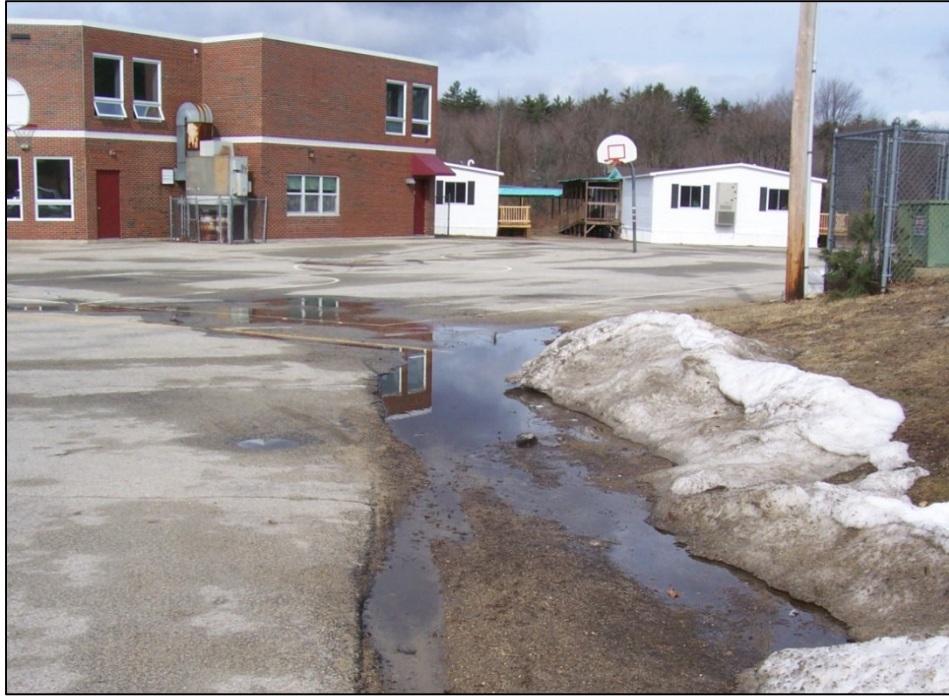
15. Ponding at edge of pavement running across lot.

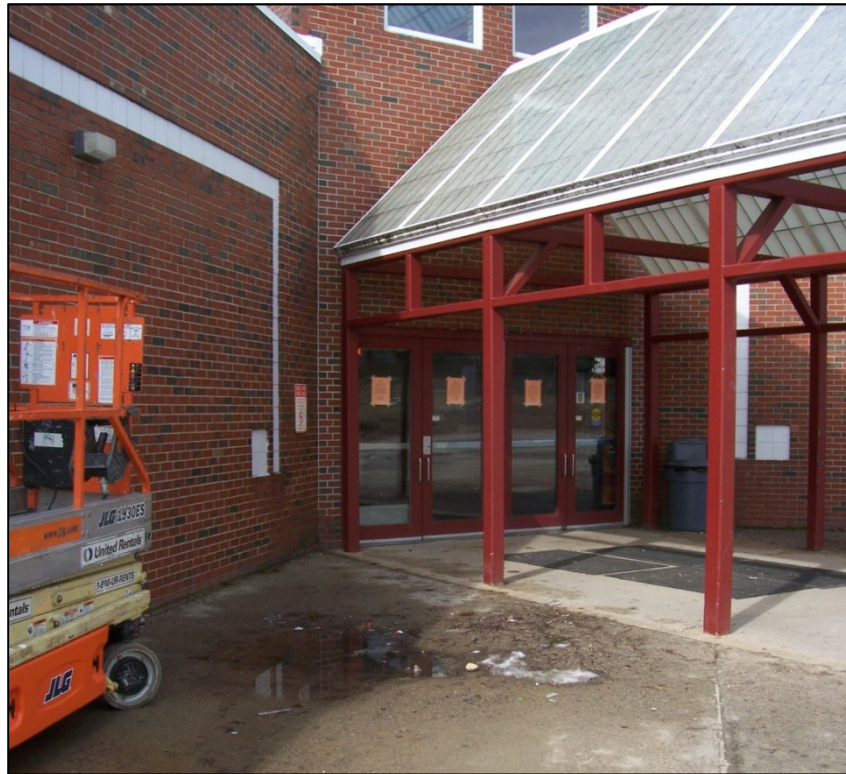
16. Ponding at east entrance.

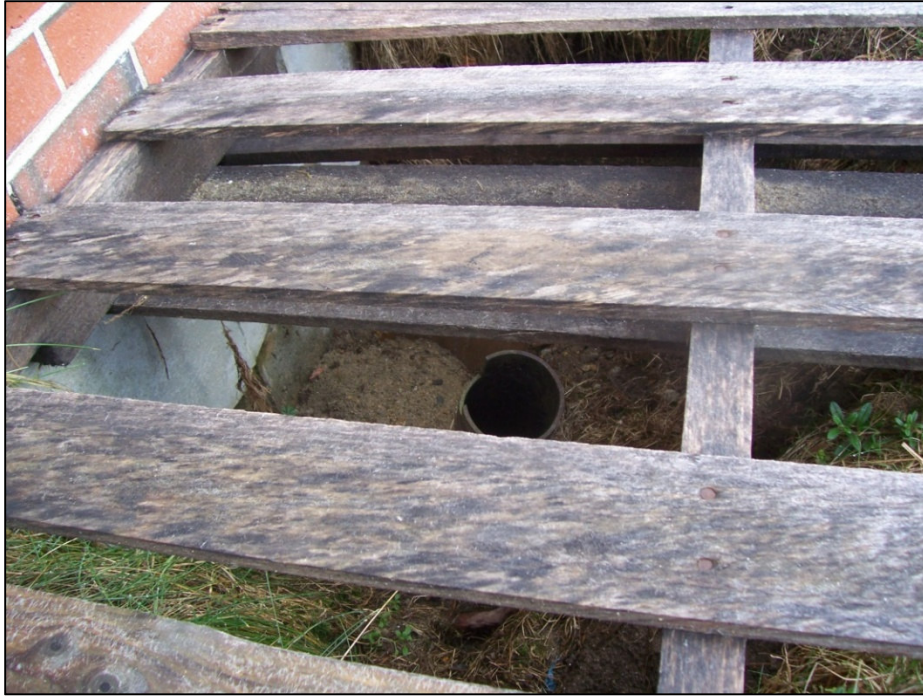
17. Open roof drain clean-out.

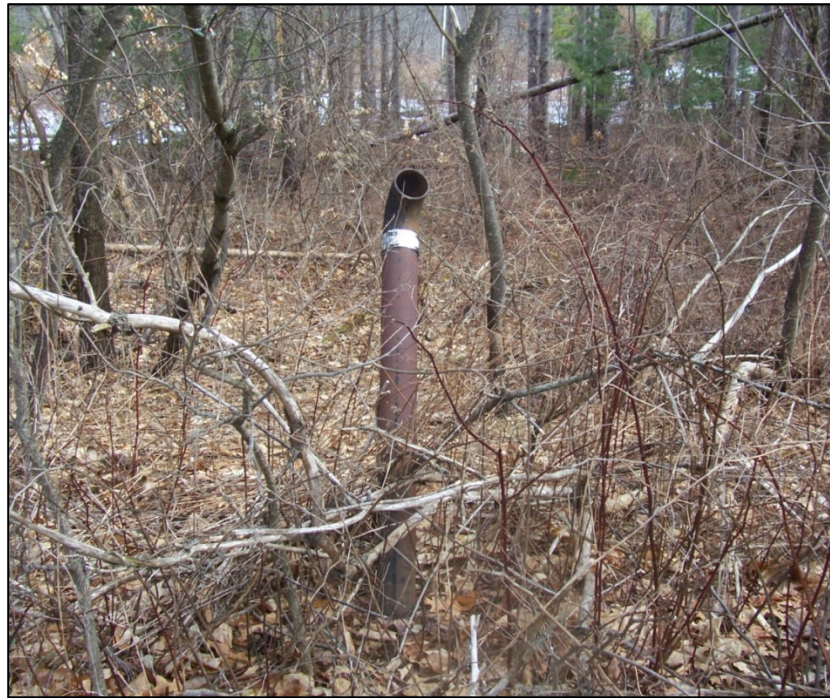
18. Leaning septic system vent pipe.

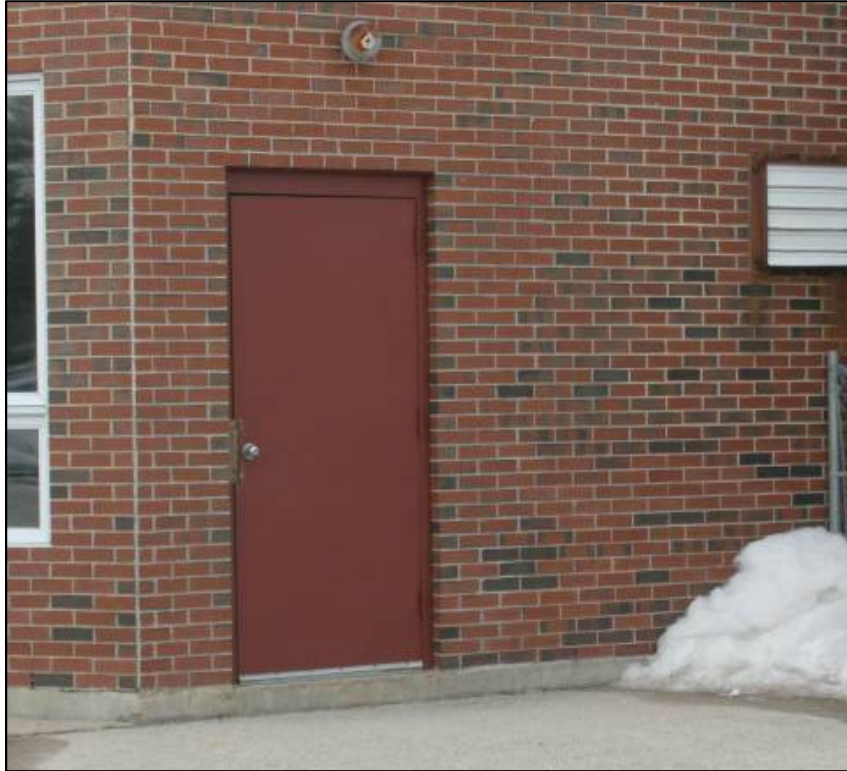
19. Classroom egress door stepping down to grade.

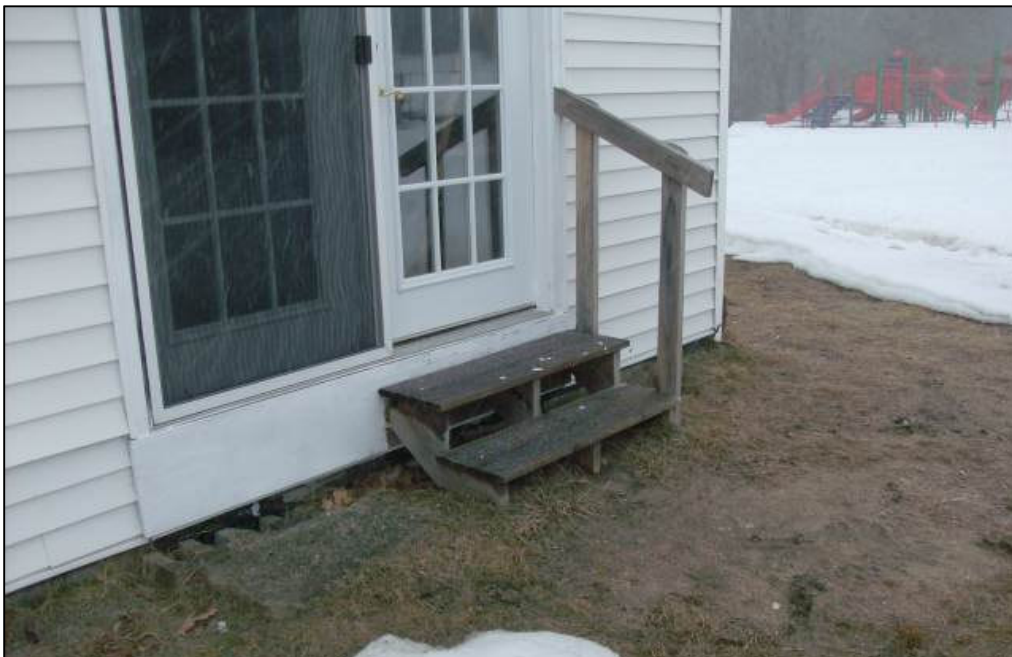
20. Non-compliant stairs and railing. Note absence of paved landing or sidewalk.

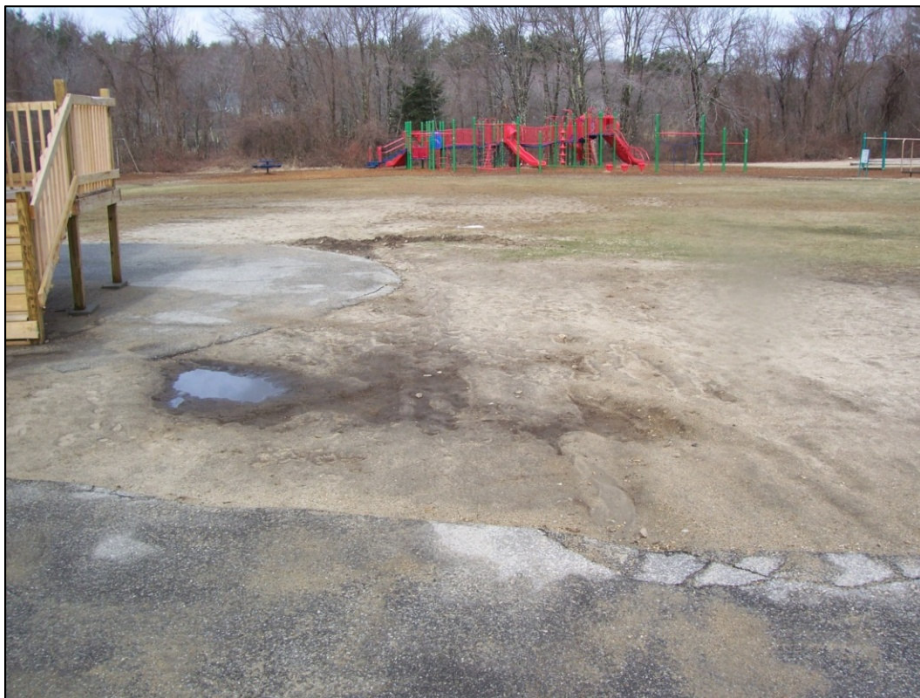
27. Sediments flushing into catch basin.
